CATEGORY 2.IMPROVED SEALING OF THE SCINTILLA CHOKETHERMAL DELAY SWITCH

No. S2/M1

No. S2/M5

No. S2/M9

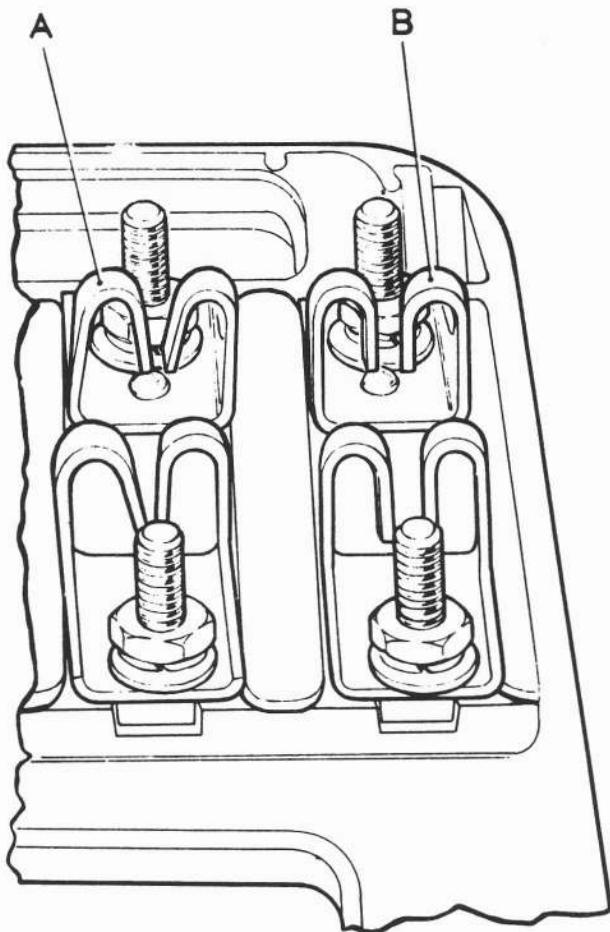
Fig.3. 'A' Fuse Clips set Incorrectly.  
'B' Correctly.

Figure 3 shows a comparison between the fuse clips set correctly and incorrectly.

Ensure that the fuse clips are not distorted. They should be set square and parallel in order to maintain the holder firmly in position.

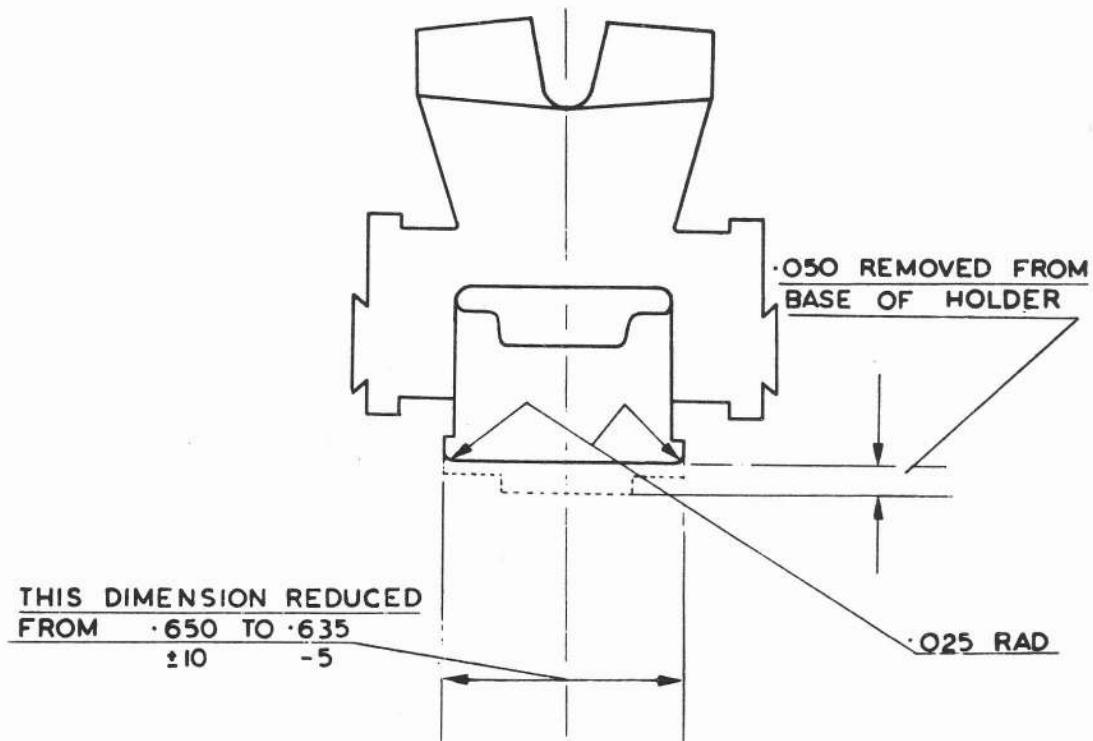
Fig.1. Method of Modifying the Fuse Holder

On late S1 cars and certain S2 cars, failure of the fuses to make good contact may be due to the fuse wires being located too high in the fuse clips. This fault can be attributed to one of the following causes.

- (a) Dimensional differences which produce a foul between the base of the fuse holder and the fuse clips, thereby preventing the holder from being pushed fully down into the clips.
- (b) The copper contact strips being incorrectly fitted, do not locate correctly on the moulding, which means that unless the fuse is carefully assembled the wire makes poor contact.

Remove .050 in. from the bottom of the fuse holder and reduce the width of the bottom to between .630 and .635 as shown in Figure 1.

This allows the position of the fuse wire to be lowered from .425 in. to .375 in. and enables the fuse holder to fit fully down between the clips.

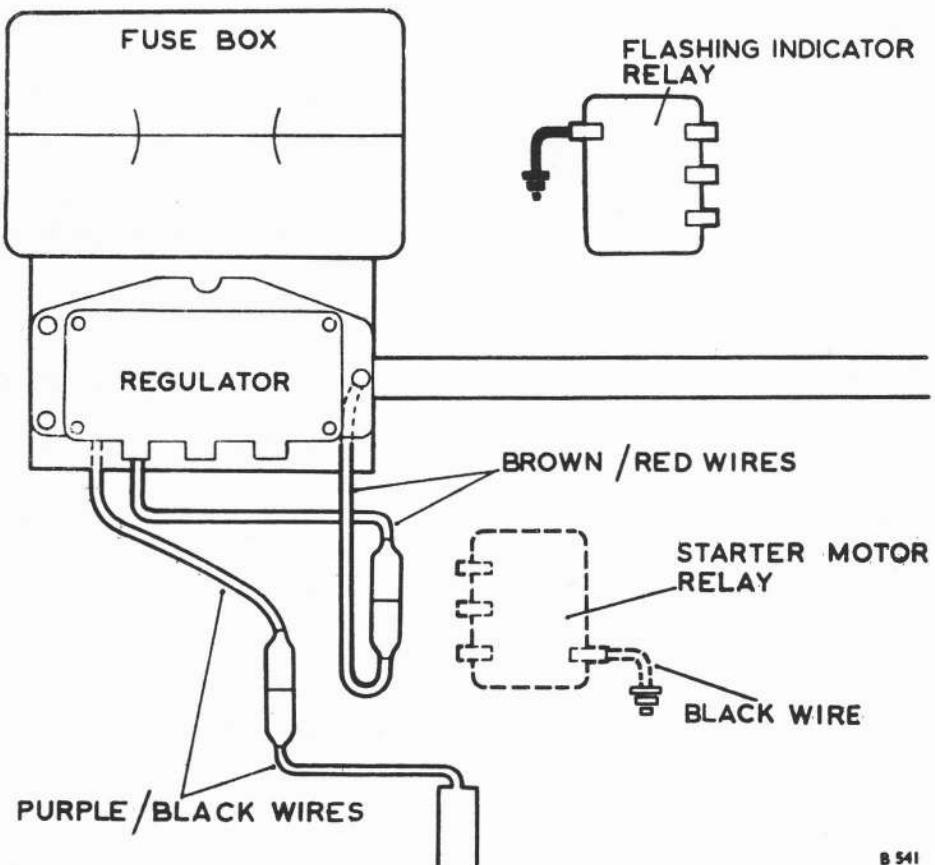
Fig. 1. Positioning of Starter Motor Relay and Re-wiring of Connections

A protective device, in the form of a relay switch, was fitted to S2 cars to prevent drivers from engaging the starter motor pinion when the engine was running. Recent Service experience has shown that this relay does not function correctly and Retailers and Service Personnel should remove these relays when affected cars next come in for Service or in the case of customer's complaint.

connector (UD.6074), (See Fig.1).

Remove the two Purple/Black wires from the connections C.2 and C.3 on the relay and connect them together using another double-ended connector (UD.6074).

Remove the Black earthing wire from the connection W.2 on the relay and from the bulkhead.

Remove the relay. The two cheese-headed screws and washers should be refitted to the bulkhead.

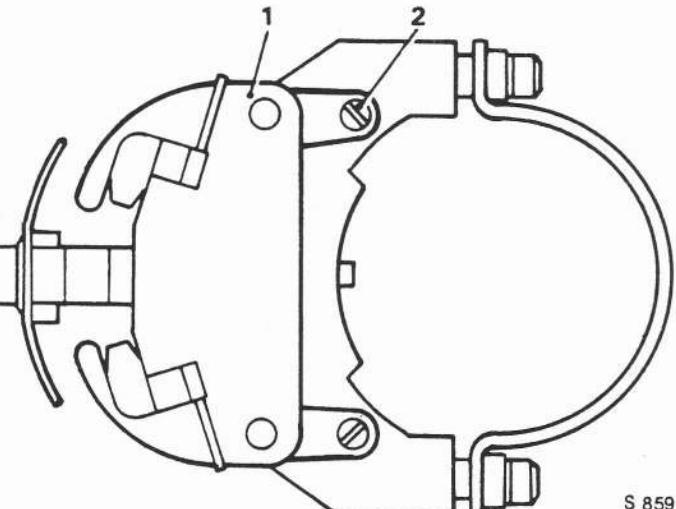
Figure 1. Direction indicator switch (UR 16530)

The direction indicator switch UR 5273 is no longer available. For replacement purposes, the switch used on Silver Shadow cars (UR 16530) will be fitted. When it is fitted, the terminal connectors must be changed.

1. The removal and replacement procedure for the new switch remains the same as for the old. However, there is a small modification to be carried out on the new switch as follows:
2. Remove the two screws and discard the brown insulation board (see Fig. 1). Replace the screws with a washer (X 4401) behind each screw head (see Fig 2).
3. Cut the 7 pin plug off and withdraw the insulation board along with the green/yellow and green/blue wires.
4. Fit 'Lucar' connectors to all the wires except the black one to which a bullet connector is fixed. Connect the wires as follows.
