**Bulletin**

MODEL : BENTLEY MARK VI

EXCESSIVE LEAKAGE OF OIL AT THE CENTRE STEERINGLEVER AND STUB AXLES(CENTRALISED CHASSIS LUBRICATION SYSTEM).FOR INFORMATION:

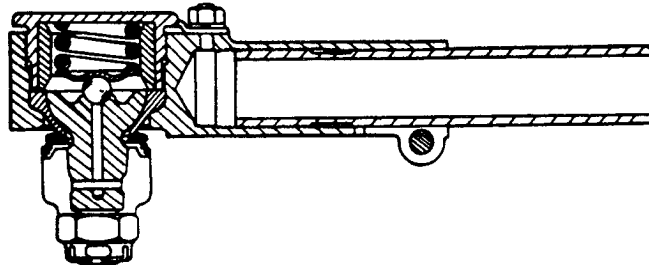
Fig. 1. Section through ball joint at front end of side steering tube.

When the pedal of the chassis oil pump is operated, a relatively large quantity of air is trapped in the three ball joints connected to the centre steering lever and compressed. During the next few hours, the trapped air expands, pushing the oil along until it escapes past the fulcrum pin bearings of the centre steering lever pivot assembly and the bearings of the stub axles.

The cure lies in packing the four joints of the cross steering tubes and the ball joint at the front end of the side steering tube with a soft type of grease such as Duckham's HBB grease in order to displace the air.

- (i ) Remove the front right-hand undershield. Jack up front wheels and turn wheels to full right-hand lock.
- (ii ) Remove split pin and nut from ball pin.
- (iii) Place a substantial steady block in contact with the lever near the ball pin to be removed, in order to provide a solid re-action point, and then with the aid of a large steel drift and hammer, give the eye of the lever (adjacent to the ball pin) one or more sharp blows which will release the tapered shank of the pin from its location in the lever. NOTE: The above method applies to all the ball joints to be removed.
- (iv ) Collect the pressure spring and the sealing disc.
- (v ) Remove the cap nut of the joint (see Fig.1) and completely pack the joint with grease.

- (vi) Before refitting the ball joint (ball pin) to the lever, clean the tapered shank of the pin and corresponding hole. With the sealing disc and pressure spring in position on the pin and the correct way round (See Fig. 1), refit the ball pin to the lever, fully tighten up the nut and secure with a new split pin of the correct size.

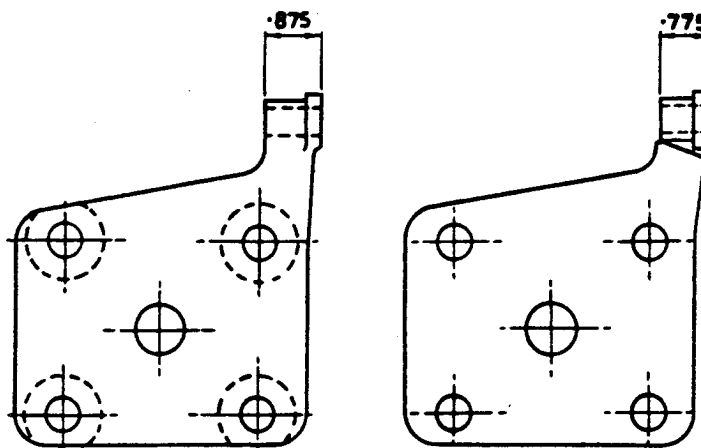
The new plate (Fig.1) is similar in general shape to the earlier designs, but no machining has been carried out on either face beyond the spot facing on the underside of the 'U' bolt holes. Owing to this, left-hand and right-hand plates are now required as follows:-

An intermediate type of modified spring plate, RF-8101 (Fig.2) was used for a short period prior to the introduction of the latest design, but this has proved unsatisfactory in service. In view of this, it has been decided to request Retailers to modify all cars in their areas fitted with this intermediate type plate on a Category 1 basis.

Although this calls for immediate retrospective action, it is realised that in many cases the geographical location of the car renders it impracticable in view of the simple nature of the work involved. In such cases, therefore, it is suggested that the action to be taken is left to the discretion of the Retailers, who may decide to forward the material and fitting instructions to the individual owner.

It should be noted, that due to the increased width of the boss on the new type plate (0.875" as against 0.775" on the earlier design) new anchorage pins for the lower shock damper linkage will also be required when these new plates are fitted. These pins are supplied separately, and should be assembled in their respective plates prior to these being fitted to the car.

Proceed as follows:- Insert the pin from the shouldered face of the boss, shorter end first, push fully home, and then fit and fully tighten up the lock nut. **Peen** over to lock.

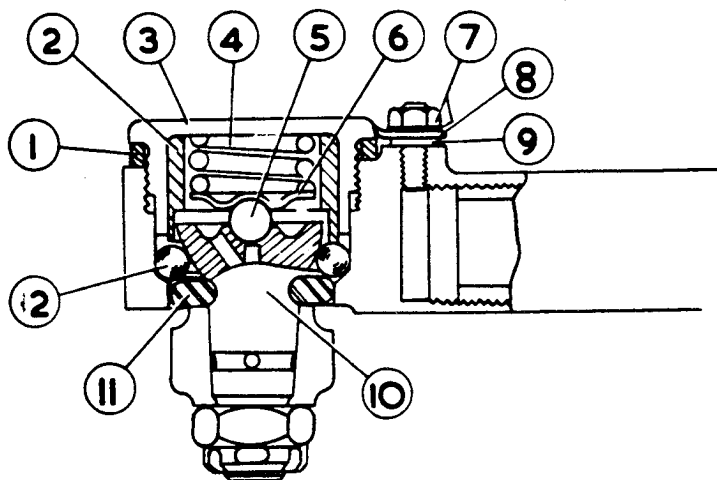
FIG.2. SECTION-SOCKET-SIDE STEERING TUBE FRONT END (PRIOR TO MODIFICATION.)

Commencing at Chassis No.B-215-PU steel balls (12 Fig.2) were incorporated in place of the previous bronze seat (2 Fig.3) in the front end socket of the side steering tube to reduce steering friction.

Owing to the steel balls grooving and causing hard steering, these have been discarded and reversion has been made to the original bronze seat as from Chassis No.B-390-TN and onwards on right-hand and left-hand drive cars.

- (i) Remove the rubber seal (11 Fig.2) from the groove in the ball pin.
- (ii) Remove the nut and spring washer, (7), the locking plate (8), the plain washer (9), and with a 'C' spanner, remove the cap nut (3).
- (iii) Remove the joint ring (1) from the cap nut, the sleeve (2), the spring (4), the spring pad (6), the ball (5), the ball pin (10), and finally the steel balls (12). Items 1, 2, 9, 11 and 12, should be discarded. The sleeve (2) is replaced by the sleeve RF-3561. Clean the remaining dismantled parts.
- (iv) Re-assemble the ball joint, using the new parts as illustrated in Fig.3, and refit to the centre steering lever.

**NOTE:** When it is found that the ball end pin (10 Fig.2) of the front socket has been grooved or pitted by the steel balls, a new pin FW-1000 (included in the list of parts on Page 1) should be fitted.
