MODEL BENTLEY MARK VI

STONE GUARDS ON REAR WINGS AND SILL.

**Bulletin**

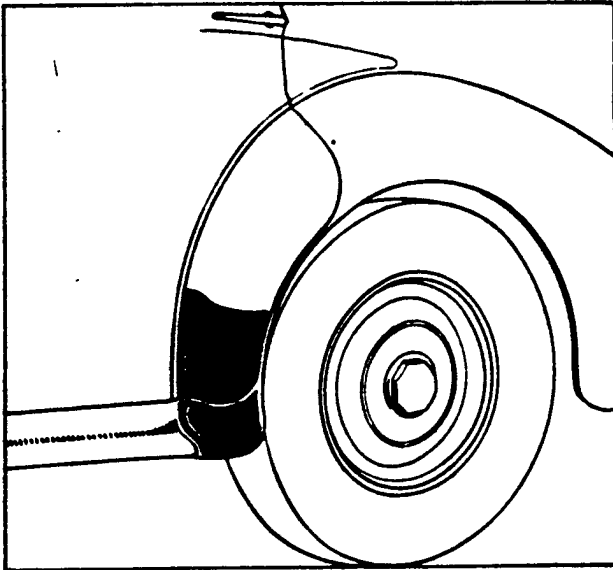
STONE GUARD IN POSITION.

Moulded rubber stone guards on the front of the rear wings and the rear end of the sills are now a standard fitment. Some cars may not have been fitted with them, in which case they may be fitted on request. In such cases they may be obtained in sets from Hythe Road Service Station together with the requisite quantity of the materials necessary for affixing them.

To fit the stone guards, first, accurately align the front edge, and with the guard pressed tightly to the wing, mark out the outline. Remove the guard, and thoroughly clean and degrease the paint using a reliable agent, trichlorethylene being the most satisfactory. Brush on a thin even coat of Bostik Company's Primer 81-15 and allow this to dry for  $1\frac{1}{2}$  hours, taking precautions to keep it free from dust. Rice paper if available, will not permanently adhere and is an excellent cover.

Next roughen the inner surface of the rubber using No.2 emery cloth or similar means. Mix thoroughly together the quantities of Bostik Company's Cement Boscroprene 2400/1 and 2400/2 as supplied, and applying one coat evenly to both the rubber and the metal, allow to dry for 45 minutes. Note that when mixed, the cement will last only 24 hours, therefore mix only the necessary amount.

When applying the rubber to the metal after the requisite drying period, tack the front top corner in position, gently align the front edge, and when sure of the position, firmly press it home. Then work from front to rear with a roller keeping the top edge in line with the marking out, and squeezing out any wrinkles and air bubbles. The

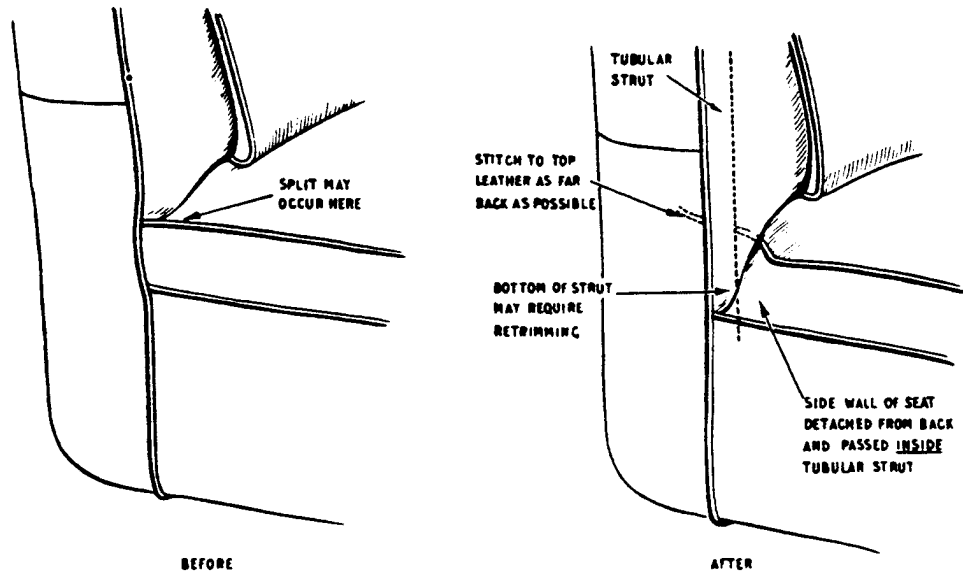
An alteration has therefore been made as shown in the drawing herewith. It will be seen that the side wall is now detached from the back and is passed inside the tubular strut. This alteration can be applied to existing seats in the event of any complaint of splitting.

1. Remove seat back millboard with carpet and hide.
2. Take side wall of seat cover inside the tubular strut and "french" securely to the top of the cover and piping. (This will allow the side wall to flex with the seat cover instead of being constrained by the tubular strut.)
3. It may be found necessary to cut a small portion of surplus hide from the rear of the cushion cover to enable you to cover a portion of bare tube which may be left exposed. This is only a matter of an inch or so of hide and may not be necessary in all cases.
4. Replace the millboard seat back together with the carpet, using the same seat back hide which is also refrenched round the top edge of the seat back.

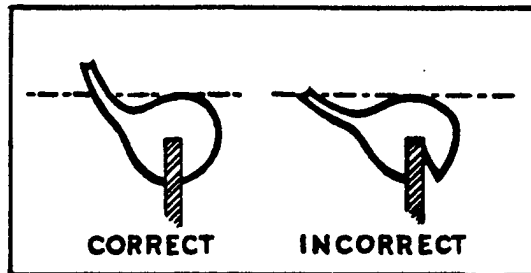
Section through rubber seal, showing correct methods of sticking seal in position.

- (v) Examination of the underside of the lip of the ventilator will show that there are depressions at each corner caused by the cut-away of the sheet metal before turning over the lip. These depressions prevent a good seal being made with the rubber, so it will be necessary to fill them in with paint fillers in order to make the surface smooth and flat.
- (vi) When refitting the ventilator, great care should be taken to ensure that it is accurately positioned in relation to the rubber seal before the four screws which secure it to the hinge are tightened. These screws pass through clearance holes which allow a limited amount of adjustment to the position of the ventilator, thus enabling an even pressure on the rubber seal to be obtained in the closed position.

Also, before allowing the adhesive to set, make sure that the rubber is so positioned that it will contact the lip of the ventilator all the way round. This can easily be checked by placing the ventilator in position and then trying to rock it.

It is recommended that a test is carried out by pouring water over the ventilator in order to check that an effective seal has been obtained.

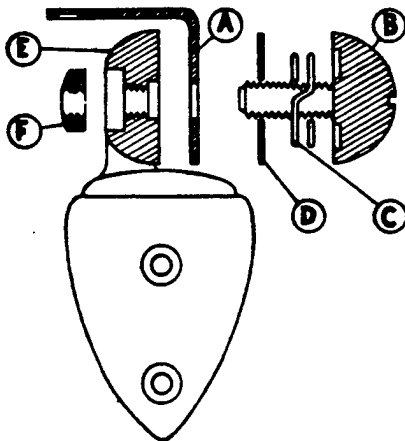
This Bulletin is issued for guidance in adjusting sun vizor hinges which are either too tight to operate or have worked loose.

The brass washer D may not always be found on early chassis Nos. and if this is the case, a similar washer should be fitted about .025" thick. This prevents the end of the Thackery washer C from biting into the bracket.

1. With the lock nut (F) loose, screw in B as far as it will go. This should completely lock the assembly.
2. To obtain the correct amount of friction, unscrew B slightly, the precise amount can be determined by testing the movement of the vizor, but it will be approximately  $\frac{1}{4}$  turn. Tighten the lock nut with a forked screwdriver as tightly as possible.
3. Increase the locking action by further unscrewing B very slightly, at the same time turning the lock nut with it. The friction of the bolt and nut thread is thus used to help the lock nut to tighten up an extra fraction of a turn against E.

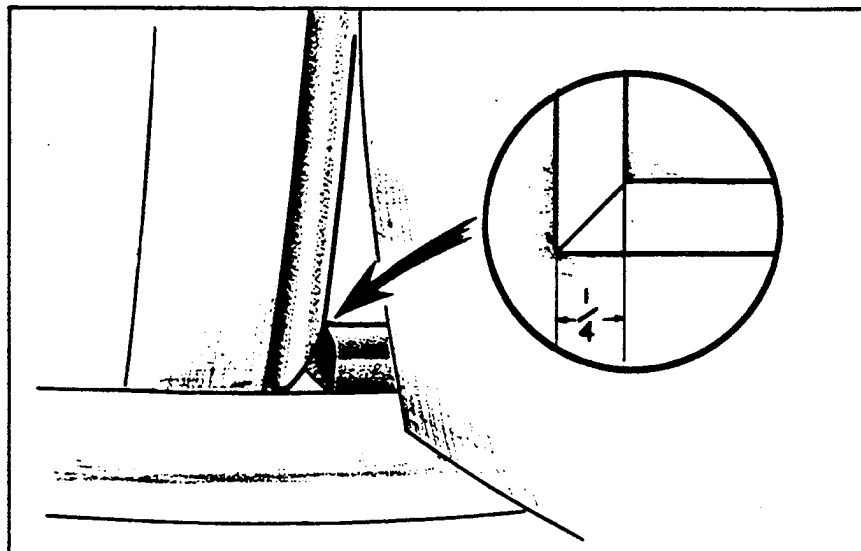
In order to compensate for this tendency to spread, and at the same time provide adequate means for drainage during wet weather, all current Standard Saloons in production have the bottom sealing rubber along the outer edges of the sills "cut back", leaving a gap of approximately  $\frac{1}{4}$ " at the point of juncture with the vertical sealing strip at the foot of the centre door pillars as shown in the attached sketch.

Retailers are advised, therefore, when dealing with complaints of such a nature from owners of earlier models of Standard Saloons, to cut the existing lower door seals to conform with the current procedure.

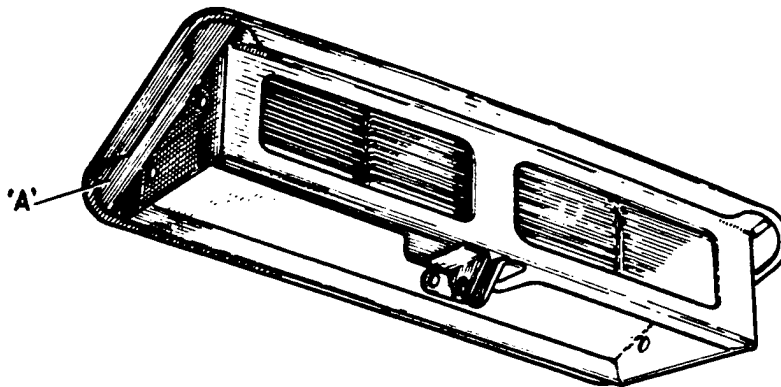
Fig. 1.

In the event of a complaint from a customer of insufficient ventilation through the top scuttle ventilator, a modification has been introduced as described below for improving the air flow, by removing the existing two grilles from the scuttle ventilator lid and fitting a nickle plated wire mesh screen. (Part No. RB.5266 - obtainable from the London Service Station.)

Note: If upon examination of the sealing surface of the underside of the lid it is found there is a depression at each of the four corners, ('A' Fig.1), caused by the clinched-over flange, then opportunity should be taken to fill them in as described below, in order to make the surface smooth and flat, thus making a better water seal.

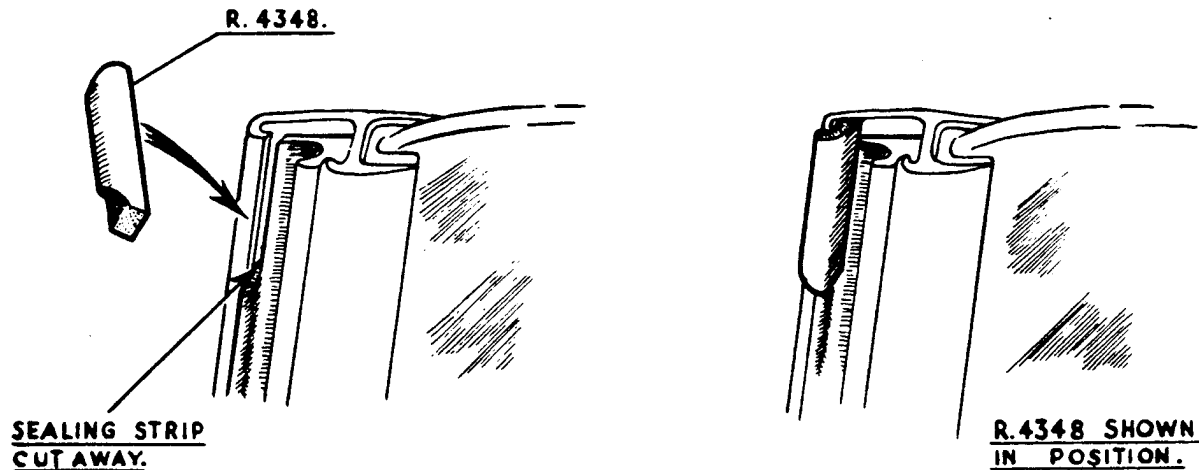
Cases have occurred in service where vibration has caused the front windows on early type Bentley Standard Saloons to rattle when these are in the half open position.

As a means of obviating this a special rubber buffer strip (Part No. R-4343) has been introduced, and Retailers are recommended to incorporate this whenever dealing with complaints of this nature.

This will involve the cutting away of approximately 1.00" of the existing seal to accommodate the rubber buffer at the topmost corner of the window frame as shown in the sketch below.

A suitable sealing compound for retaining this buffer strip in position is Bostik No. 252.

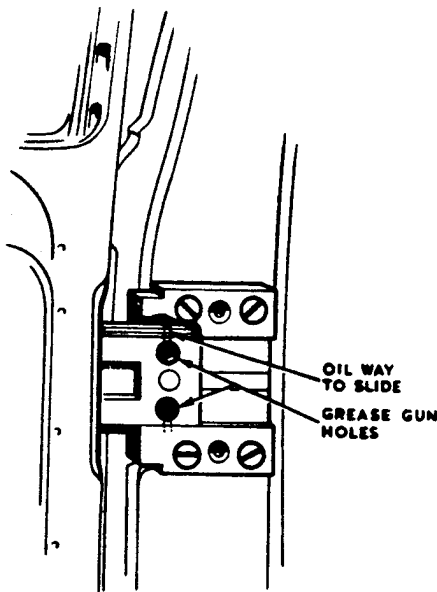
It is realised that the effective lubrication of the top slide, where roughness occurs due to the tilting action of the hinges under the weight of the door, presents some difficulty, as the lubricant is likely to be scraped off by the sliding action of the moving parts.

It has therefore been decided that on the original build up of the car at the Factory, that the door hinges are to be lubricated with a graphited grease, namely D.A.G. graphite grease "G.A", and Retailers are recommended that if a door is being overhauled in service, that they should also carry out similar action.

A modification is to be introduced by the drilling of two suitable holes in the slide piece for the insertion of the grease gun, (see illustration) and it will be recommended in the Owner's Handbook that this part is periodically serviced, every 10,000 miles by the Owner, using Mobilgrease No. 2 as the grease gun in the car tool kit is already charged with this grease.

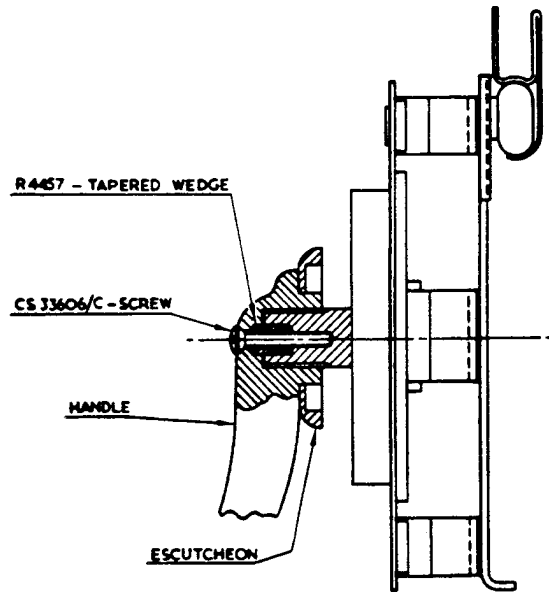
FIG. 1.

A few instances have been reported where the quick-lift window regulator handle has worked loose during service on existing models of Bentley Mark VI Standard Saloon.

As a means of overcoming this, a tapered plug (Part No.R-4457) has been introduced for fitting into the end of the existing splined shaft of the window regulator, and Retailers are recommended to incorporate this whenever dealing with complaints of this nature.

Fig. 1 illustrates the general arrangement of the regulator assembly with the plug in position.
