MODEL BENTLEY MARK VI

MODIFICATIONENGINE OIL FILLER CAP WASHER.

REPLACEMENT OF TAPPETS.

FOR INFORMATION:C & A CYLINDER HEAD GASKETS.

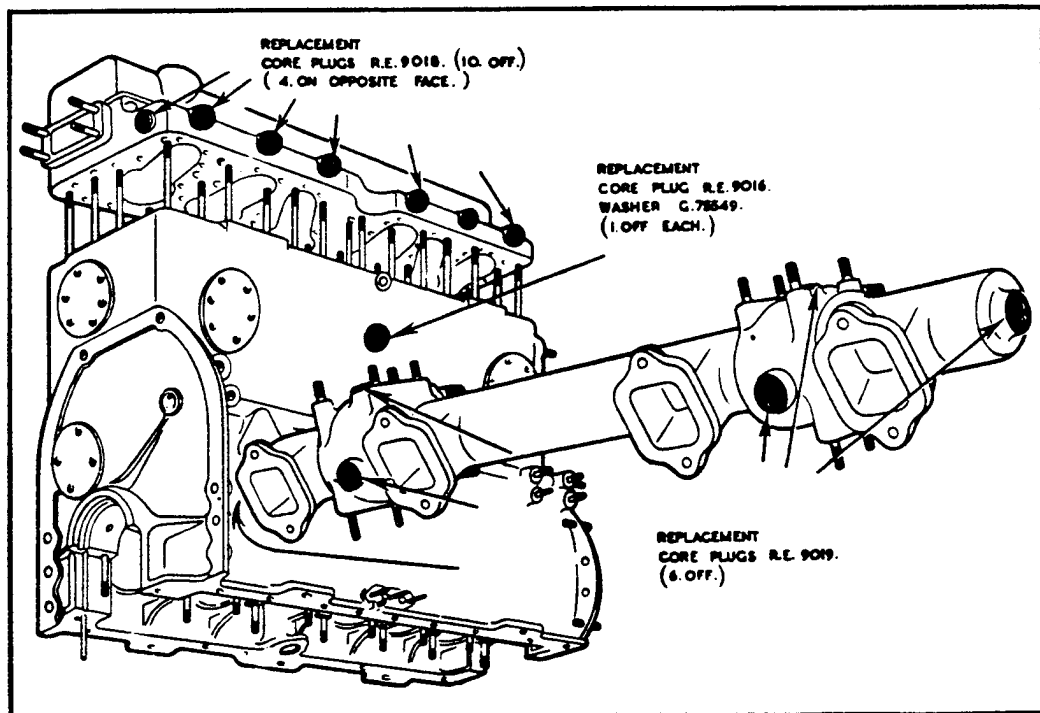
Bentley Service Bulletin BB-19 deals with the replacement of engine core plugs on a Category 2 basis, conditional upon partial or complete overhaul.

The following illustration gives fuller details of the location of the core plugs to be replaced, together with replacement part numbers.

It should also be noted that if a coolant leak develops from any of the core plugs when the engine is fitted with the pre-modified type, this may indicate that a state of corrosion exists in other core plugs caused initially by the engine remaining drained of coolant for lengthy periods of storage or shipment. If a leak is apparent therefore, the instructions given in Bulletin BB-19, limiting this modification to overhaul cases only, must be disregarded, and all core plugs replaced with the modified type.

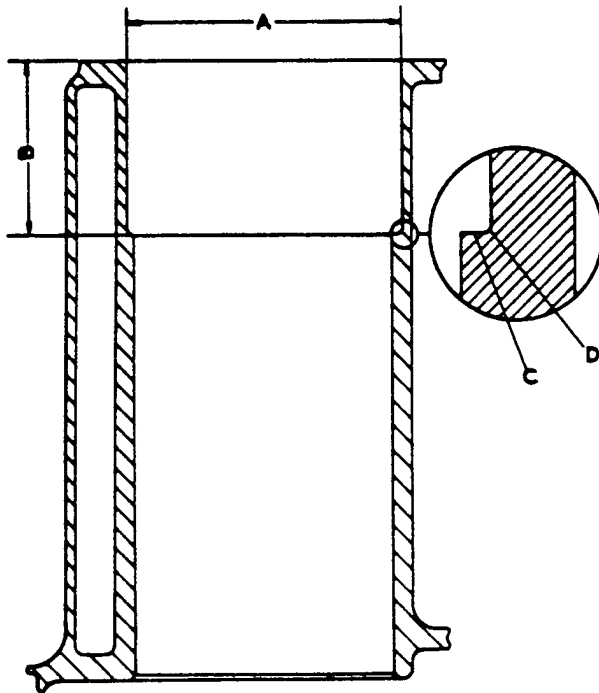
FIG.1. SECTION - CYLINDER-SHOWING COUNTERBORE.

cylinder bore. Next, adjust the boring cutter so that the first cut is heavy enough to get underneath the original chromium plating and counterbore the cylinder to a depth of 2.245" to 2.250" (57.02 to 57.15 m/m). See 'B' Fig.1.

The bottom face, 'C' Fig.1, of the counterbore must be machined perfectly true. Any slight discrepancy on this end will cause a gap on one part of the "butt" joint.

NOTE: If, when measuring the diameter of a counterbore ('A' Fig.1), it exceeds 3.6265" (92.11 m/m), it will be necessary to fit an R-4610 oversize short liner. This liner is marked with white paint and has an external diameter of 3.631" to 3.632" (92.23 to 92.25 m/m), and one should be selected that will not allow an interference exceeding .004" (.1 m/m), or less than .0025" (.06 m/m).

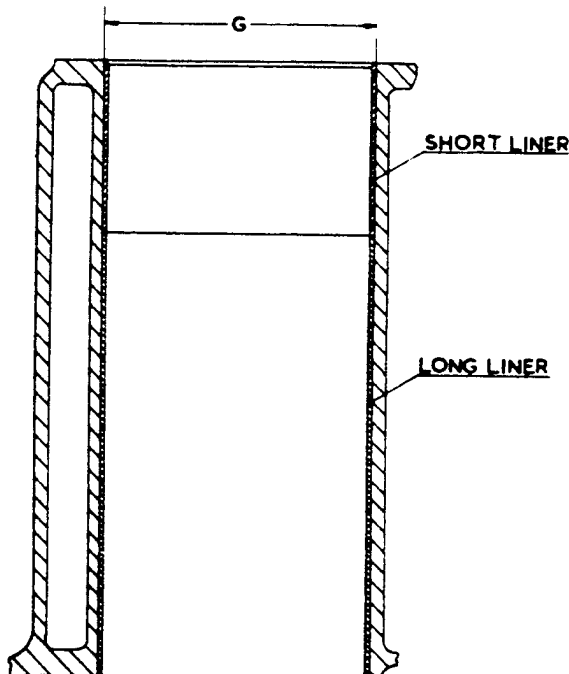
FIG. 3. SECTION - CYLINDER - TWIN LINERS IN POSITION (3 500" DIA. BORE ENGINE).

- Bore out the short liner in stages, until it has a wall thickness of not more than $.015'' (.38 \text{ m/m})$. This operation must be carefully carried out in order that the boring cutter does not contact the cylinder counterbore. As a guide when boring, it should be borne in mind that the external diameter of the liner (in position) is $3.625'' (92.07 \text{ m/m})$ i.e. the same diameter as the counterbore 'A' Fig.1. From the upper face of the cylinder block, the liner should be bored to a depth of $2.250''$ to $2.255'' (57.15$ to $57.27 \text{ m/m})$.

- With a sharp suitable hand tool, carefully break away the upper end of the liner from the cylinder wall and remove the remaining portion.
- (iv) To assist in obtaining the required interference of $.0025''$ to $.0035'' (.06$ to $.09 \text{ m/m})$ between the cylinder and the liners, the short and long liners (RE-9921 and RE-9922) are colour coded (graded) in their bores as follows:-

- Those marked with blue paint have an external diameter of $3.638''$ to $3.6385'' (92.40$ to $92.42 \text{ m/m})$
 - Those marked with yellow paint have an external diameter of $3.6385''$ to $3.639'' (92.42$ to $92.43 \text{ m/m})$
- (v) Apart from the liner dimensions given above, the long liners should be measured at six different diametrical points; take the mean of these measurements for the external diameter. Select a suitable short liner to match with the obtained measurement. It is not necessary to similarly measure a short liner; refer to the colour coding.

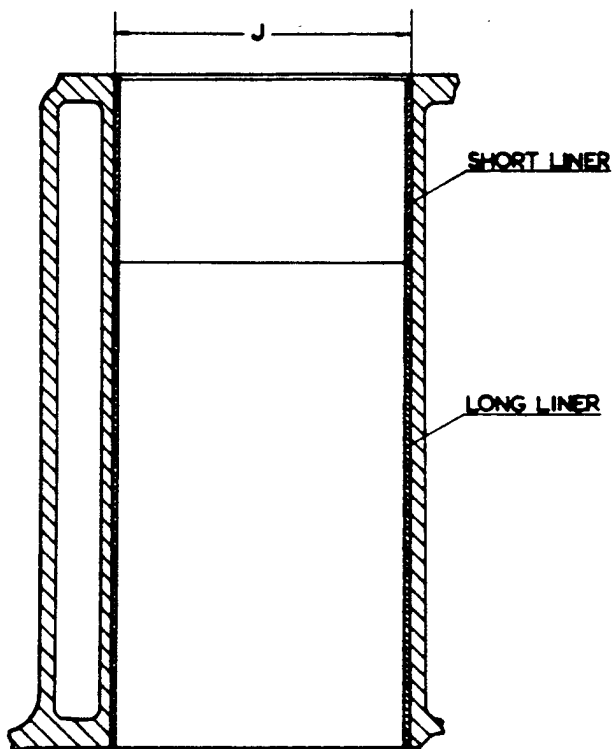
FIG.4. SECTION - CYLINDER-TWIN LINERS IN POSITION (3.625" DIA. BORE ENGINE).

- (i) Remove the short liner from the scored bore as described in Sub-para.(iii) of para.4 and note that when boring out the liner prior to removal that the external diameter (in position) is 3.750" (95.25 m/m) i.e. the same diameter as the cylinder counterbore.
- (ii) To assist in obtaining the required interference of .0025" to .0035" (.06 to .09 m/m) between the cylinder and the liners, the short and long liners are colour coded (graded) in their bores as follows:-

- a) Those marked with blue paint have an external diameter of 3.763" to 3.7635" (95.58 to 95.60 m/m).
- b) Those marked with yellow paint have an external diameter of 3.7635" to 3.764" (95.60 to 95.62 m/m).

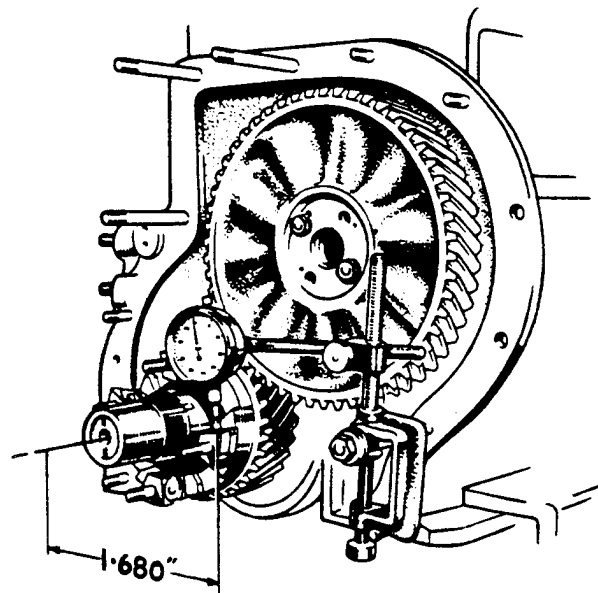
FIG. 2. CHECKING BACKLASH BETWEEN PINION & CAMSHAFT GEAR.

- (ii) Place the crankshaft pinion on to the crankshaft. Secure the dial indicator to the crankcase as shown in Fig.2 and check the camshaft driving gear for backlash at four equidistant places. The registering member of the dial indicator should rest on a driving lug of the pinion as shown in the illustration and at a radius of 1.680" (42.7 m/m) from the centre of the crankshaft.

In the unlikely event of the backlash being less than .002" (.05 m/m) or exceeding .006" (.15 m/m), then the only alternative would be to try another set of gears.

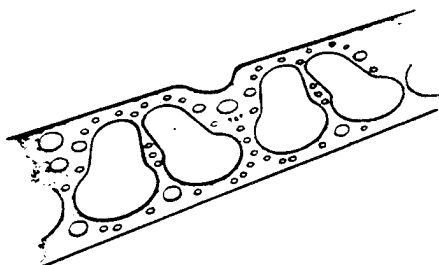
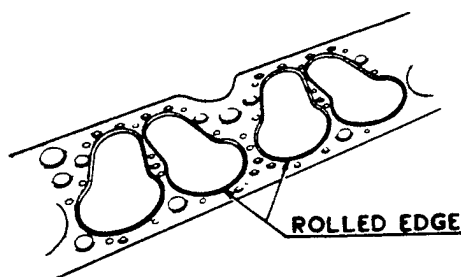
Retailers are advised that the correct procedure when fitting replacement C & A cylinder head gaskets in service is to ensure that these are fitted with the plain face uppermost and the rolled, or lapped, face to the cylinder block.

As an aid to recognition the characteristic differences between the top and bottom faces of the gasket are illustrated in the above two sketches. A further means of identification is provided by the word "TOP" which will be found stamped between Nos. 3 & 4 cylinder openings on the plain face as shown.

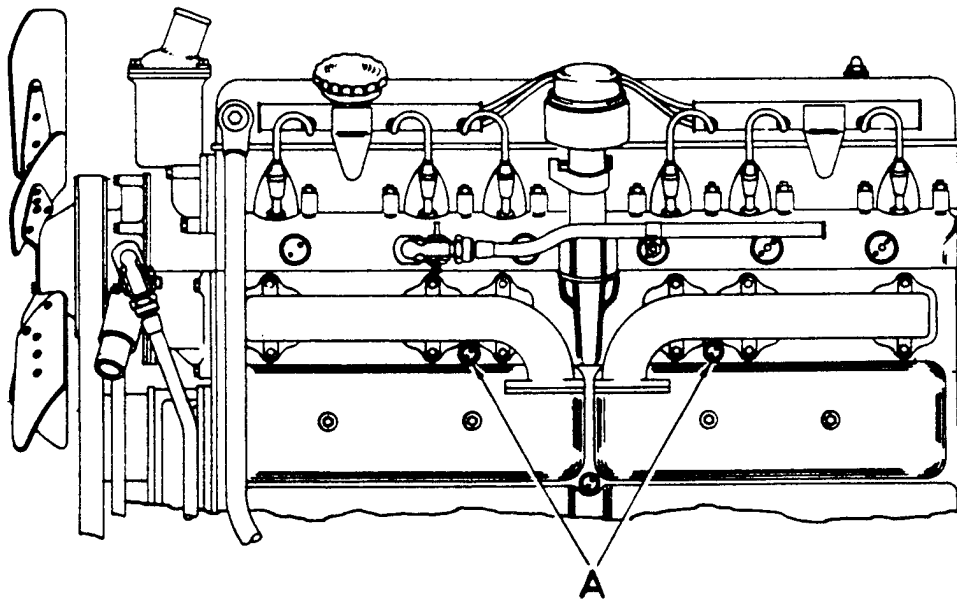
FIG.1 LOCATION OF CORE PLUGS

The aluminium plugs have proved subject to corrosion in service and are to be replaced with cadmium plated steel core plugs and aluminium washers as a retrospective modification. Retailers are asked to carry out replacement on all affected cars in their area when they are next being serviced.

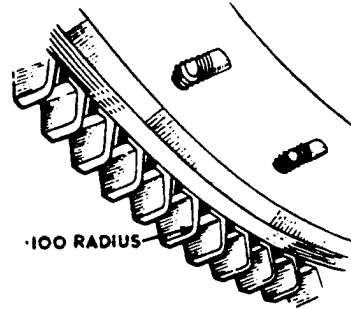
FIG.1.
RADIUS ON FLYWHEEL TEETH.

- (i) Remove the starter motor complete. Remove the starter drive assembly from the motor and refit the new drive assembly.
- (ii) Remove the flywheel lower cover and radius the flywheel teeth with a medium file as shown in Fig.1.
- (iii) Refit the starter motor and flywheel lower cover.

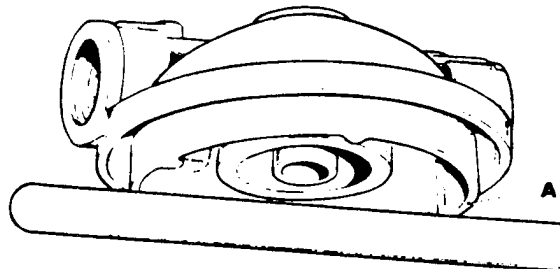
Fig.1 Outer Lip Proud of Inner Sealing Face.

Therefore when the bowl of the filter is removed to change the filter element and seals, on the 5,000 miles service schedule, Retailers should check the filter head with the aid of a straight edge as illustrated in Figures 1 and 2.

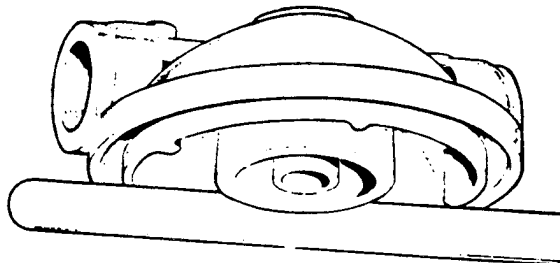
Fig.2 Inner Sealing Face Proud of Outer Lip.

If the inner sealing face stands proud of the outer lip (see Fig.2) the original 'Top Cap' (as shown in Fig.4) can be retained. For future replacements only the modified 'Top Cap' will be supplied.
