**Bulletin**

MODEL: BENTLEY MARK VI

CLUTCH PEDAL.

CLUTCH SLIP.For Information:

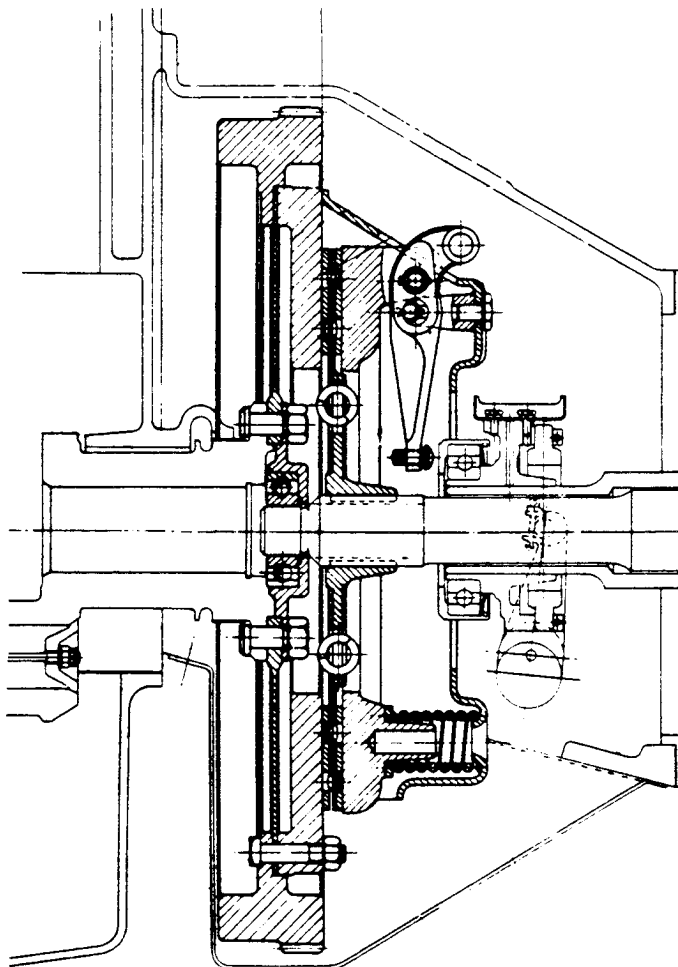
Fig.1. Section through flywheel and clutch.

With the clutch pedal lever against its up-stop under the pedal gap plate, place the edge of a rule against the centre of the side of the pedal and the end of it against the dash, depress the pedal by hand until the clutch release bearing just touches the three release levers of the clutch. Measure the free travel which should be  $1\frac{1}{2}$ " (38 m/m). A turnbuckle adjuster with a central spanning point is provided. Insufficient free travel of the clutch pedal can be one of the causes of clutch slip. If clutch slip is experienced at high engine R.P.M., it indicates that there is insufficient pedal clearance.

Before resorting to any dismantling for slip, the free travel of the clutch pedal should be measured and adjusted if necessary as follows:-

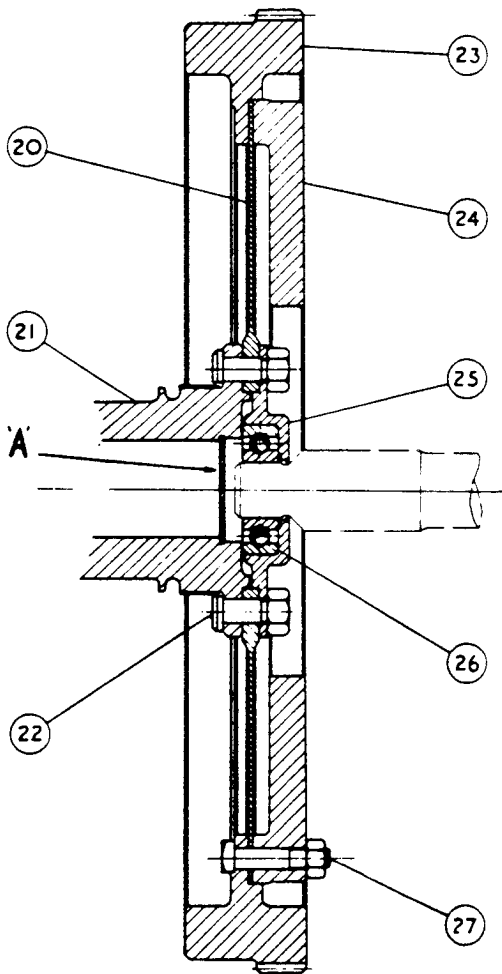
Fig.2. Section through flywheel.

1. Oil leakage past the sealing washer 'A' Fig.2 at the rear end of the crankshaft.
2. Excessive initial loading of grease into the clutch spigot ball bearing (26 Fig.2) of the flywheel, distinguished by radial grease marks on the friction plate (24).
3. Over zealous application of the foot-operated chassis oil pump or a faulty oil restrictor (Type ZEO), allowing too much oil to reach the clutch release bearing (32 Fig.5) eventually working its way along the splines on to the driven plate.

It has been found on investigation, that under certain conditions there is a possibility of an oil leakage past the sealing washer ('A' Fig.2) at the rear end of the crankshaft. If the leakage is sufficient, oil may reach the front facing of the driven plate. In practice, it is likely that the first indication will be a clutch shudder and then a slipping clutch. If after removal of the clutch, oil, apart from grease, is found to be present in the spigot bearing (26 Fig.2), it can be assumed that it is leaking past the sealing washer.

Whenever there is evidence of oil leakage past the sealing washer, a rubber plug should be fitted as described herein. If however, a rubber plug is not immediately available, then it will be necessary to solder the sealing washer ('A' Fig.2) to the crankshaft as described in Paragraph 1b.

With the clutch removed from the flywheel, remove the crankcase lower half. Remove the nuts from the twelve bolts (22 Fig.2). Providing the nuts have not been over centre punched, it should be possible to use them again. Leaving the flywheel assembly in position on the crankshaft, remove the bearing housing (25) complete with the spigot bearing (26). Remove any surplus oil or grease from the spigot bearing and housing and do not add any additional oil or grease.

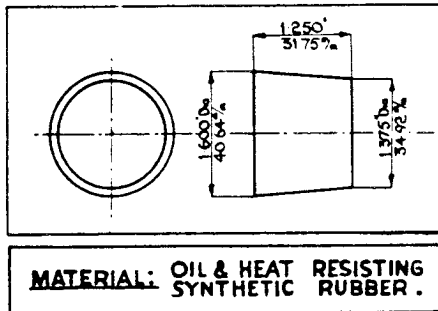
Fig.3. Details of oil sealing plug.

**MATERIAL: OIL & HEAT RESISTING SYNTHETIC RUBBER.**

As a service rectification, a conical synthetic rubber oil sealing plug (Fig.3) has been introduced and is shown in position in the bore of No.7 crankshaft journal in Fig.4. Arrangements are being made for supplies of these plugs to be sent to all Overseas Retailers. Will Retailers in the U.K. kindly note that supplies are available from the London Service Depot.

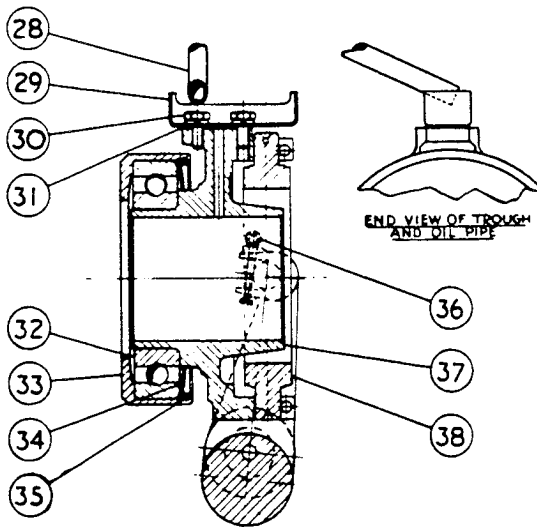
Fig.5. Section through clutch release bearing and trunnion.

The above will probably allow too much oil to reach the clutch release bearing (32 Fig.5) and eventually find its way on the rear facing of the driven plate assembly. The chassis oil pump should only be operated in accordance with the instructions given in the Owners Handbook i.e. "Depress

If the clutch has been removed for the purpose of fitting a new driven plate assembly, then prior to refitting the gearbox to the clutch casing, ascertain that the oil feed pipe (28 Fig.5) to the oil trough of the clutch trunnion is correctly positioned above the trough. The end of the pipe should be approximately over the front setscrew (i.e. the one nearer to the flywheel) retaining the trough to the trunnion when the clutch release bearing housing (33) is in contact with the adjusting screws of the three clutch release levers. Check that the oil feed hole from trough to the trunnion is clear. With sufficient oil in the foot-operated oil pump, depress the pedal once and count the number of oil drops delivered to the trough of the trunnion.

Approximately three to five drops should be delivered with each application of the pedal. If either above or below this rate of flow, check the restrictor elbow situated on the right-hand top side of the clutch casing, by replacing with a new one of the same type (ZE0).

If the flow is still too great, then fit a type ZE00 elbow which will give a reduced rate of flow, conversely if there is still insufficient oil delivered, then check for a leakage or pipe breakage at some other point in the centralised chassis lubrication system.

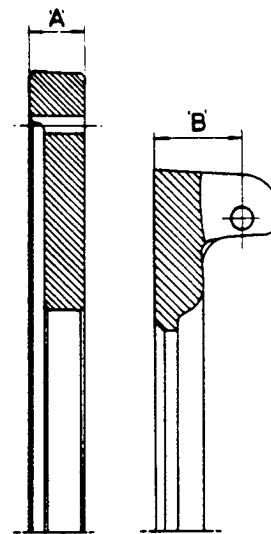
FIG.1 FLYWHEEL AND PRESSURE PLATE - ORIGINAL DIMENSIONS.

It is permissible to regrind the surface of both the flywheel friction plate and the clutch pressure plate should they show signs of scoring. Only the minimum amount of metal necessary to provide a clean, smooth surface should be removed. Grinding limits and original dimensions are given in Fig.1.

A flywheel friction plate that shows any sign of small, hair-line, contraction cracks should be discarded.

A surface grinder should be used and a Carborundum stone of grade BA80-N5-VBLU is recommended. The clutch pressure plate may be placed face downwards on the machine table and the backs of the lugs for the toggle levers lightly ground flat to provide a true surface. The plate may then be reversed and the face ground as required.
