Bulletin

MODEL BENTLEY MARK VI

MODIFICATION.**REAR BRAKE EQUALISER.**

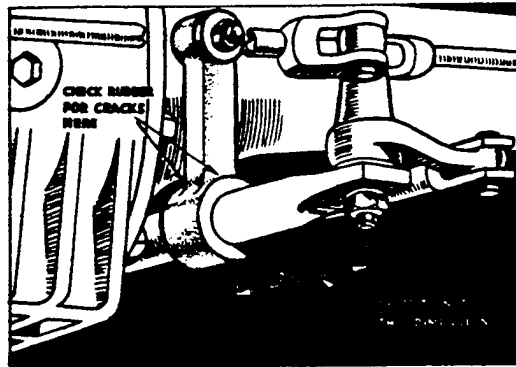
A certain number of cars were built with the rubber support of the rear brake equaliser fitted and positioned whilst in the chassis stage of production. When the body is mounted, the effect of its weight on the geometry of the rear suspension causes distortion of the support which may lead to fracture; repositioning of the support is therefore necessary in some cases.

1. Disconnect the rubber support from the axle tube and flex it backwards and forwards so as to examine for cracks in the neck at the junction with the main boss. If there are any signs of cracks, replace with a new support.
2. Check that the rear face of the main boss is 2.275 ins. from the centre of the rear brake equaliser bolt, and reposition if necessary.
3. Paint the letter 'E' on the rear face halfway down the rubber leg after examination and repositioning.

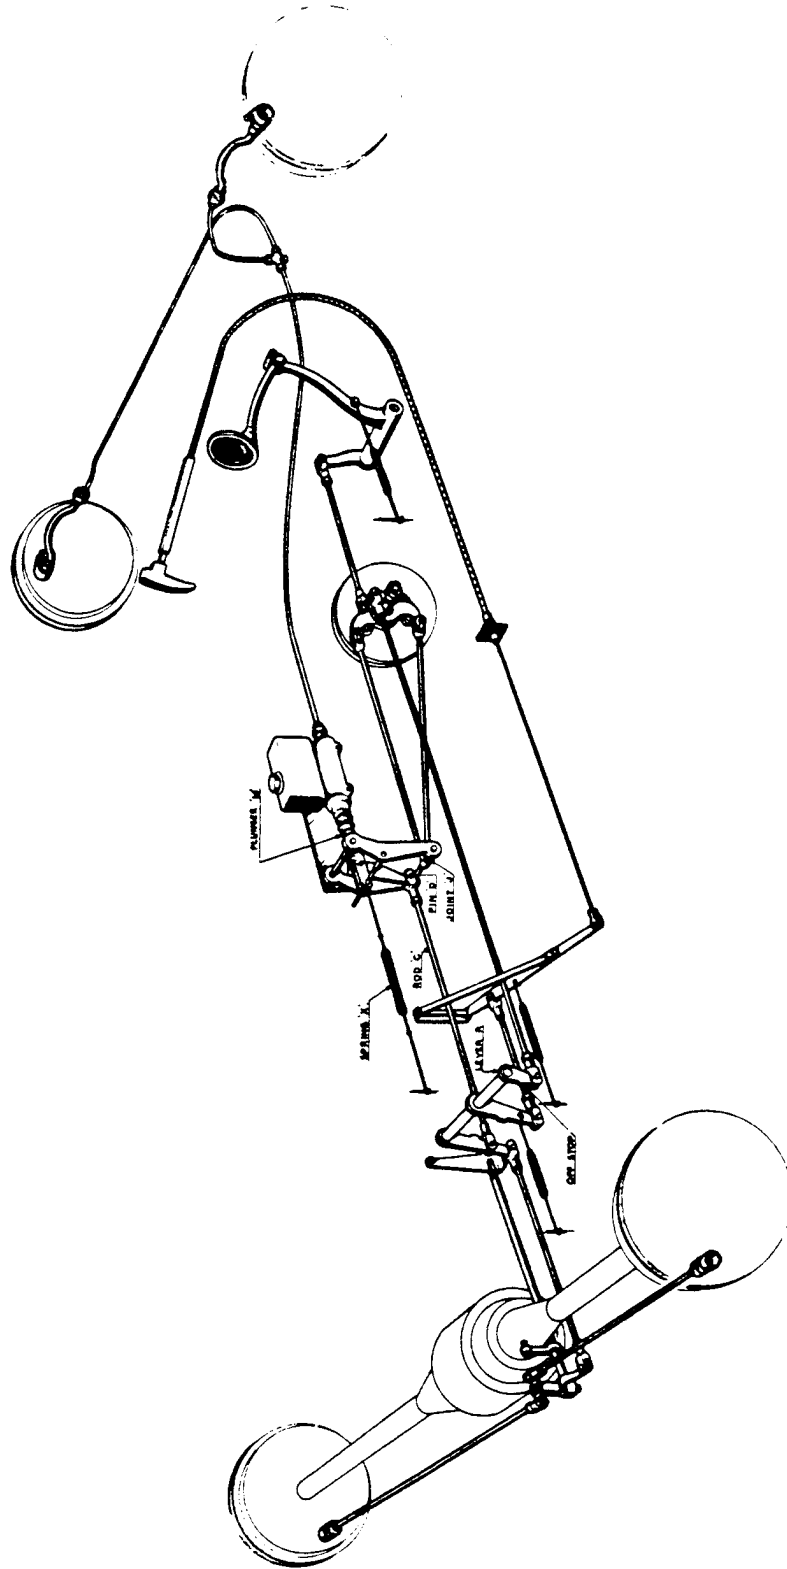
A modification is introduced to reduce a mechanical noise that can more accurately be described as a "clonk" from the brake linkage which may occur on application of the brakes.

In many cases, the origin of this noise has been traced to excessive free travel between the plunger and piston of the brake master cylinder, and adjustment of the brake linkage as described hereunder, has in certain instances effected a noticeable reduction of the noise.

1. Ensure that the rear brakes are in the OFF position and that the lever 'R' is against its OFF stop.
2. Remove the master cylinder pull-off spring 'X' and the clevis pin 'D'
3. Adjust the rod 'C' so that the joint 'J' has zero to .050" free travel before the plunger 'M' contacts the master cylinder piston.
4. Tighten the locknut on the rod 'C'. Replace the clevis pin 'D' and the master cylinder pull-off spring 'X'.

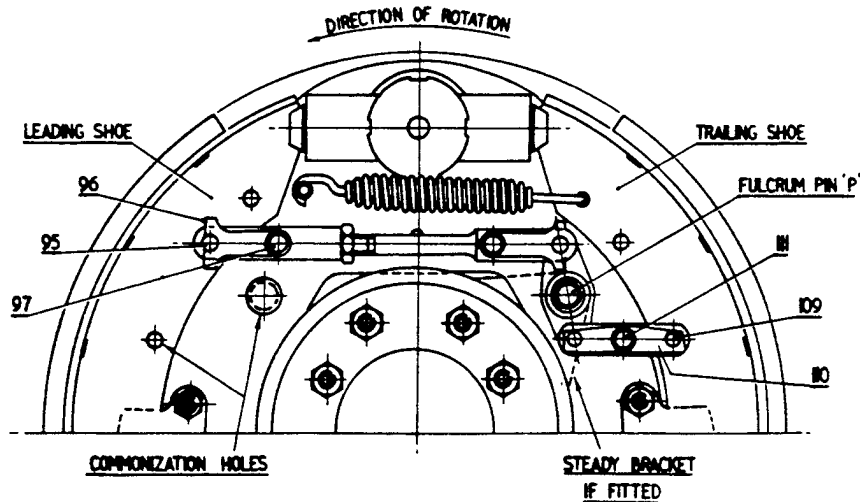
FIG. 1.

Instances have occurred in service with the Bentley Mark VI, where the front brakes have failed to release properly after application. This "Spragging" of the front brakes is due to an excessive self-servo action of the shoes, and manifests itself by a locking of the brakes even after the foot pedal has been released. In all such cases, the following modification should be carried out.

REMOVAL OF EQUAL WEAR LINKAGE (FIG.1).

- (a) Remove setscrew and spring washer (111) and the locking plate (110) and by easing the load from the pull-off spring, withdraw pin (109).
- (b) Remove setscrew and spring washer (97) and locking plate (96) and withdraw pin (95).
- (c) Remove equal wear linkage from fulcrum pin (P) complete.

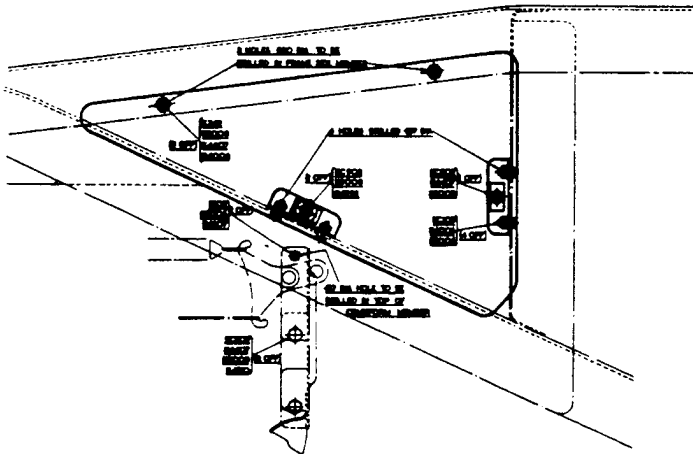
FIG. 1. FITTING OF UNDERSHIELD.

Current Bentley chassis in production are provided with protection against the possible loss in servo efficiency in wet weather, due to water finding its way on to the friction surfaces.

bolt holes in the lower flange of the frame side member, also for the two supporting brackets as shown in Fig.1. Drill the two 0.250" dia. bolt holes in the frame side member.

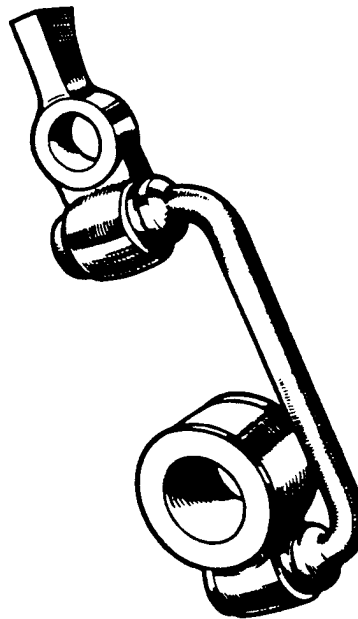
FIG. 1. MODIFIED TYPE SUPPORT

Instances have occurred where the rubber support (RG-3552) for the rear brake equaliser bar has fractured on existing Bentley Mark VI cars in service.

The modified type support assembly, illustrated in Fig. 1 above, consists of a "U" shaped metal link, which is retained at either end by brackets in silentbloc bushes. The upper bracket has a radiused face to correspond with the outside of the rear axle tube, while the lower bracket carries another silentbloc bush through which the equaliser bar passes.

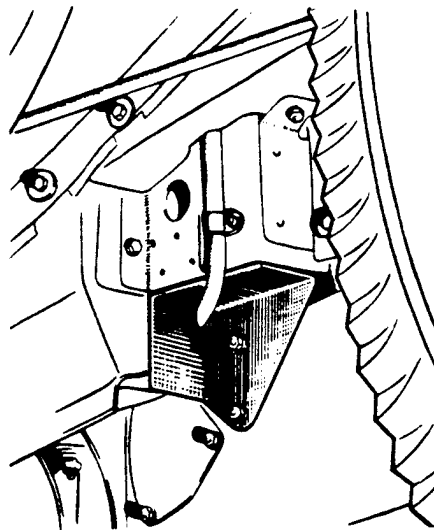
Investigations have shown that the deletion of the dashboard side mounting brackets (Service Bulletin BB-115) renders it possible in wet weather for water to reach the servo motor and gear change mechanism through the gap between the front of the body and frame member.

This protection consists of a flanged plate (Part No. RF-8881) which is fitted in the position originally occupied by the lower dash mounting bracket on the right-hand side of the chassis as shown in the above illustration. The existing bracket mounting holes in the frame are used for fixing the plate, and it should be noted that when this is finally fitted, there must be a clearance of approximately 0.187" between the top and rear flanges and the dash and body respectively. The two bolt holes in the plate itself are of a slightly larger diameter than the retaining bolts supplied thus permitting a certain degree of adjustment when fitting the plate.

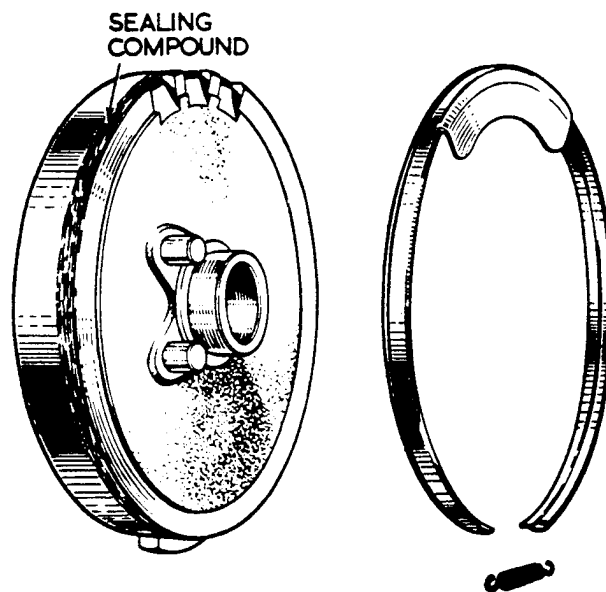
In order to prevent the possibility of oil seepage into the servo motor, the joint between the flange of the spring backing plate and the pressure plate is being coated with "Wellseal" on current production. "Wellseal" is a sealing compound with a rubber solution base which remains soft and pliable when dry.

Retailers are advised that, whenever a servo motor is removed for overhaul or other reason, it should be treated with "Wellseal" or an equivalent compound. After assembling the servo in the usual way, but before fitting the protector ring, the compound should be applied with a thin brush as shown in the illustration.

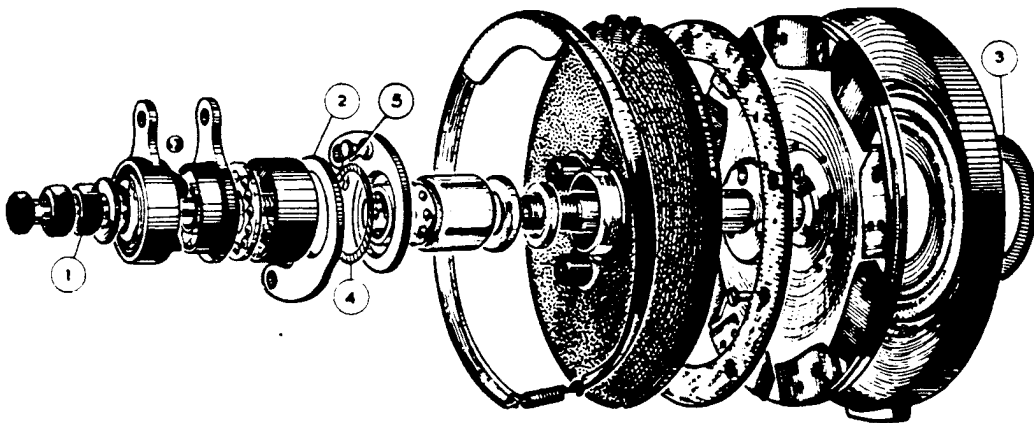
FIG.1. EXPLODED VIEW OF SERVO MOTOR.

A corrugated washer, Part No. R.5037, has been developed to overcome cases of servo judder on brake application. The washer is fitted between the brake actuating levers in place of the plain washer GB.5083 and effectively damps the servo output to prevent minor fluctuations in the brake linkage from developing into judder.

Retailers should fit the washer in all complaints of servo judder but, at the same time, check that obvious causes, such as air in the hydraulic system, maladjustment of the brake linkages and deterioration of the servo motor linings, are not responsible for the condition.

1. Adjusting Nut.
2. Brake Actuating Levers.
3. Ferodo Washer (To be replaced by R.5285 if necessary).
4. Plain Washer GB.5083 (To be replaced by R.5037).
5. Spring Clip (To be removed).

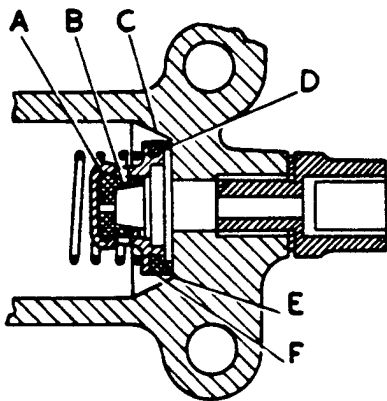
Fig.2. Section-Return valve assy.
master cylinder.

There have also been cases of ingress of air into the system due to non-sealing of the rubber valve washer 'F' Fig.2. against the face 'D' at the outlet end of the cylinder. The sealing lip 'A' Fig.1. of the rubber cups in the front brake expanders is normally held in firm contact against the bore of the expander by a residual hydraulic pressure of about 12-14 lbs.per sq/in. created by the spring loading of the return valve illustrated in Fig.2. Should this valve fail to maintain the hydraulic pressure, air may enter past the cups of the expanders owing to the comparatively low pressure exerted by the cups themselves against the bore.

Examination revealed that the primary cause of the valve washer 'F' not seating correctly, was due to the diameter of the face 'D' of the master cylinder being too small, causing the valve washer to make heavy contact with the rough un-machined tapered sides 'C' of the cylinder resulting in excessive wear and distortion of the valve washer.

- (i) Fit a new rubber washer 'F' (RG-7043) and a rubber cup 'B' (CD-130) to the valve body 'A'. Place the coil spring on to the valve and enter into the cylinder and check that the valve assembly has a diametrical movement of approximately 0.020" (0.50 m/m) to ensure that there is sufficient clearance between the outer diameter of the valve washer at point 'E' and the cylinder.

If the valve assembly cannot be moved as above, it will be necessary to fit a new master cylinder. Retailers in the United Kingdom only, should return the original one to the London Service Station; this also applies if the cylinder bore is scored or corrosion pitted. Where a bore has only slight scratch markings, proceed as described for a front brake expander.
