# TEE-ONE TOPICS

Number 79    November, 2008

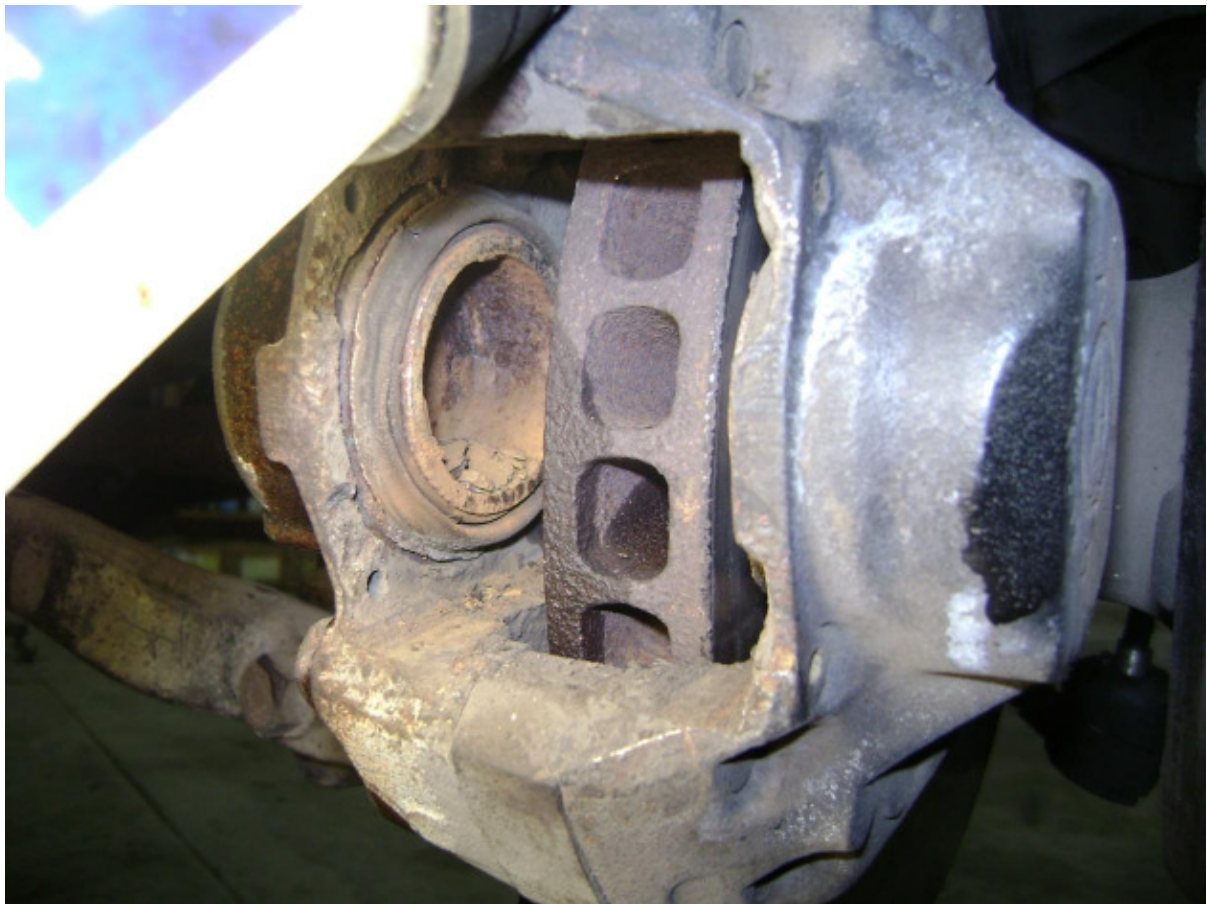
This stopping gear was attached to one of the iconic early Corniches. The owner, one of the more optimistic members of our group that I have met said that he was despairing of the reliability of the handbrake to stop the car and indeed was contemplating bypassing the handbrake safety lock so that he could deploy the folding roof when real retardation was required.

First step was to remove the brake pads which fairly typically were not original and the above mess greeted my eyes. A small digression. I have as much knowledge of the composition of the brake lining material as I do of the sex life of a Siberian Newt so I tend to rely on the Factory to supply stuff that is capable of doing its job. Twice now I have seen non-standard pads used on our brake rotors which have then been eaten by whatever was in the friction material. An expensive economy? This car has, as seems so common these days, an

You will notice rust around and in the visible calliper piston. This is largely unavoidable given the temperature the things have to endure and the frequent dousing with dirty gutter water. The only part however that should get rusty is the very tip of the piston where it meets the back of the brake pad and probably in the cavity. The only real protection is that thin rubber boot that

surrounds the piston but even that has its limits as you can see.

The service books list regular inspections of the boots and probably the best method here is to crack the nearest bleed nipple ease the pads and piston back, close the nipple and extract the pads. You can then have a good cleaning session and check the boots. On top of this maintenance you will of course be flushing the system once a year if you are using brake fluid. If all this happens you should not see messes like this on your car.

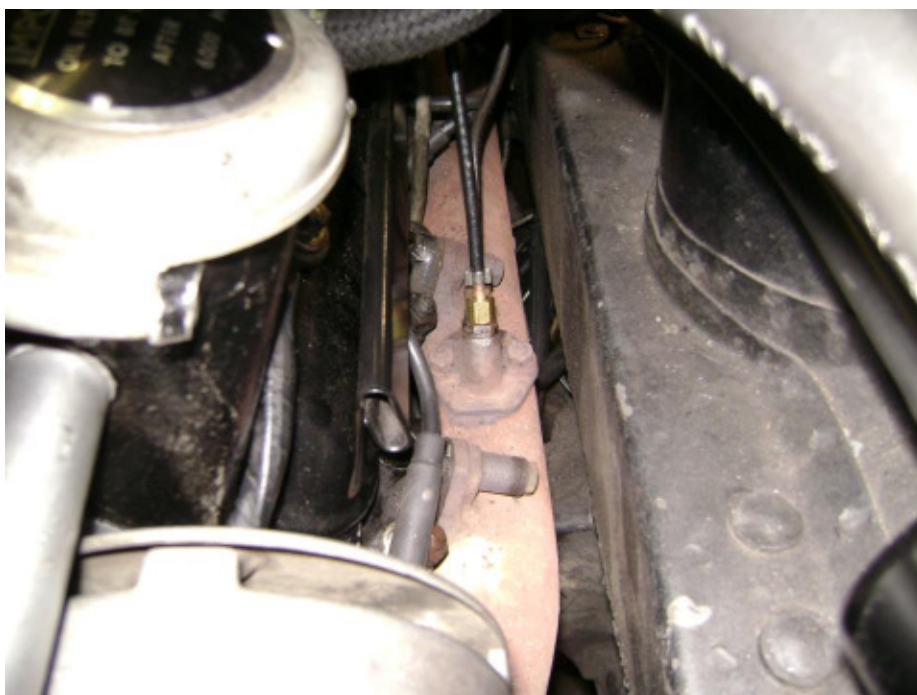
#### WARMING THE CHOKE COILS

These little pipes that screw onto the 'B' bank manifold on all carburetted vee eight engines, are subjected to a great deal of heat. Although the nipples are brass they still oxidize and not infrequently either hole or snap off at the manifold. The view here is privileged, taken from a camera shot

at the end of my arm. What with the brake reservoir position above the junction and the general clutter in the area the condition of the stove pipes is easily overlooked. If the pipes

hole they will suck ambient air rather than air passed through the in-manifold heat exchanger, the choke will close and the car will eat fuel.

After market pipes are now available from Introcar in the UK. They come in two sizes, long and short. The insulation is no longer woven asbestos as will be seen above.

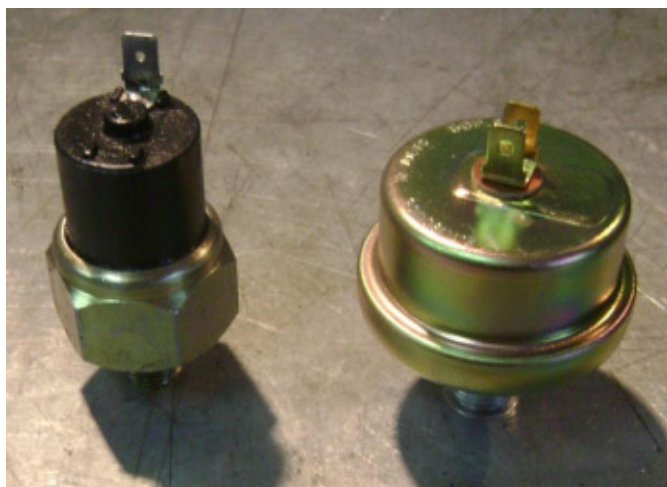
It was one of those very comfortable things you noted when snooping around an engine particularly one of dubious heritage. Here are the new leaking version on the left and the newer no-leaking 'tuna-can' version.

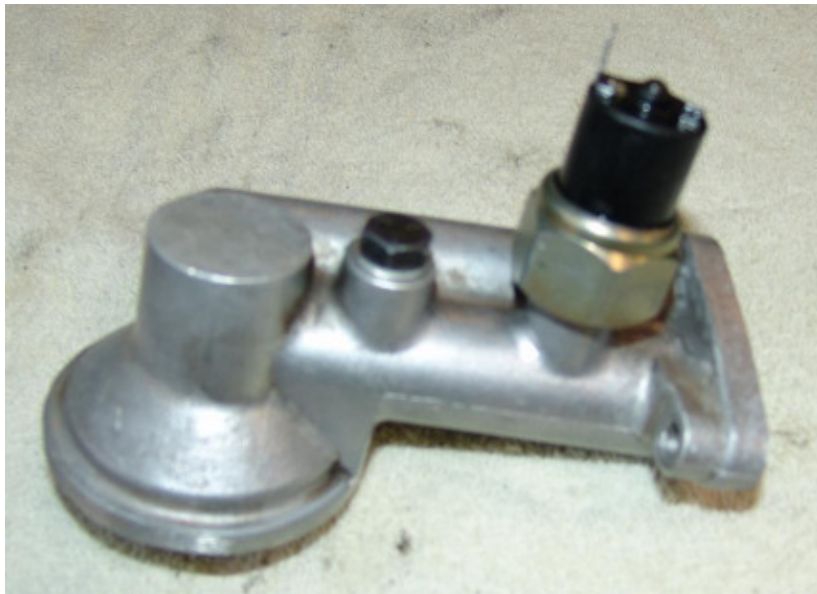
There is a Phantom VI which shall not be identified that has now had no less than five of these gadgets fastened to its lofty engine and every single one has leaked. Imagine the

purveyor of items for Rolls-Royce and Bentley motor cars. I wondered to him that it would appear nobody would get off their aspect to have this problem fixed and lo, he produced a stock of 'tuna can' senders! Not only do these items not leak. They actually send an excellent signal to the beautifully veneered fascia surrounded oil pressure gauge, so that you have an even better idea of what that little pump up the front of the engine is actually doing!

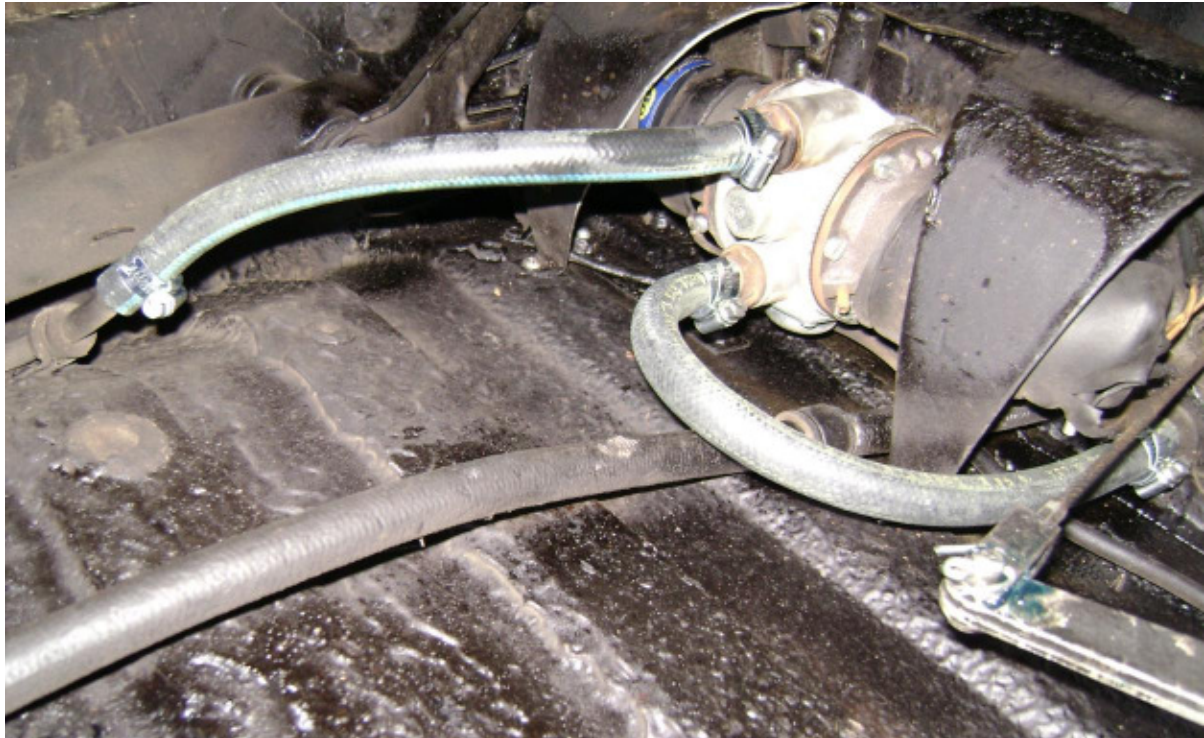
Here we have the next two fuel hoses, the original wire clad ones shortly to be scrapped. These deliver fuel to the main fuel pump seen top right and carry the output from the pump up to the noisy end of the car! The thick umbilical seen passing under the pump is the main battery cable also going up to the front to help all the bits function.

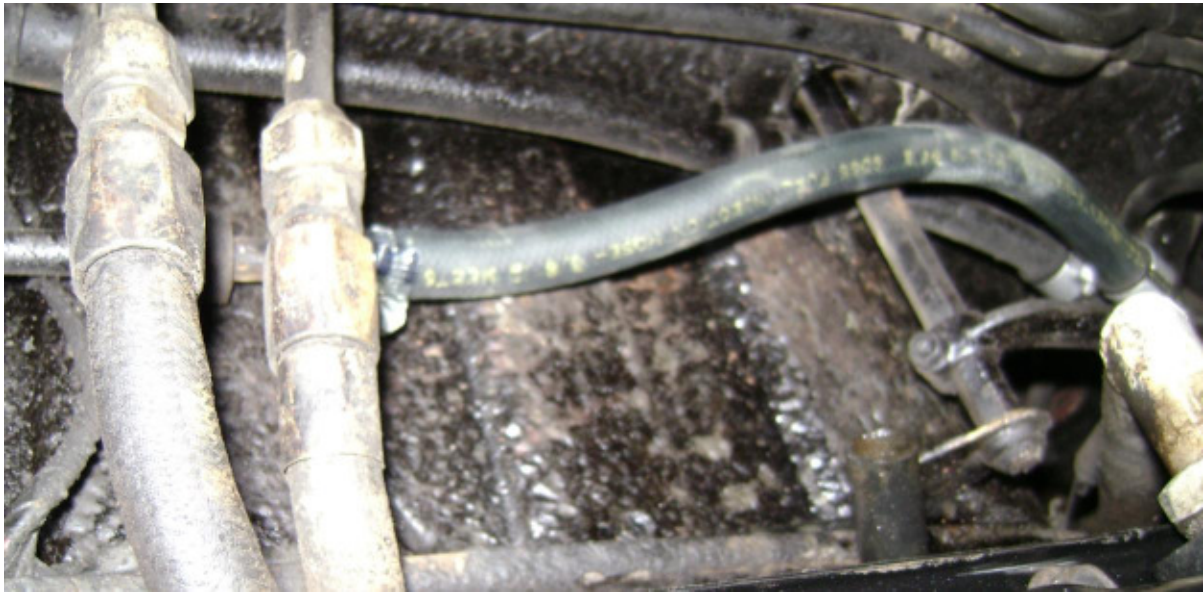
Here we have progressed in this 1972 Shadow to a point roughly below the driver's bottom. The fuel line can be seen arching over a shaft which in turn has a small lever fixed thereto. The latter is actually the working end of the beautifully styled accelerator pedal. The two very obvious pipes to the left are from and to the transmission and eventually connect to the oil cooler in the base of the radiator core.

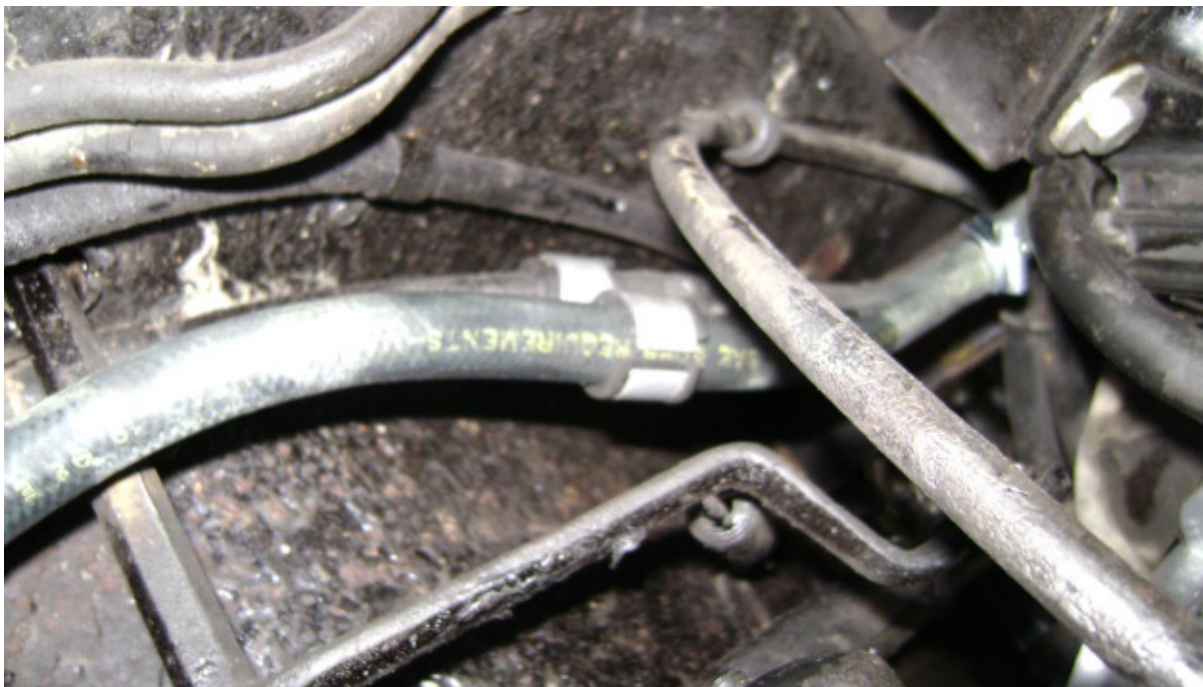
And here is the last lap. The fuel pipe (the one with the printing on it) has been bracketed to the main battery cable for stability. The length of fuel hose is the longest of the line and is simply clamped to a metal feed pipe beside the torque converter housing which in turn feeds the carburettors. It is interesting that in the later SZ cars this final metal piping was dispensed with, modern rubber hosing thought to be quite adequate for the job. The need therefore to keep an eye on these fittings and replaces them from time to time, is all the more important.

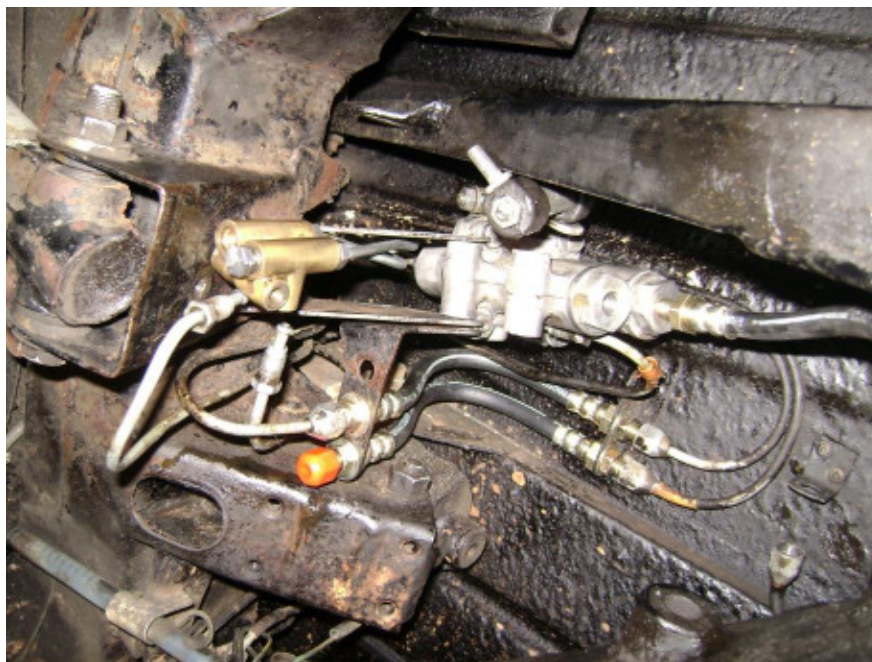
workshop manual with its pretty colour coded diagrams. The valves are held by two bolts to a bracket welded to the rear sub-frame seen at left in the picture. The three flexible pipes in the picture incidentally have nothing to do with the functioning of the brakes but in a frenzy of hose changing are often overlooked. Sundry pipes here have been disconnected and of course you would not start this job without

exhausting the accumulators. You will notice the orange cap on the end of one pipe. This happens to be the line to return the RR363 back to the reservoir after it is no longer needed to lift stout passengers in the back seat! So if you do not seal it off, the reservoir will simply drain itself all over you and the floor. You will also have noticed that the valve itself has been unbolted and about to be extracted.

A word to the wise. The biggest ache in the rear end is getting the various nipples and pipes back where they belong without crossing the threads. The best advice I can give you is to screw the various connections in to their places before you mount the valve to the sub frame. This means that you can wiggle the valve around as well as the pipes to ensure that the threading is according to Hoyle! Best practice is to do this by finger. Ideally you should be able to screw all these fittings in by hand. Cross the threads and you start to doubt the life expectation you have come to expect! ✂

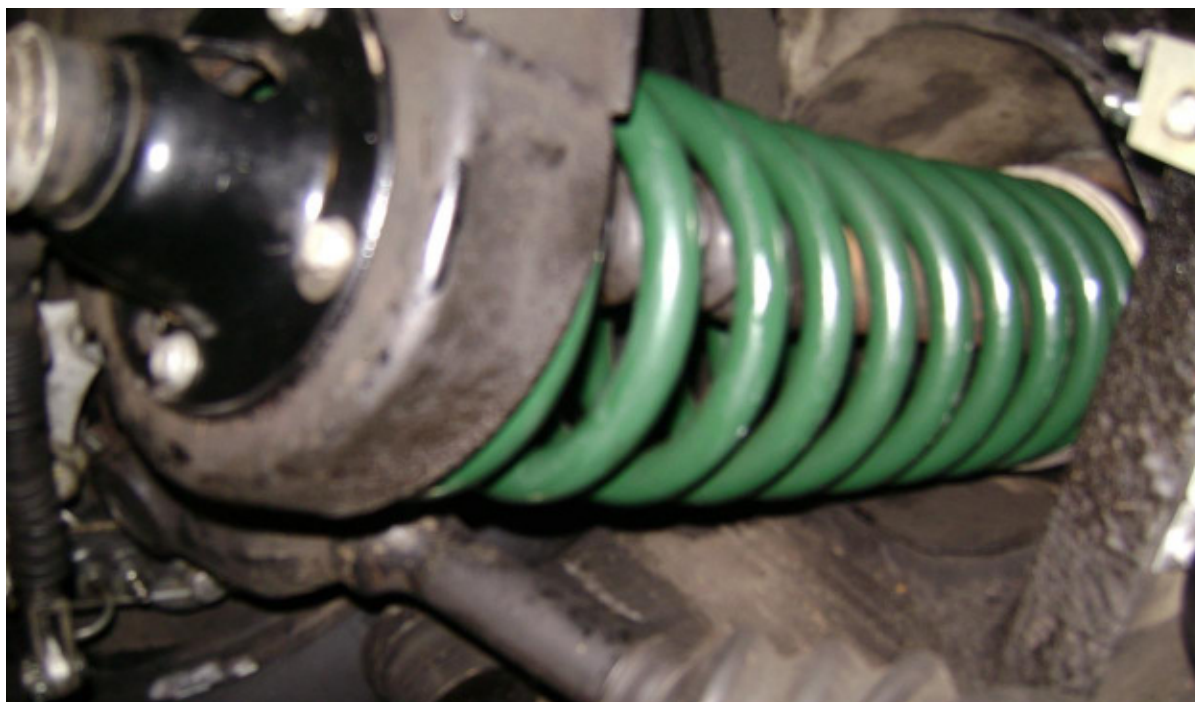
While under the car surveying the wonderful job you have done on the fuel hoses you may care to have a lighted look up the rear spring housings. Here you see the spring fully extended, at least as far as the retainers will allow. At the top is the platform that the spring sits on, which in turn is pushed up and down to raise or lower the rear of the car. Running through the centre of the spring is one of the rear shock absorbers. If you need to replace these you should be aware that they are gas filled and when released from the confines of the suspension will extend some inches. The black cup at the bottom of the spring seen here at the left can be released with 4 small bolts but to release the top end of the damper you will need to exhaust the hydraulics and remove the rams in the boot. No big deal just confined working. Think of the Beaconsfield miners that were trapped! At least you can get out of the boot when you want to, throw the spanners on the floor and go get a cold beer!

The springs are of interest. Once again I called on Robert A Chapman and his services in Bayswater, a suburb of Melbourne. Robert has had these springs manufactured locally to replace the factory items. They apparently have an extra coil which in my experience give not only a better ride but improve the cornering!

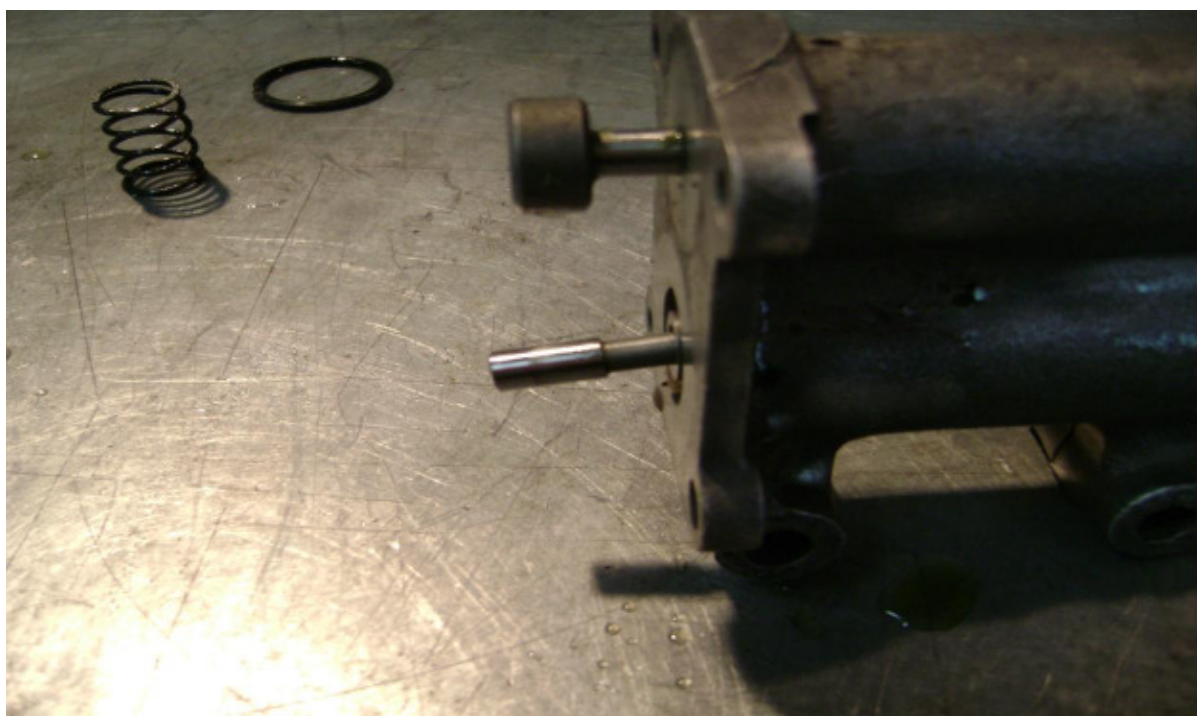
The experts will tell you that there is nobody silly enough to put this little valve in back to front! They are wrong. You are looking at one half of the levelling valve on a Shadow. The little bit hanging out of the assembly can indeed be inserted back to front and no amount of wiggling the operating arm of the valve will produce the requisite lift of the car. Because the cross sectional drawings in the manual variously show the bits from one side of the other and because the scale of the drawing is rather small, it is easy to get confused as to which end is which!

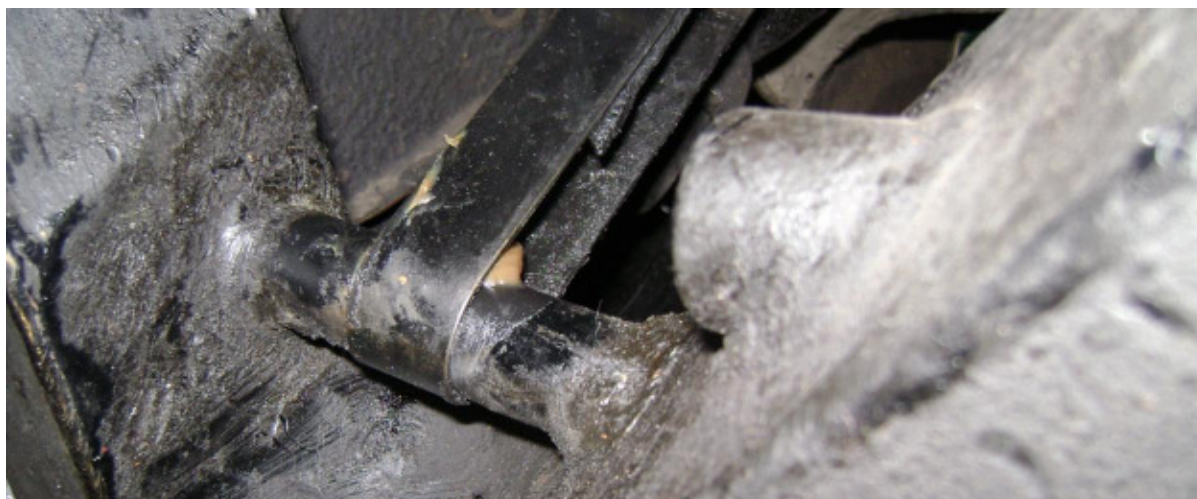
While rummaging around the rear end of your Shadow, be aware that these simple straps are the rebound stops for the rear suspension. Originally they were lined with rubber to soften the 'clunk' as your wheel drops into a pothole but these wear and the replacements if they are still available cost several arms! The main maintenance seems to be to poke a finger full of grease in them to stop squeaking.

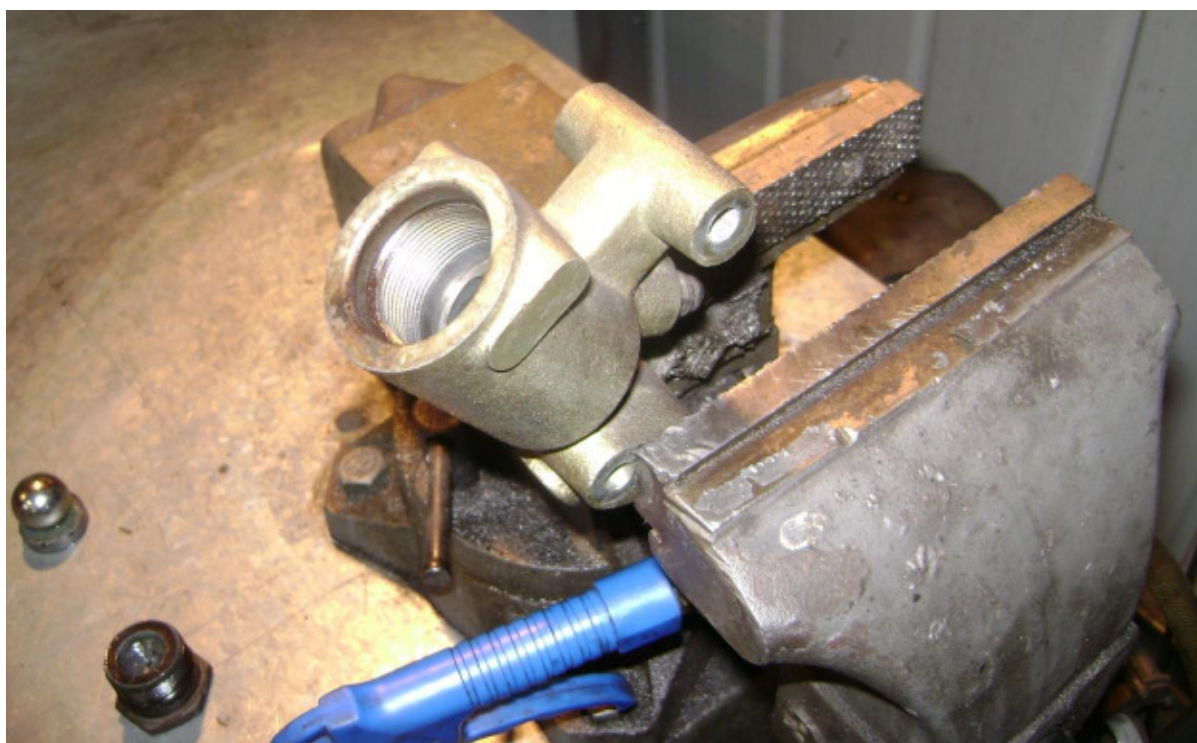
This little valve as you know sits precariously at the back of the rattrap and sits astride one of the rear brake lines. The idea is that under heavy braking, a heavy steel ball, seen at the lower left of the picture, rushes up an incline and blanks off further fluid going to the rear stoppers. This is highly desirable since locked rear wheels in a major skid are a perfect assist for pirouetting in your car. The valve requires no maintenance other than to benefit from the annual flush of the whole system which you religiously carry out!

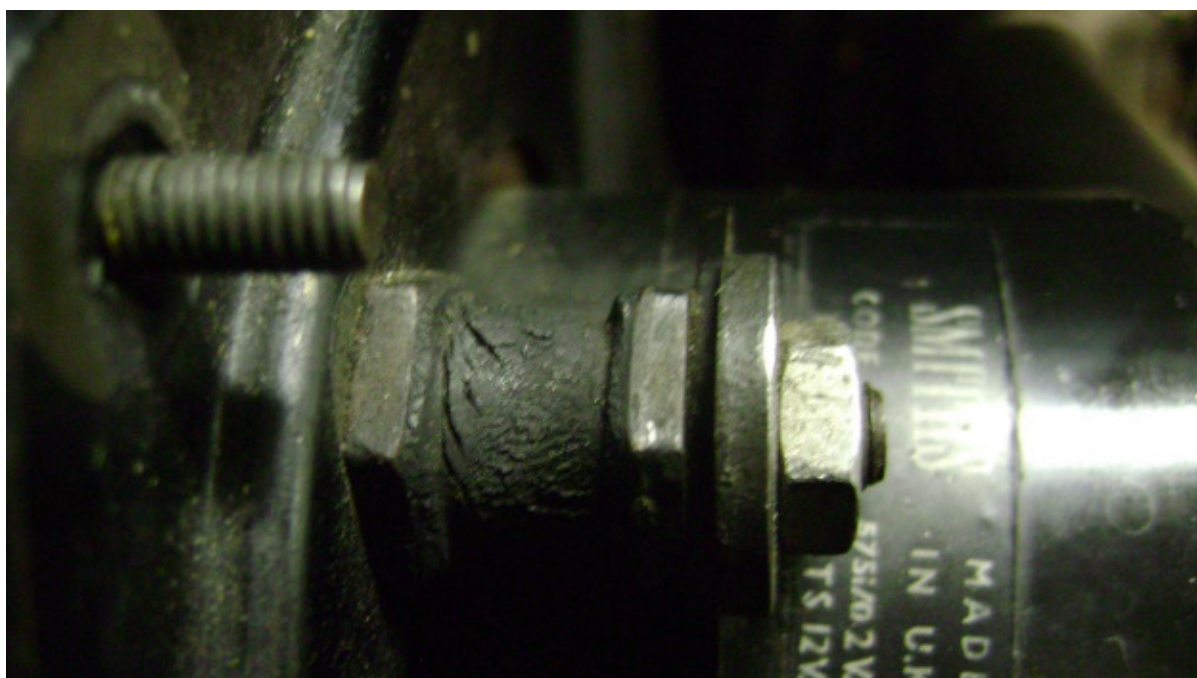
A common problem. To minimise transmission of air conditioning fan noises into the body of the car, most of our fan motors are suspended on rubber, one of which is seen here. If the rubber mounts are fractured, replacements are usually available from commercial hardware outlets, although the threading will probably be metric. As a temporary measure, you will note that initially the rubber mounts sag with heat and age. It is often quite practical to rotate these through 180 degrees which should stop noise transmission by lifting the fan motor.

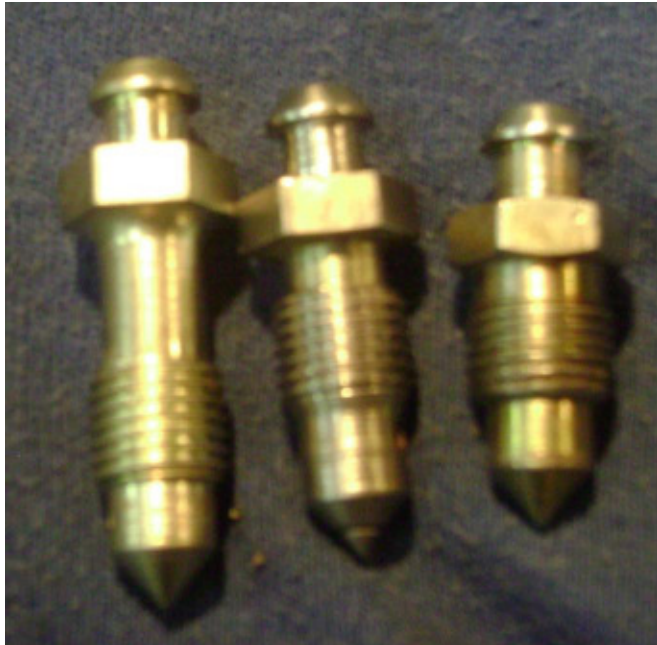
Lastly be aware that there are three size nipples supplied by the Dealers. These are shown in the picture and I will not attempt to define which nipple is used where. When trying to identify replacements it is as well to have a sample of those available and work out which fits best. The centre nipple shown for instance because it has a longer 'pointy bit' if screwed in some holes will 'bottom' after about two threads have engaged. Clearly this is to be avoided!
