## A THING OF BEAUTY IS A JOY FOREVER

## HAS YOUR SHADOW ENGINE LOST THESE?

## THINGS THAT GO CLICKETY CLACK

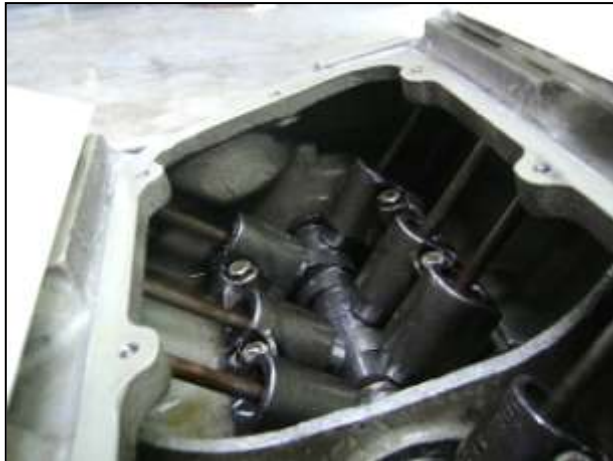
Here is where it all happens in the valley of a Shadow vee eight engine. The cam followers here doubling as hydraulic valve lifters are located by carefully designed 'blocks' which in turn are bolted to the cylinder block connecting with the main oil galleries beneath.

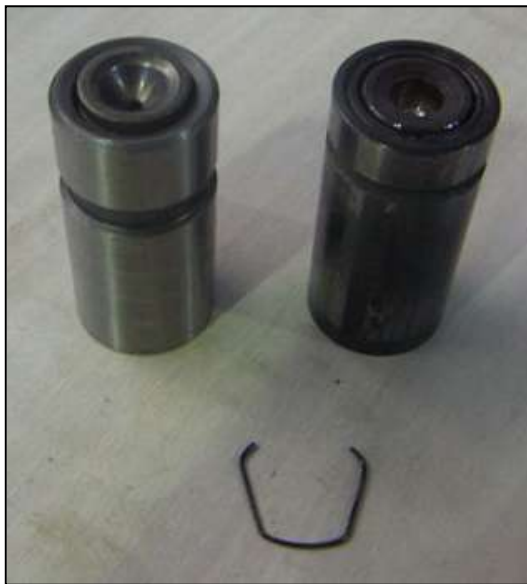
Here a lifter from an engine that has done some 90,000 miles sits beside a new item. The circlip which retain the piston in the follower have been removed. One is shown. The new lifter is not of Rolls-Royce manufacture in this case since the cost of a set of the latter would exceed the total value of the entire car!

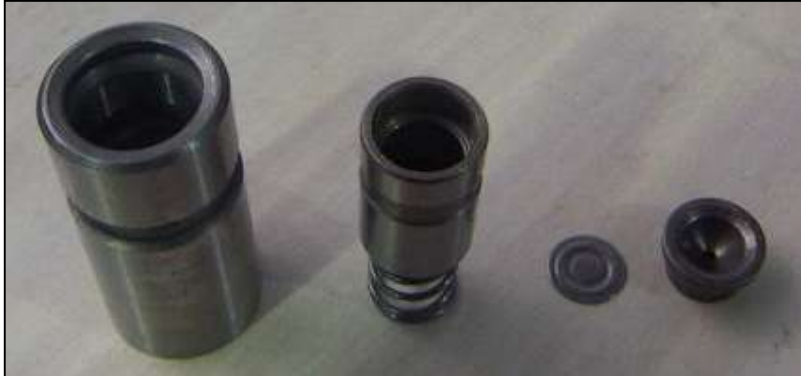
The one difference between aftermarket lifters and the genuine ones is in the head of the piston

where the base of the push rod sits. The solution is to swap the items from the old to the new.

Above can be seen the disc valve and piston head and the piston with its small tensioning spring that ensures there is no slack in the valve train!

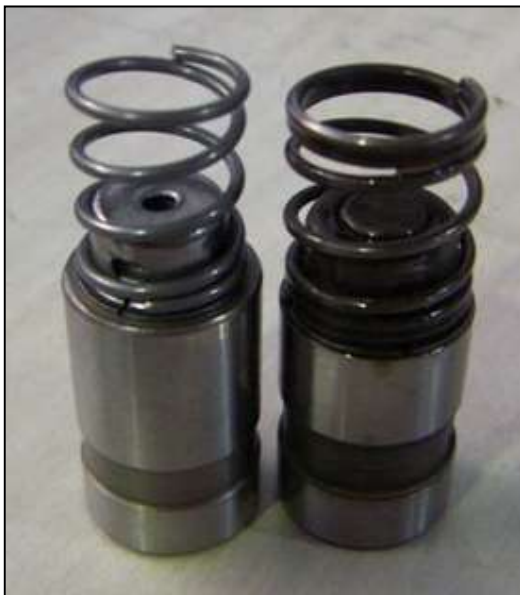
The tensioning spring mentioned above and a comparison between old and new. The valve that shuts and retains the oil in the follower while it is under pushing pressure can also be seen in the spring.

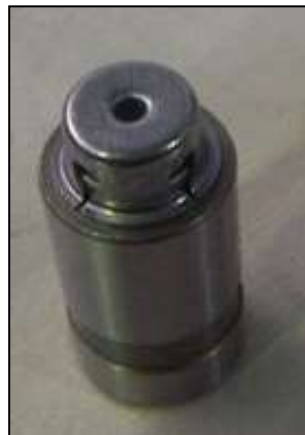
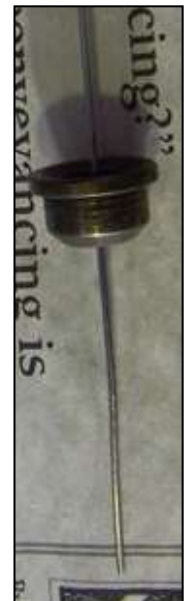
Having assembled the new lifter with the genuine piston top it is desirable to fill the cylinder with engine oil. Trying to push the piston cap down to insert the retaining circlip will be practically impossible so the solution is to push the disc valve beneath the cap away from its seat with a fine steel wire, the piston can then be pushed into the follower cylinder and the circlip fitted.

'Priming' the followers before assembly ensures quiet initial operation and avoids occasional problems of bleeding air out of the system!

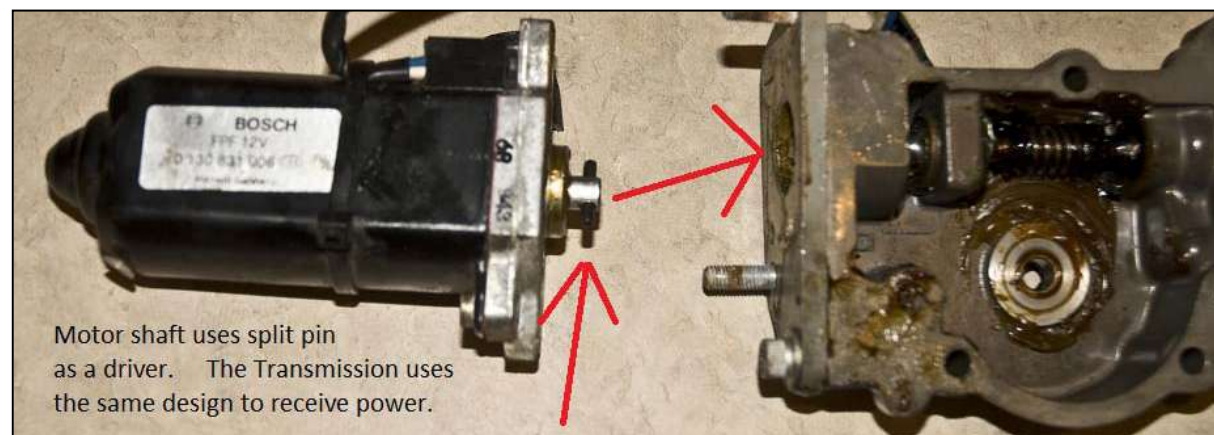
The rubber coupler resides in the housing indicated by the topmost arrow.

The rubber (polythene-Ed) “coupler” between the motor and the transmission was broken into 2 large pie ces and one small piece. Running the motor in one direction would cause the rubber pieces to “bind” and therefore it was “slow” in operation.

I am sure there are commercially available couplers available and I may put some research effort into this in the coming weeks, but for now I’ll just go to the lathe, mill, and cut 4 new ones, and replace the couplers in all of my windows. Probably though I will use a lightweight high density nylon or brass for longevity. If anyone wants to cut their own I will also provide the dimensions. Once you remove the Drive Motor and Transmission you can see the housing for the bushing.

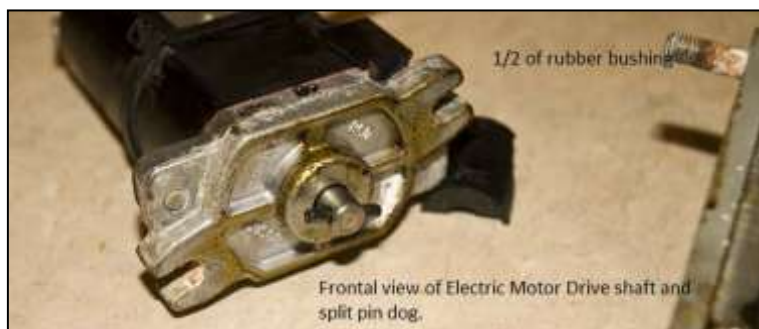
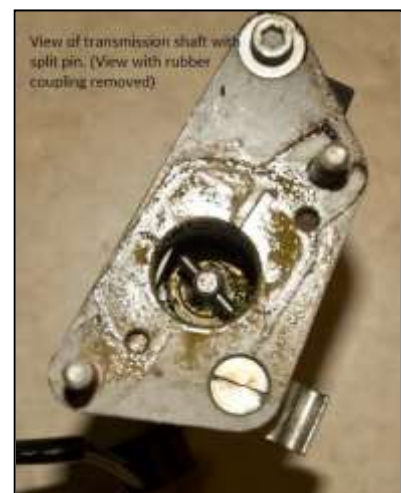
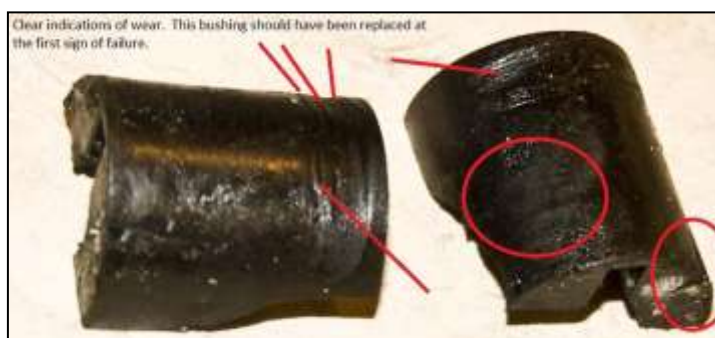
*Ed note:- Australia among other countries still insists on electric window operation in cars being overall controlled by the ignition switch. Allegedly, this was to prevent small children and the odd mother-in-law being inadvertently decapitated. The gearing you will note from the picture is very powerful and I suspect the rubber coupling is there to disintegrate before total decapitation occurs. For this reason I suggest a brass facsimile as the writer suggests could be unwise!*

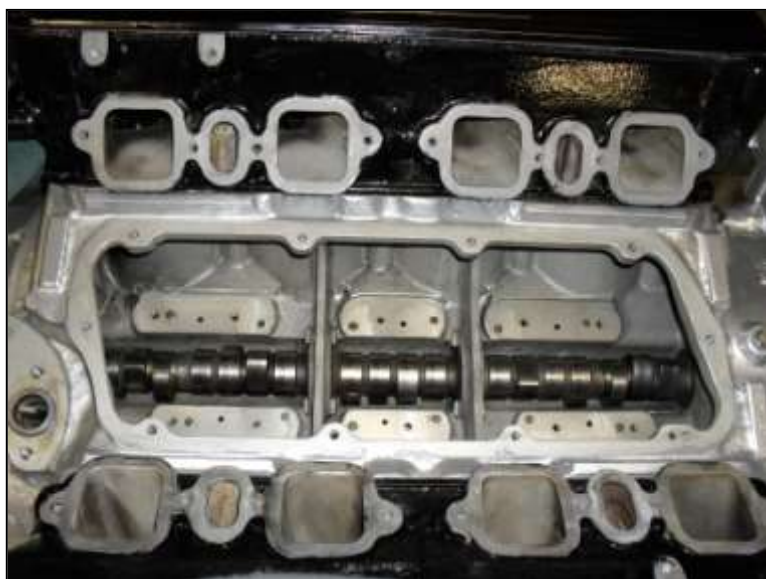
Thought I would share this view with you as it is a sight not seen by the average owner. Earlier we talked about cam followers and here we see the cam itself stripped of encumbrances.

The flat machined surfaces are the mounting places for the tappet blocks; four have three cam followers and two have two followers. I think that adds up to 16! Beneath those machined surfaces are the two main oil galleries that pump oil at full

pressure to these blocks and thence to the followers to make sure that they stay full at all times.

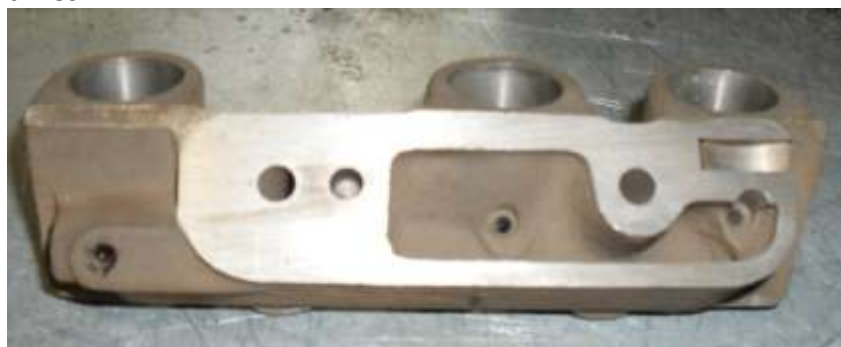
And here are the two sized blocks. The concave groove locates the block relative to the camshaft. These grooves engage dowels which can be seen in the above picture. The 'three' cam block is held down by two bolts and

the 'two' by one bolts. All bolts are washer locked.

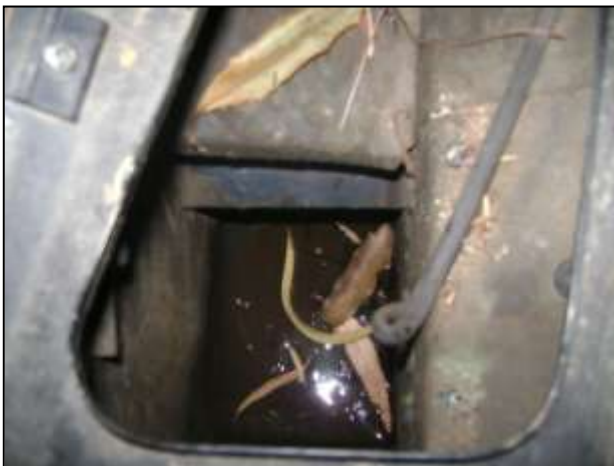
The picture above shows the top of the plenum chamber for the air conditioning, normally covered by a grille, coarse gauze and thin plastic sponge sheeting. All this, to prevent muck getting into the ducts; yet it does.

The wire gauze seen in the top picture is the last bastion to guard the air intake and is easily removed after lifting one screw. Hopefully you will find no water and if there is dirt leaves etc they can be removed with the household vacuum cleaner. Since vacuum cleaners were not considered by Rolls-Royce designers when cobbling these cars together, you will have difficulty getting around the corner at the bottom of the chamber. Try some largish rubber heater hose taped to the vacuum nozzle which you can slosh around corners to pick up the nasties.

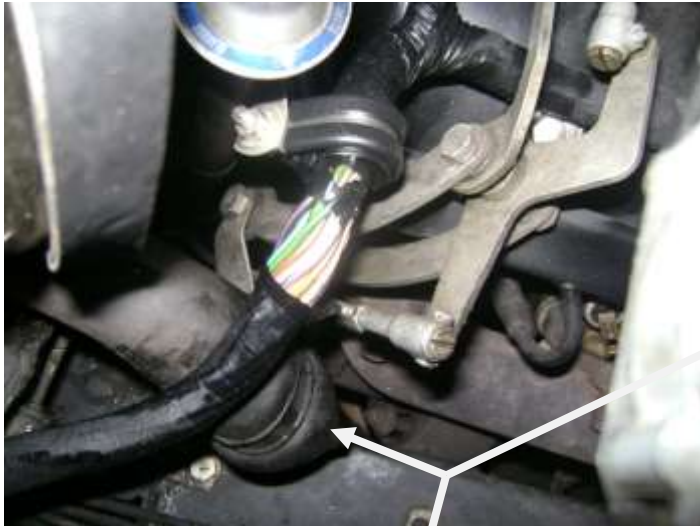
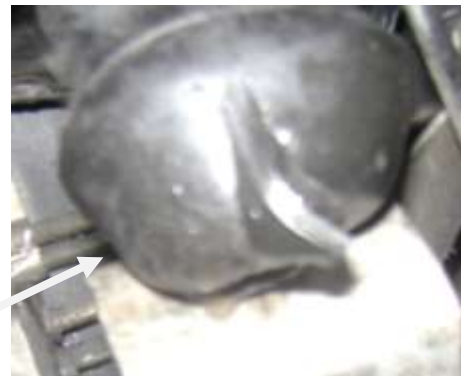
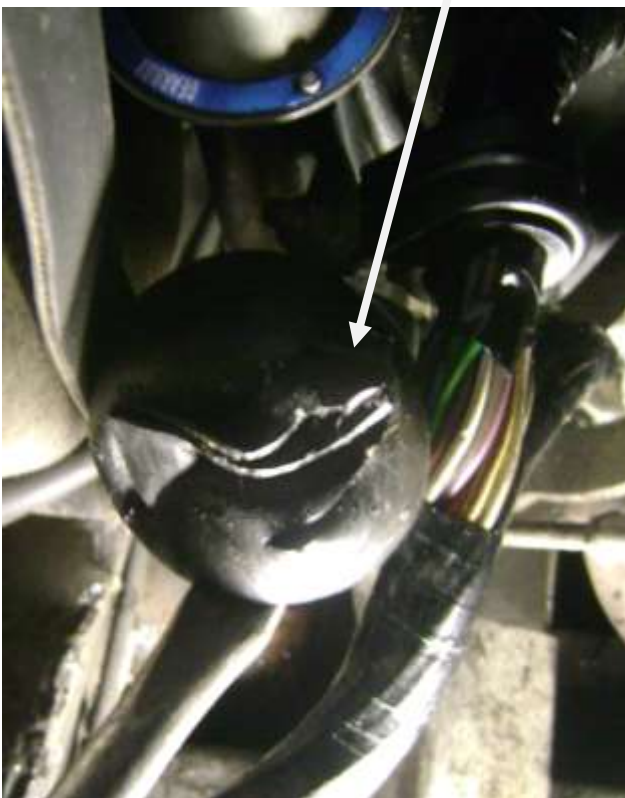
And above is the culprit. This is one of the two valves at the bottom of the pipe seen lower left, at left and below. The slit in the end is designed to let water out and keep smells and dust from the engine room getting into the car. It is intended that the usual vibration with car movement would keep the lips apart but with no rain or car wash the lips stick together and you have a stoppage and subsequent wet feet. The slit also becomes distorted through either poor initial fitting or being moved during repairs and left jammed against another component which is what appears to have happened in the lower picture

Simple prophylaxis is to run water onto the windscreen and down into the air intakes on each side and check that water is coming out of the valves. If they do block they can usually be squeezed open and if necessary get your pinkie in there and clear out any accumulation of muck. If all that fails open up the plenum and remove the valves for a good cleanout. Not doing this is a great recipe for rust and a rebuild of the bulkhead!

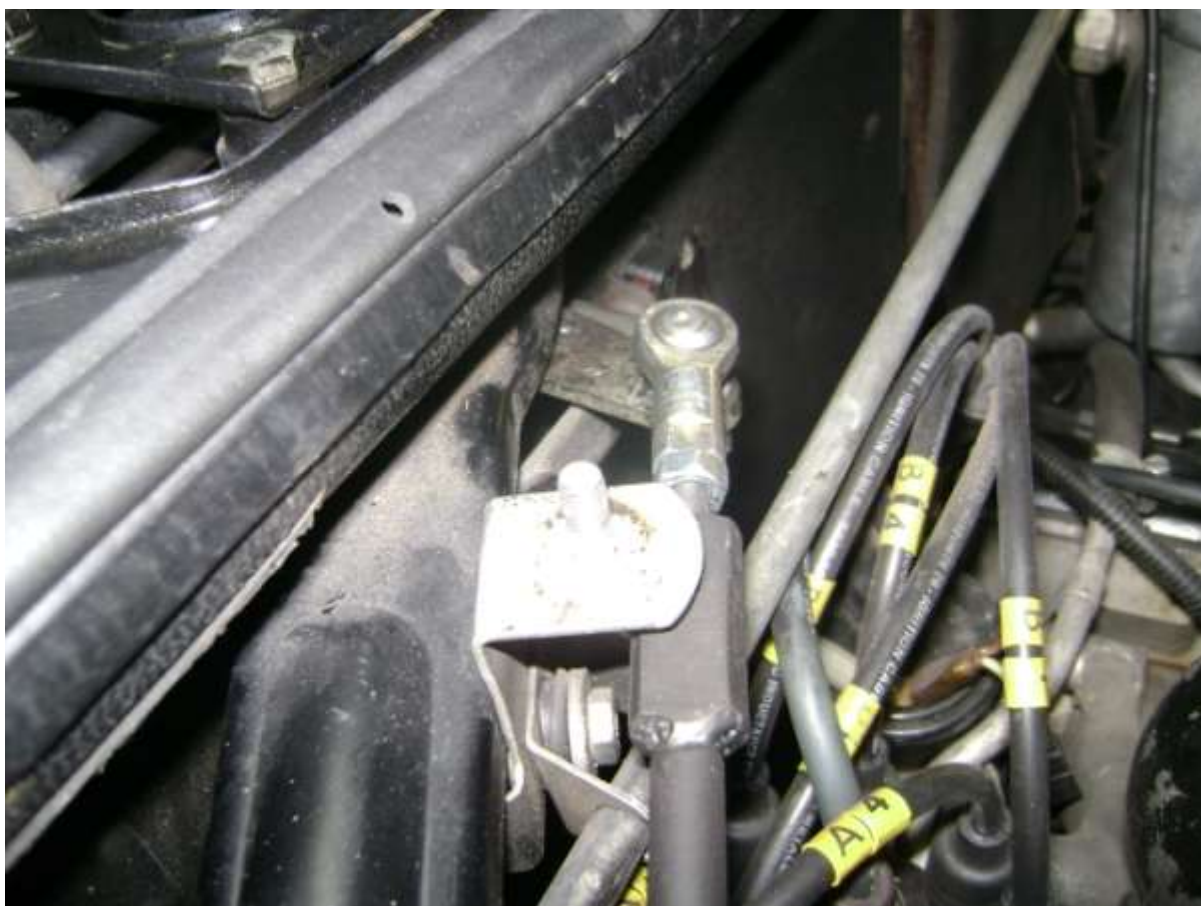
While you are cleaning out your plenum chambers, have a look at the myriad of levers and joints that jointly operate the windscreen wipers. The rod in the centre of the picture is driven back and forth by the wiper motor and gearbox. The rod is connected to the flat lever seen poking out of the bulkhead, that lever in turn operates more levers to operate the wipers. The swivel joint seen at the end of the first rod, collapses and although the wipers move more or less normally they produce a very audible clunk. It is usually this joint that has failed although there are a number of similar joints in the wiper drive train.

The joint is not replaceable. Apparently the Factory decided the whole setup was scrapped and the repair is to pull the whole mechanism out and replace it with a newly designed assembly. These are readily available, apparently for a few thousand dollars! If you don't want to spend that kind of money you might like to replace the original joint that has collapsed with a rose joint as it is known readily available from engineering suppliers or more easily from RA Chapman in Melbourne.

The repair involves removing the arm, grinding off the stub of the old joint, drilling a hole in the arm and welding the adjusting end of the rose joint to the shaft having cut off the old end. As I remember about \$25!!

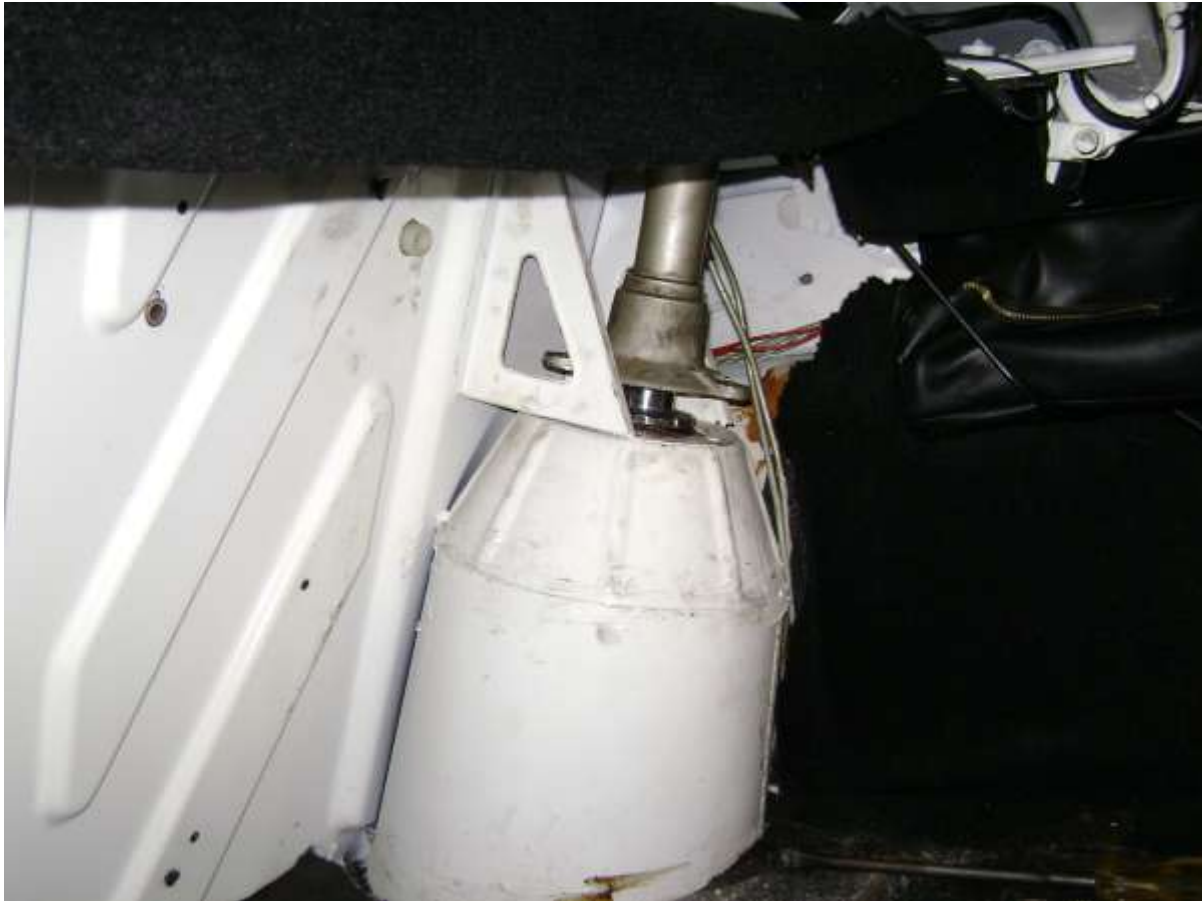
If there was an Achilles' Heel in the Shadow it would surely be the rear leveling. The system is powered from the number 2 accumulator and controlled by a two way valve mounted on the body adjacent to the rear wheel arch. The valve has an operating arm which is linked to the rear suspension arm. As the body is pushed down by loading the valve is opened admitting high pressure brake fluid to the rams one of which is seen in the above picture.

The picture shows the ram cylinder unbolted from the body mount and pushed up to the limit its travel. Within that cylinder is a very powerful lip seal and 'wiper' that prevents oil at up to 2500 psi escaping down the ram and onto the floor.

The ram seal wears and eventually leaks evidenced by a loss of fluid level in the rear section of the reservoir in the engine compartment and the extraordinary sight of oil dribbling down one or both of the rear springs. The immediate solution is to block off the oil supply to the ram with a small ball bearing at an appropriate joint. If this is not done not only will you empty the reservoir but if you are driving at any speed the 'cloud' of drops of RR363 will be sucked into the vortex following the boot lid and next day you will find the lovely paint work ain't lovely anymore!

Have you ever noticed that people who really have no idea how to fix a problem will exhort your help prefaced by the words 'all you have to do is....'. Well all you have to do in the above case is to undo the cylinder as in the picture having disconnected the interchangeable

feed and exhaust pipes, then using a strong 'C' spanner, unscrew the ram piston from the top of the spring mount. It will be very tight. In fact it is usually so tight that the spanner actually rotates the spring mount, which doesn't help at all. You can try jacking the subject wheel up until the suspension arm squashes the bump rubber which will entail lashing the body of the cat with chains to the jack. This will jam the spring mount up hard against the body mount. Try making a dam around the damn thing and keep filling it with your favorite release mixture. Try freezing spray on the piston. Use a small flame to heat the spring mount and freeze the ram. That usually gets it undone. If you have a very early car, prayer helps since the threads are fine rather than the coarse ones used later. These have defied God and man and in the end an angle grinder is used to cut the piston.

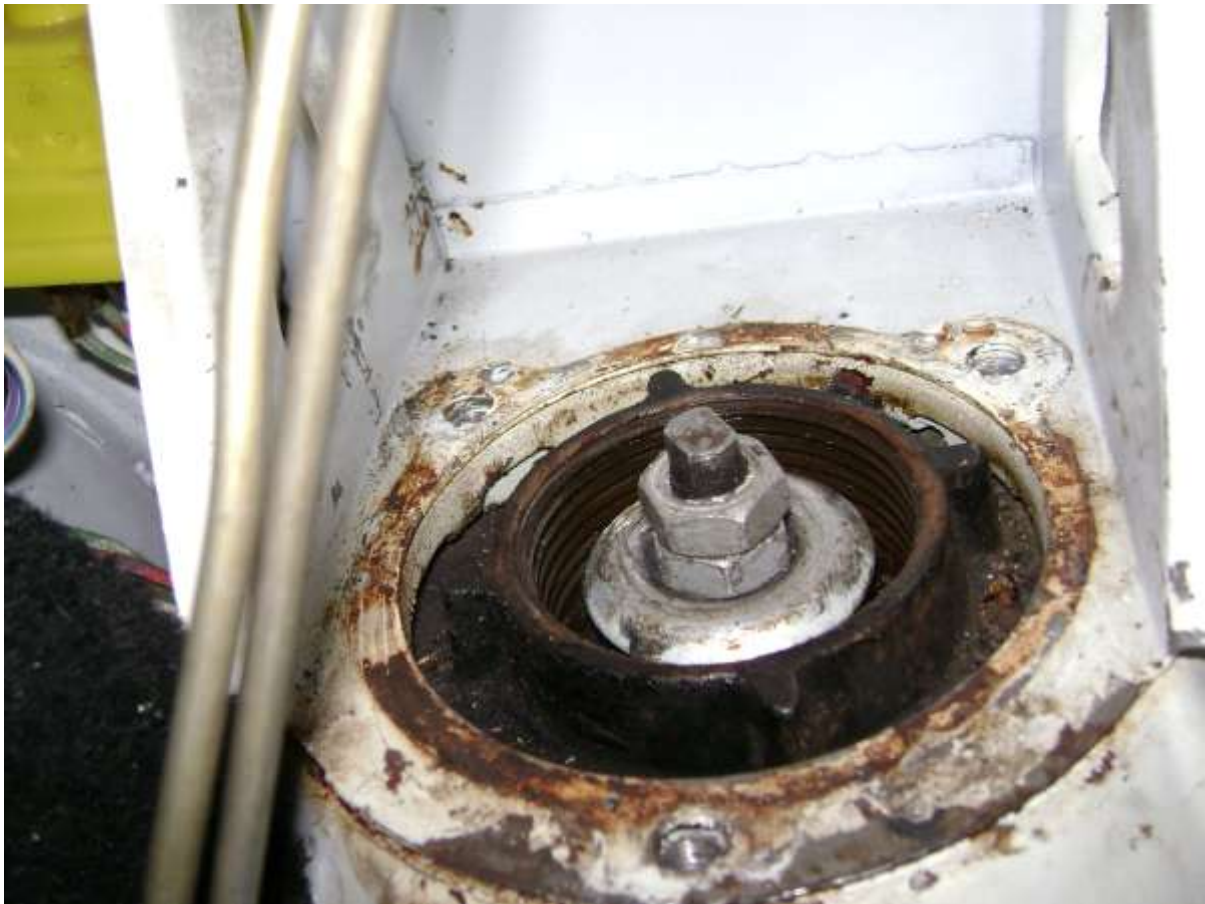
Here our efforts were rewarded. This is later car with the coarse threads. The 'lugs' on the spring carrier provide some assurance that the unit will stay in the hole. The friction between that carrier and the underside of the body mount is all that is available to stop the latter turning. The stud and nuts are the top rear shock absorber mount, which to get at to change the units, the rams have to be removed! Cars that have been used on bullock tracks often tear these spring towers out of the floor or crack the bracing panel across the front of the boot., All this can be repaired by an adept welder and a wallet!

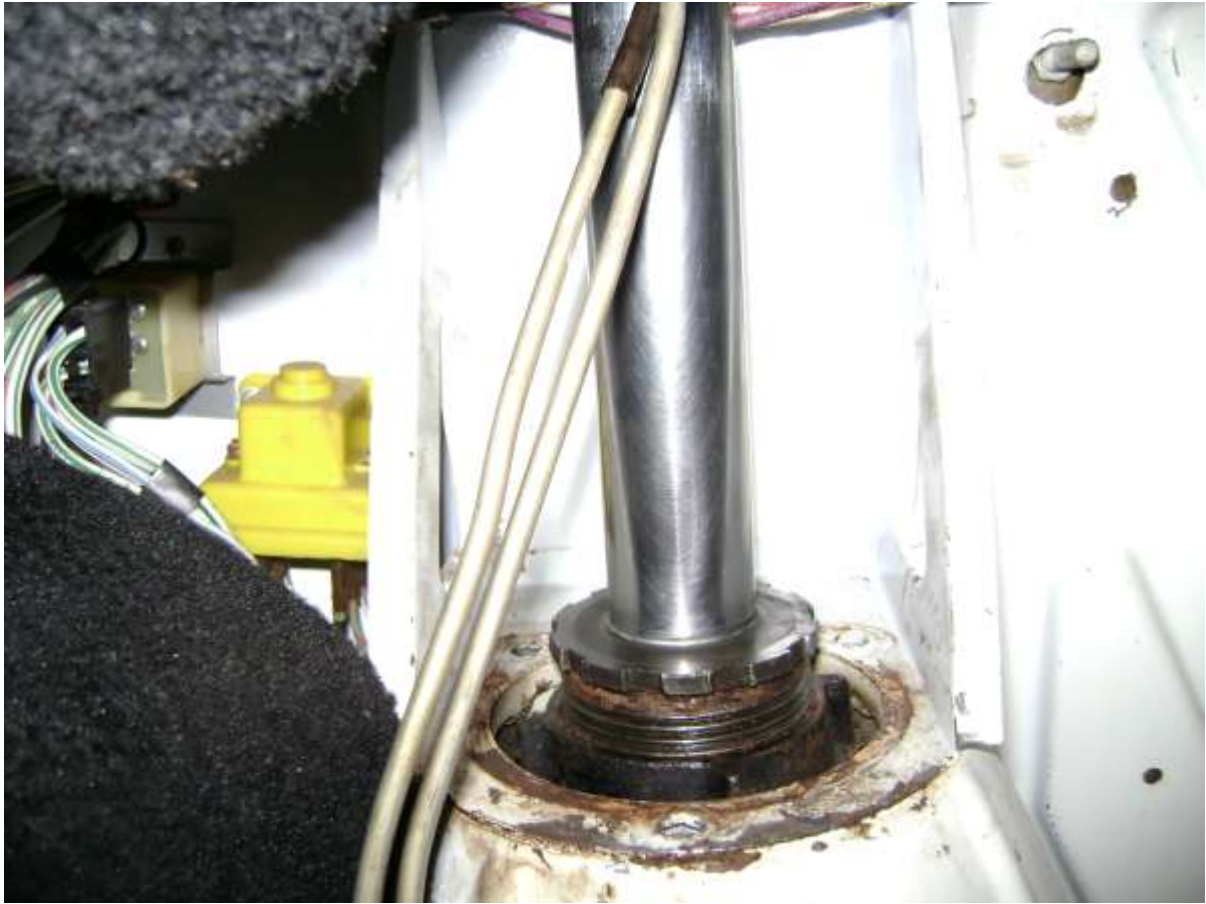
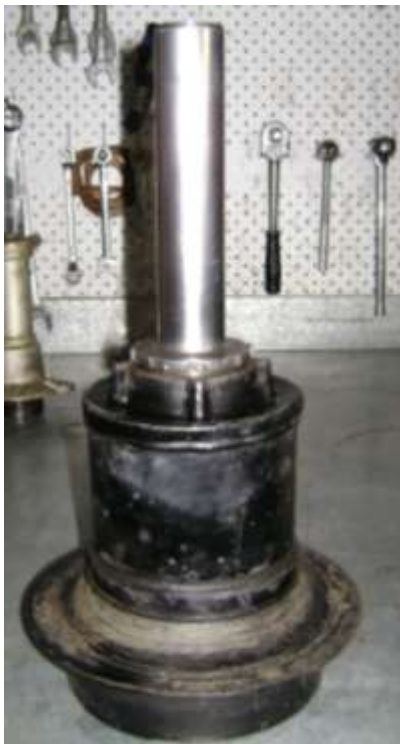
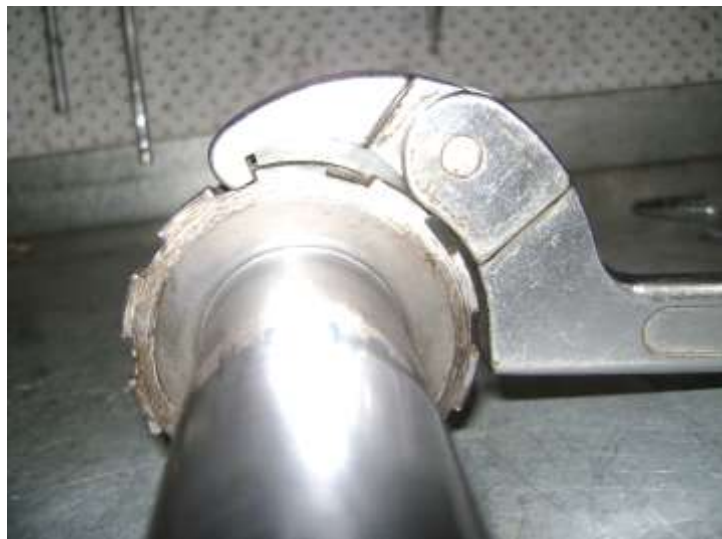
Some views of the ram piston. Above: usually the most welcome sight, the thing unscrewed without damage. At left: Just to show you the spring pot with centering lugs and the piston. And below: The 'C' spanner in operation. The 'notches' obviously get mangled but having got the thing out, with a little dexterity and a good file, these can be cleaned up and be as good as new.

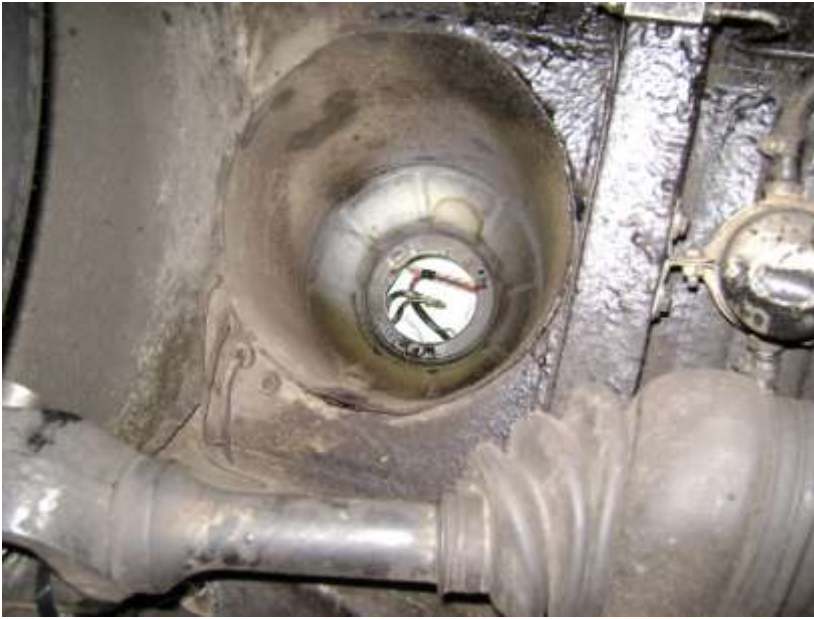
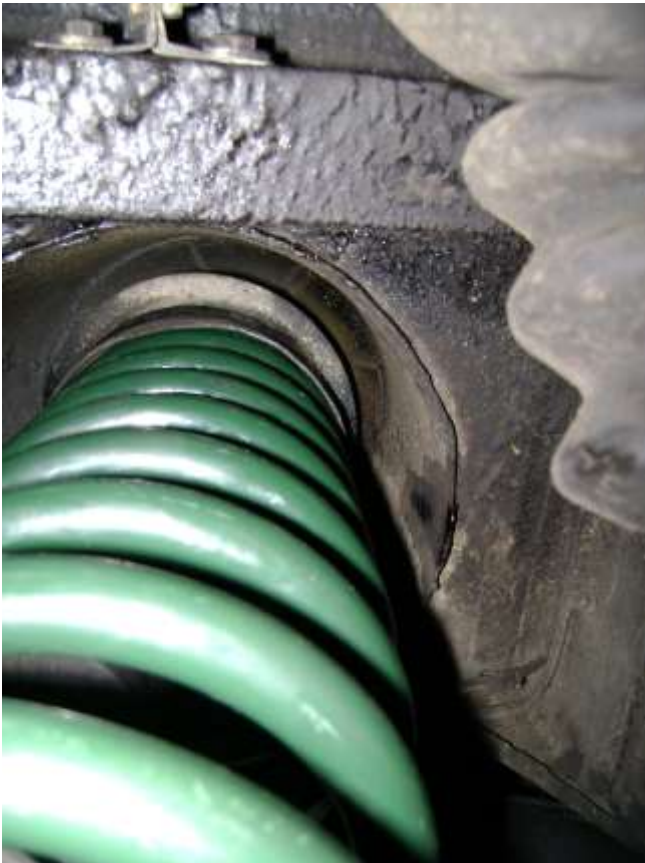
Top left: A worm's eyeview of the tunnel in which the rear spring operates. Note the absence of any 'fangs' on the underside of the top of the cavity. These would be a great help by stopping the spring seat from revolving while you are trying to unscrew the ram! Bottom: The spring and its seat in position. Bottom right: As springs go these are exceptionally long. R A Chapman have replacements at a very attractive price that have an extra coil. These seem to improve cornering and certainly lift the 'saggy bum' look these cars adopt in old age.
