# — Technical Topics No. 11 — Racking Your Brains

By Richard Treacy  
(Switzerland)

## Introduction by Bill Coburn (ACT)

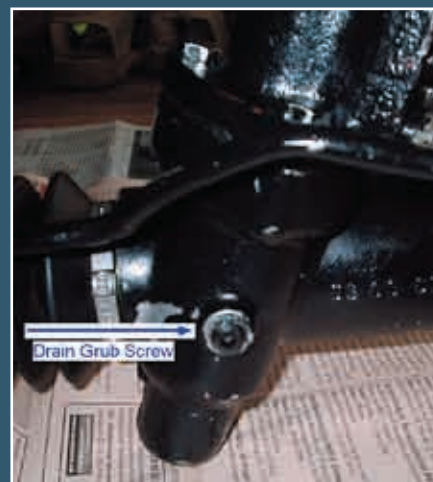
*Above: The leaked fluid drain grub screw.*

There is a simple check for a suspect rack. In the main housing on the lower protrusion for the pinion and towards the rear of the vehicle, there is a grub screw drain plug. Remove it with an Allen key. If any sizeable quantity of red fluid comes out, then you have troubles. If gear oil comes out, then the rack is an early type and has been mishandled during assembly, shipping or fitting: the rack tube may be refilled with gear oil through the blanking plug above and forward of the pinion in-situ in this case. Many a vehicle's rack is drained by this method before sale to disguise a leaking rack during the warranty period, so beware. Having said that, it will let you cheat through a roadworthiness test, giving you time to consider the options.

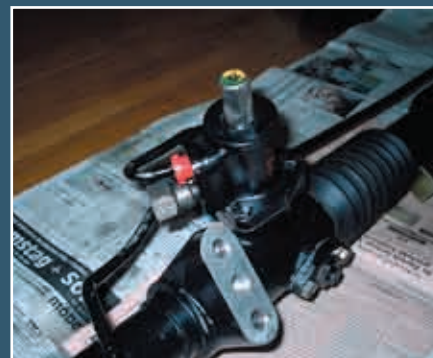
*Above: The late-type rack, showing the cast mounts integral with the aluminium end housings and the external backlash adjuster. Early types have their mounts fabricated and welded to the end-housings.*

In it went. Great. Until October 2004. AGAIN AGAIN. Depleted fluid was followed by leaks soon after. Yet again, I bought an exchange rack, this time a UR71818 from a 1997 model. This third and final design incarnation from about 1992 onwards has a useful external backlash adjustment rather than using shims on the spool valve. That's applaudible, but I was suspicious of why such a young rack was on the exchange programme. This time I fitted a system fluid filter for good.

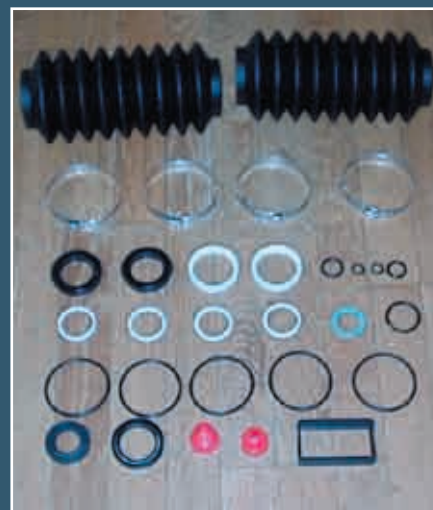
*Above: A seal kit from Crewe.*

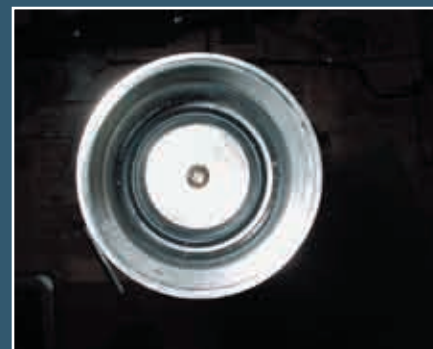
*Below: End view of the main seal in-place.*

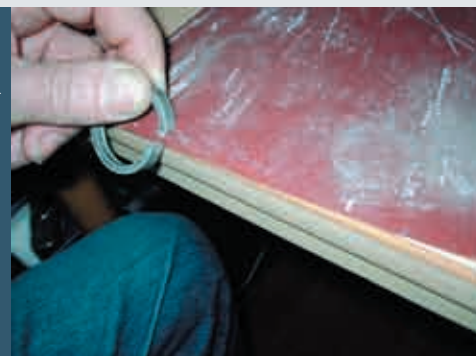
Here Richard is gapping the PTFE bearing. You of course know that P.T.F.E. is a convenient way of referring to Polytetrafluoroethylene! (Try saying that quickly when you are a few sheets into the wind!) You know it as Teflon, a non-stick coating for your saucepan. It was first produced commercially after the last war.

This appears to be the root cause of our problems, as just a few thou off-centre allow leaks. Gapping is a simple task, using 420 grit paper on a flat surface. Measure the gap in the shaft tube bore using a feeler gauge in exactly the same manner as you would a check a piston ring gap, although the gap in the PTFE bearing is at 45 degrees.

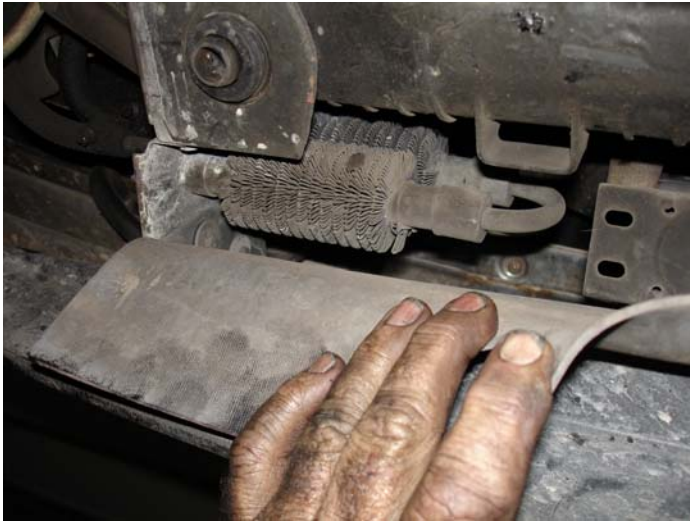
**At Left:** The little oil cooler under the radiator of the Spirit seems to be a token effort at trying to keep the internal fluids at a reasonable temperature.

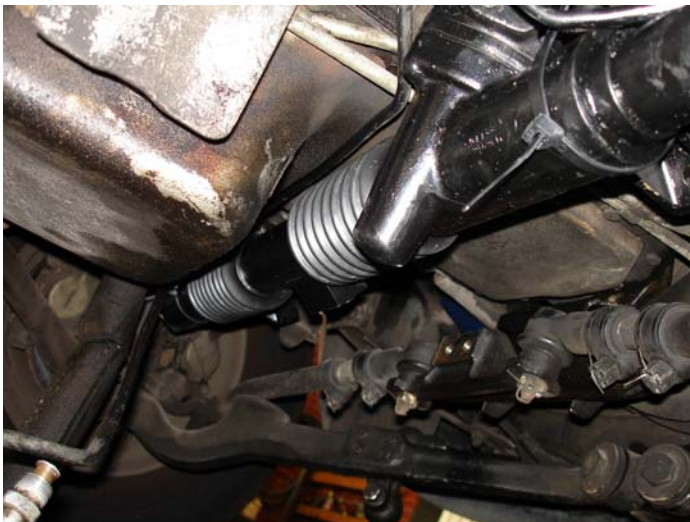
**At left:** One reason I do not remove and replace racks for recreation is the small task of trying to hold the unit which must weigh some 40 lbs while you are trying to thread the pinion shaft onto the end of the steering column and then start at least two of the 4 large bolts that secure it to the sub frame. The plastic tie strap seen poking out on the right of the picture is my method of loosely supporting the thing while you swear and grunt. The large straps are adjustable and are more than adequate to take the weight.

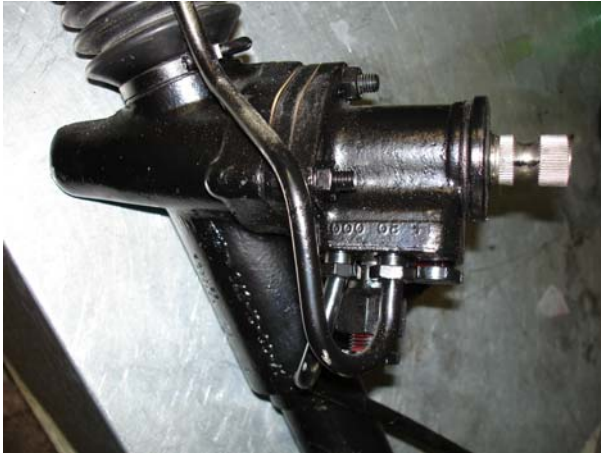
**At left:** The dreaded spool valve which controls the amount of hydraulic assistance to be supplied to the rack. The splined shaft connects to the steering column. This bit of the assembly seems to require more precision in setting up than a Swiss watch!
