THE ROLLS-ROYCE OWNERS' CLUB

THE FLYING LADY

SILVER CLOUD/S: 1955-1966

VOLUME I
A/C & VENTILATION
ENGINE & POWER TRAIN
SUSPENSION & BRAKES

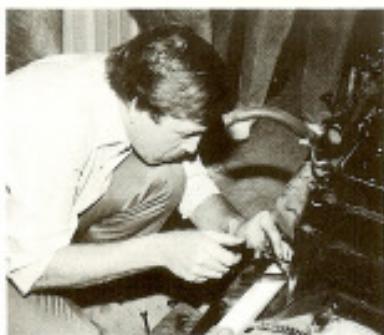
Left: Jim Shelly, NY, adjusts the exhaust valves on the RROC Foundation's R Type engine. Center: Even with the correct exhaust valve tool to keep the cam follower from turning as you adjust the valves (left, early post-war cars; right, R Type and Silver Cloud), access is extremely difficult when the engine is in the car. Right: Tool and wrenches in place for adjusting exhaust valves.

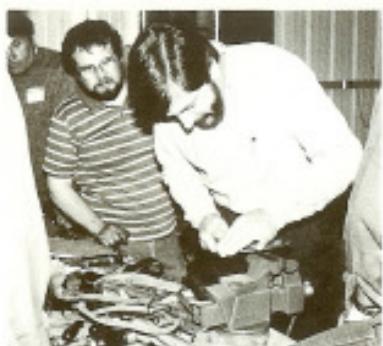
Above: To correct uneven wear, Ralph Curzon files the servo lining in a circular pattern, always touching two sides of the plate at once. Left: Ken Collier, Jr., gives it a try.

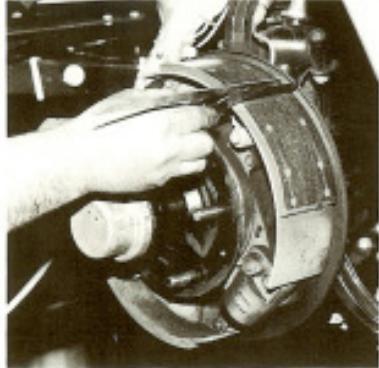
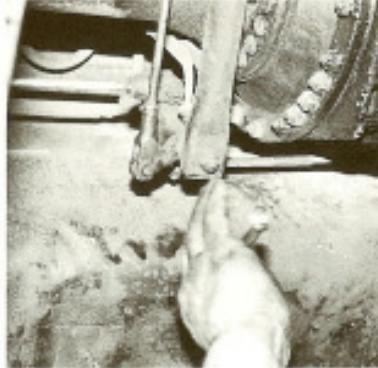
Two of the adjustments necessary for proper braking: left, measure the squareness of the brake shoe to the hub (within $\frac{1}{32}$ "); right, check the rear brake compensator for stop: no movement here!

- Master cylinder end: connect rods back here, remembering spacers. Tighten snugly. Remount rubber stop pad. Continue to back of car to tee at axle. Want NO movement there. Undo locknut, turn fastener, and retighten very tight (rear compensator).

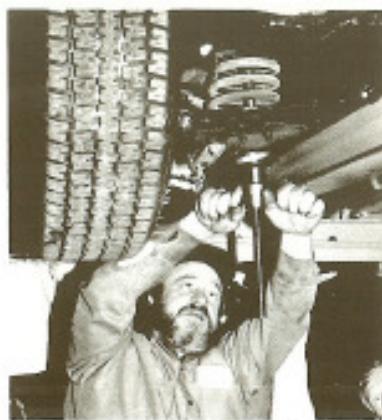
Doug Seiber, NY, compresses an SCI front spring to relieve pressure from the front suspension while he checks components for wear.

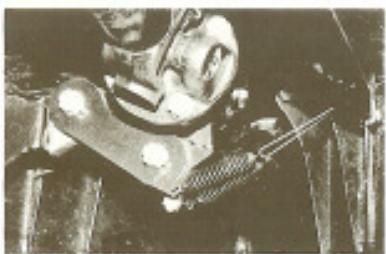
Mounting for u-joint holds driveshaft horizontal. Check for spring tension and rust. If the springs do not pull the shaft back, remove, clean, and re-fit, or replace springs as necessary.

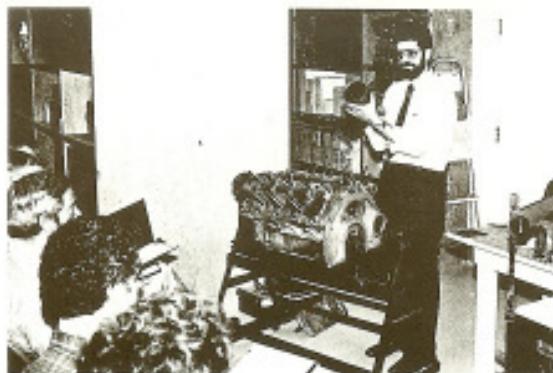
Cal West is about to fit a cylinder liner in the demonstration V-8 engine block.

Sleeve removal requires considerable application of force, even after warming the block and cooling the sleeve with sprayed freon. This force can distort the thin aluminum webbing that separates cylinders if it is unsupported, so each pulled sleeve should be dropped back in as its neighbor is pulled. Without its o-rings, it goes in and out quite easily. The factory sleeve puller (liner extraction tool RH7095) can be assisted in its operation by molybdenum disulfide on its threads, to cut friction. Member Roy Wilson also suggested the fitting of a radial thrust bearing, such as a PII throwout

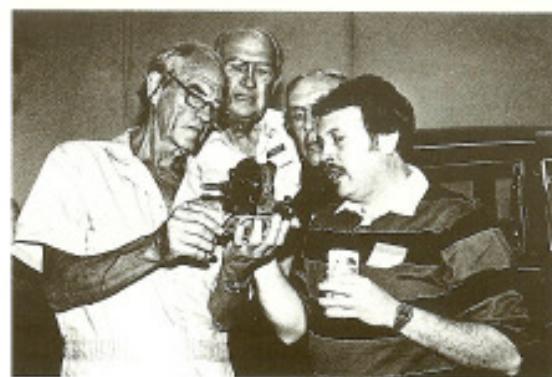
Ed Shaffer, Chuck Byrne, Sid Greenspan, and Jim Steiner examine a cutaway carburetor.

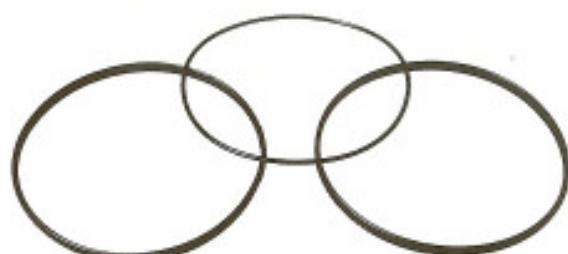
Cylinder liner o-rings: flat for coolant, round for oil.

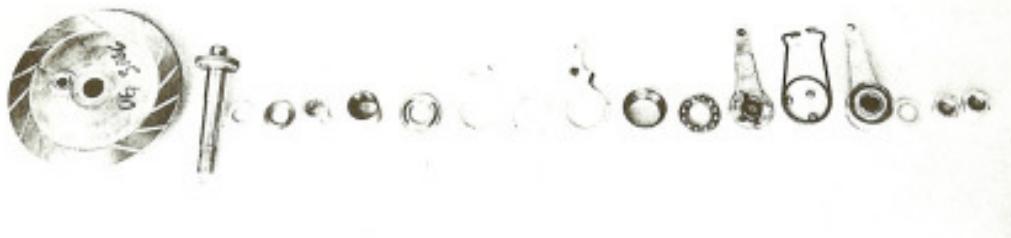
Servo mechanism exploded.

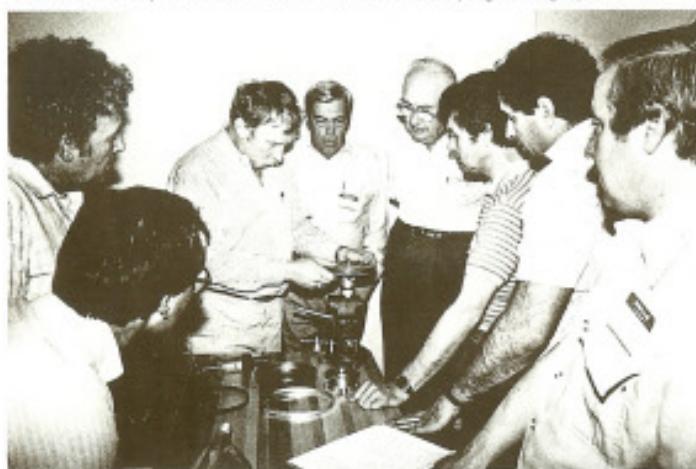
Larry Paquette shows Ed Collins, Chuck Byrne, Dave Brokaw, and others how to fit the friction plate in the servo mechanism, keeping all fingerprints off.

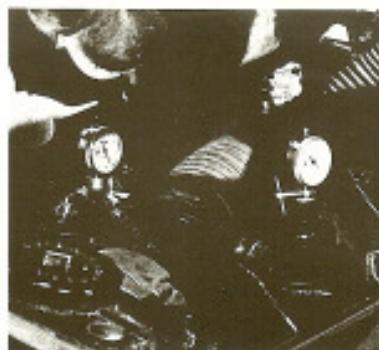
The dial indicators measure piston height in the carburetor suction chambers. Left, LSAE365, carbs are quite even, while, right, the Shadow needs some adjustment—one carburetor is doing most of the work.

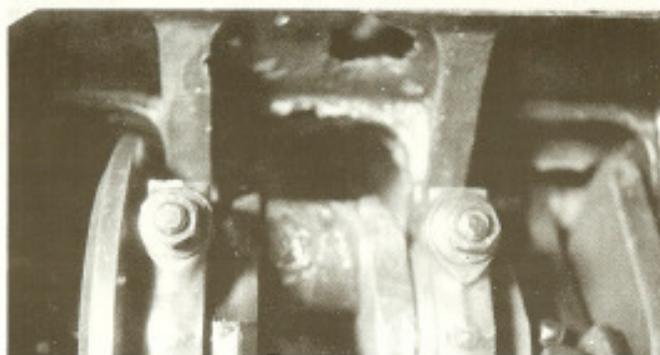
This engine was over-revved, throwing 2 rods, one through the block ... see hole.

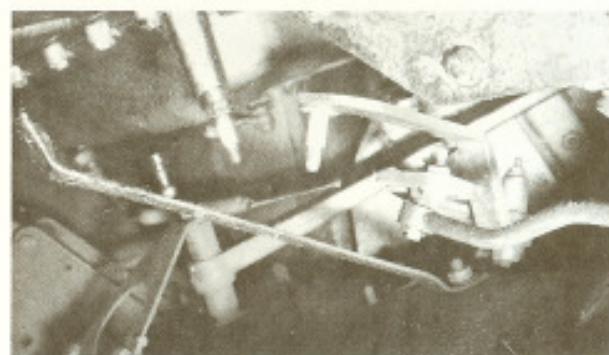
This confusion is the Hydra-Matic linkages which must be disconnected from the frame.

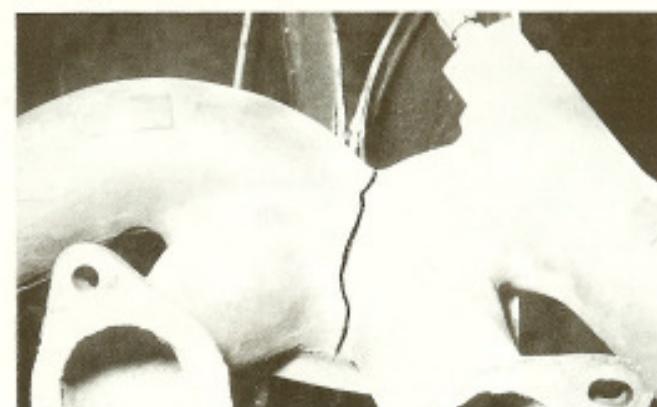
The exhaust manifolds are not strong. This one cracked from twisting engine pipes to get holes to line up. About \$40 each.

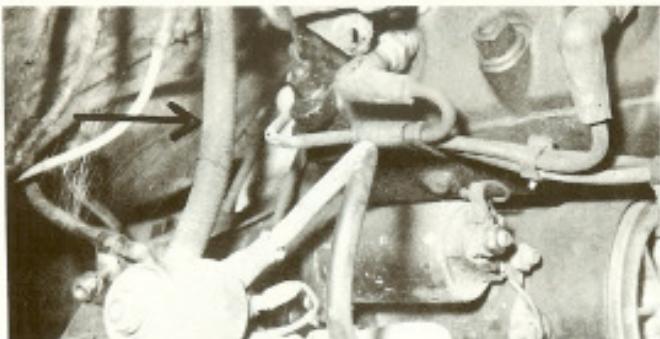
Be certain to remove the metal fuel line leading from the frame to engine (see arrow).

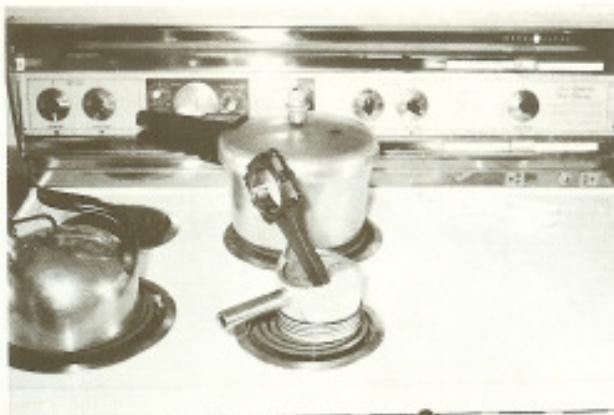
Clean cooking on the stove. Heat the piston until the pin enters. Unit will be quite warm at completion.

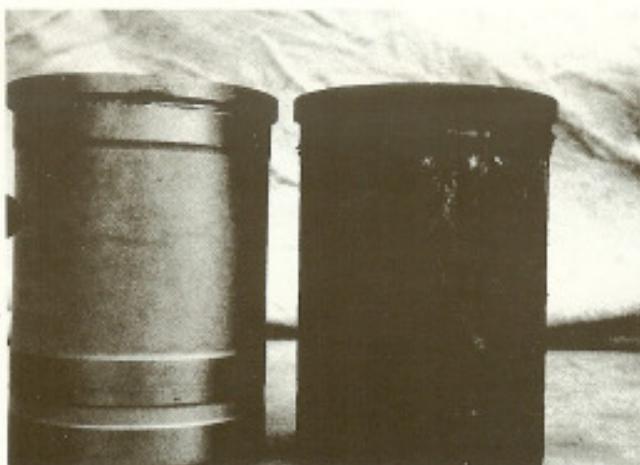
The old sleeve shows why the sleeves are often well-secured to the block. The build-up is basically aluminum corrosion.

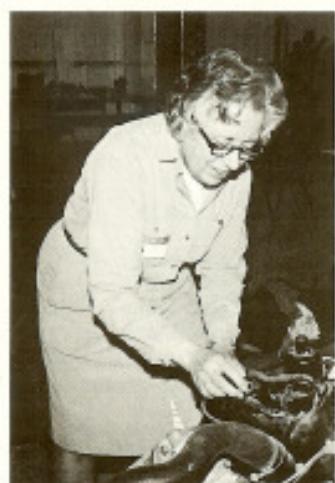
Louise Newman, NH, investigates the workings of the automatic choke which she expects to repair on her own Silver Cloud II.

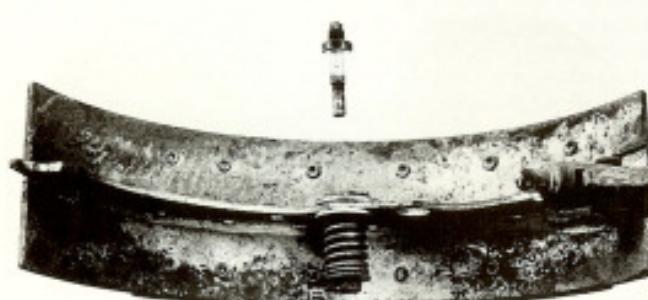
Figure 2: Front brake shoe and steady post which slips into shake back stop. Adjustment of post squares up shoes to drum.
Figure 3: Shake back stop—exploded view. The shake back stop functions chiefly to hold brake shoes just at the interface when the brake pedal is released. It introduces friction into the system. Normally, such a device (in other makes of car) is built right into the shoe and is not adjustable, whereas Messrs. Rolls-Royce make theirs adjustable.

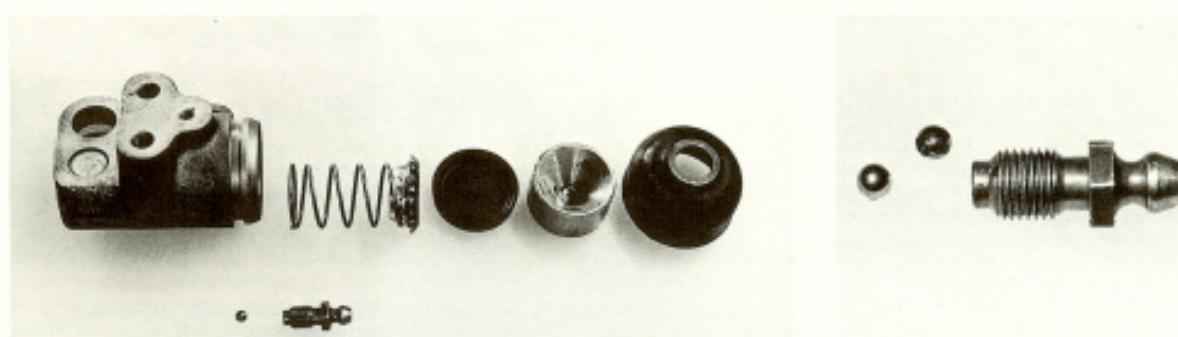
Figure 4: Front wheel cylinder, exploded view. The plungers in the cylinder should just pull out—with finger pressure only. If the plunger binds, carefully use compressed air to force the plunger out, say into a towel. If your system of compressed air is not sufficient to push the plunger out, use an hydraulic pump after making a fitting to the hydraulic line. Two hundred to 300 lbs. of hydraulic pressure should be enough for even the worst—or use a separate grease gun. The thread in the fluid pipe hole is the same as an ordinary 3/8 NF bolt. Be sure the plungers are the chromium plated type. A flawlessly smooth surface is what's wanted and needed here. Hone the wheel cylinders smoothish and clean. Surface finish and consistency are the goal for smooth working. **Figure 5:** Bleed screw with old and new steel balls. Discard the old ball. Do not lose the bleed screw balls in the cylinders. Remove the little ball from the cylinders first.

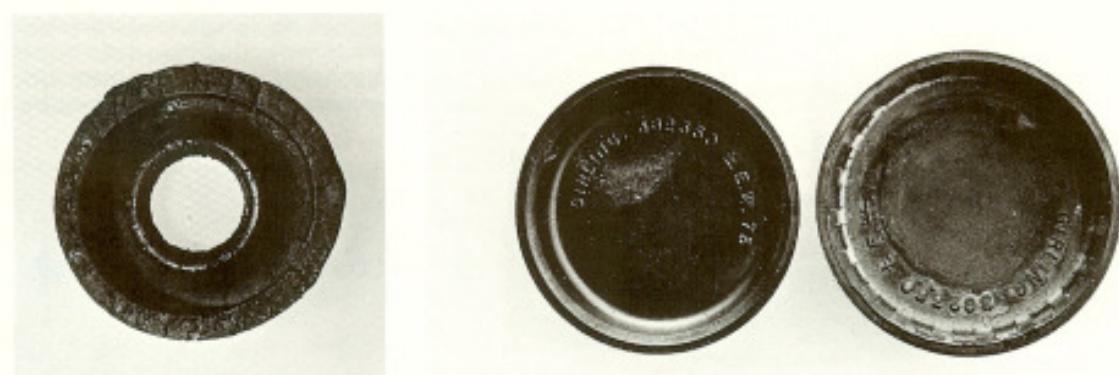
Figure 6: Water and dirt excluder for rear brake expander. Deterioration allows water and dirt into unit, which in turn corrode plunger and expander cylinder and damage rubber seals. Then brakes don't release. **Figure 7:** Rubber seals, front wheel cylinder. Left: new one; note sharp edges. Right: old and swollen, thereby binding brakes. Deterioration results from old age and soaking in brake fluid. You'll feel the difference between the old and new rubber parts. The old seals have expanded 3/16", are softer, and will bind in the cylinder. Replace all soft parts on overhaul. Don't argue. Just do it.

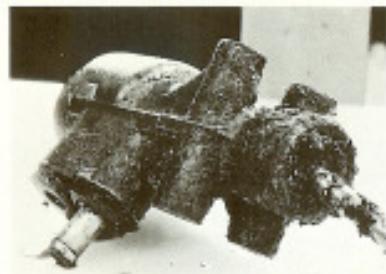
Figure 15: Master cylinder immediately on removal from car. Grit and muck indicate seepage and leakage—clearly time for overhaul. The muck is the result of a mixture of brake fluid and water attacking die-cast aluminum. Despite all the corrosion, these brakes worked, though they did not retract. You can inspect for corrosion without removal or disassembly; just look under the rubber covers. **Figure 16:** Master cylinder, exploded view. Notice corrosion on plunger at top right. Either fit replacement cylinders or bore and sleeve the old ones; cost considerations may dictate the method of repair.

Don't remove the metal hydraulic tubes from the chassis. Just disconnect the other end from the master cylinders and blow them out with air.

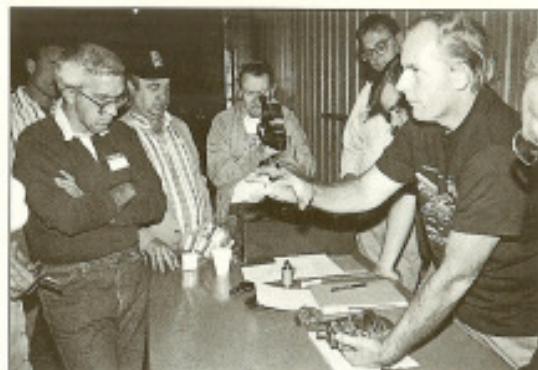
Guy Williams makes his point – note the cutaway Shadow accumulator.

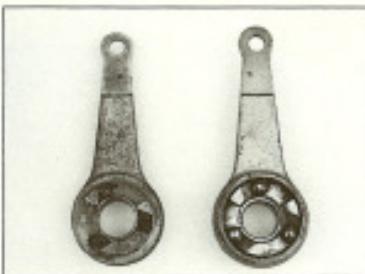
As the servo arms pivot during brake application, ball bearings on small ramps force the arms apart, engaging the servo which then assists in brake application. These bearings rarely wear. Use chassis grease to keep them from falling out during assembly.
