**Bulletin**

MODEL : BENTLEY MARK VI

EXCESSIVE LEAKAGE OF OIL AT THE CENTRE STEERINGLEVER AND STUB AXLES(CENTRALISED CHASSIS LUBRICATION SYSTEM).FOR INFORMATION:

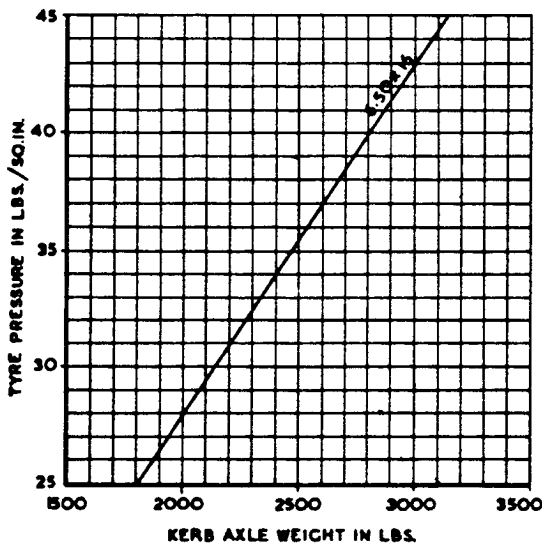
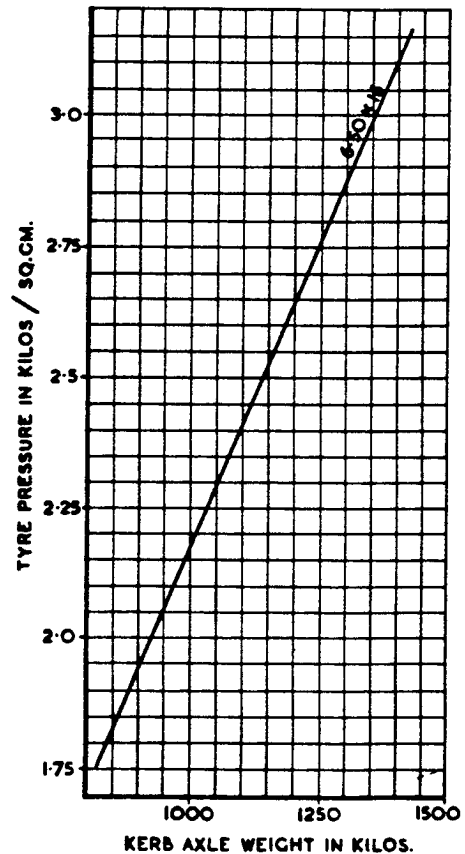
The following chart shows the recommended rear tyre pressures for a given unladen rear axle weight. (This weight is the kerbside weight, i.e. full tank but no passengers).

Certain cars which have a lot of overhang at the rear, but are not necessarily heavy, will steer better if the rear tyre pressures are increased a few pounds.

The weight on the front wheels is unlikely to vary sufficiently to warrant any alteration in the recommended front tyre pressures, but the rear axle weight on certain cars may necessitate an increase in the rear tyre pressures.
