MODEL BENTLEY MARK VI

STONE GUARDS ON REAR WINGS AND SILL.

**Bulletin**

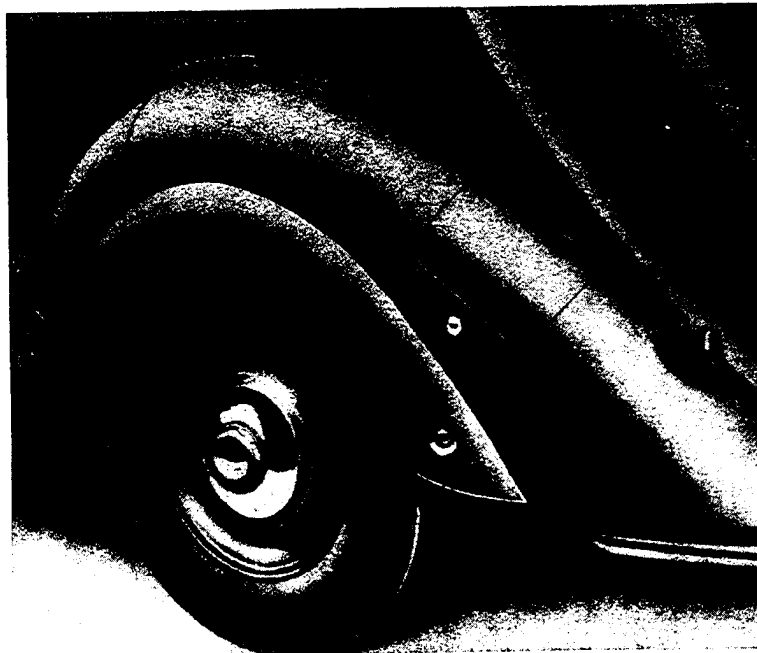
FIG. 1.

Fig. 1, shows the finished appearance of a rear wing with a fairing fitted.

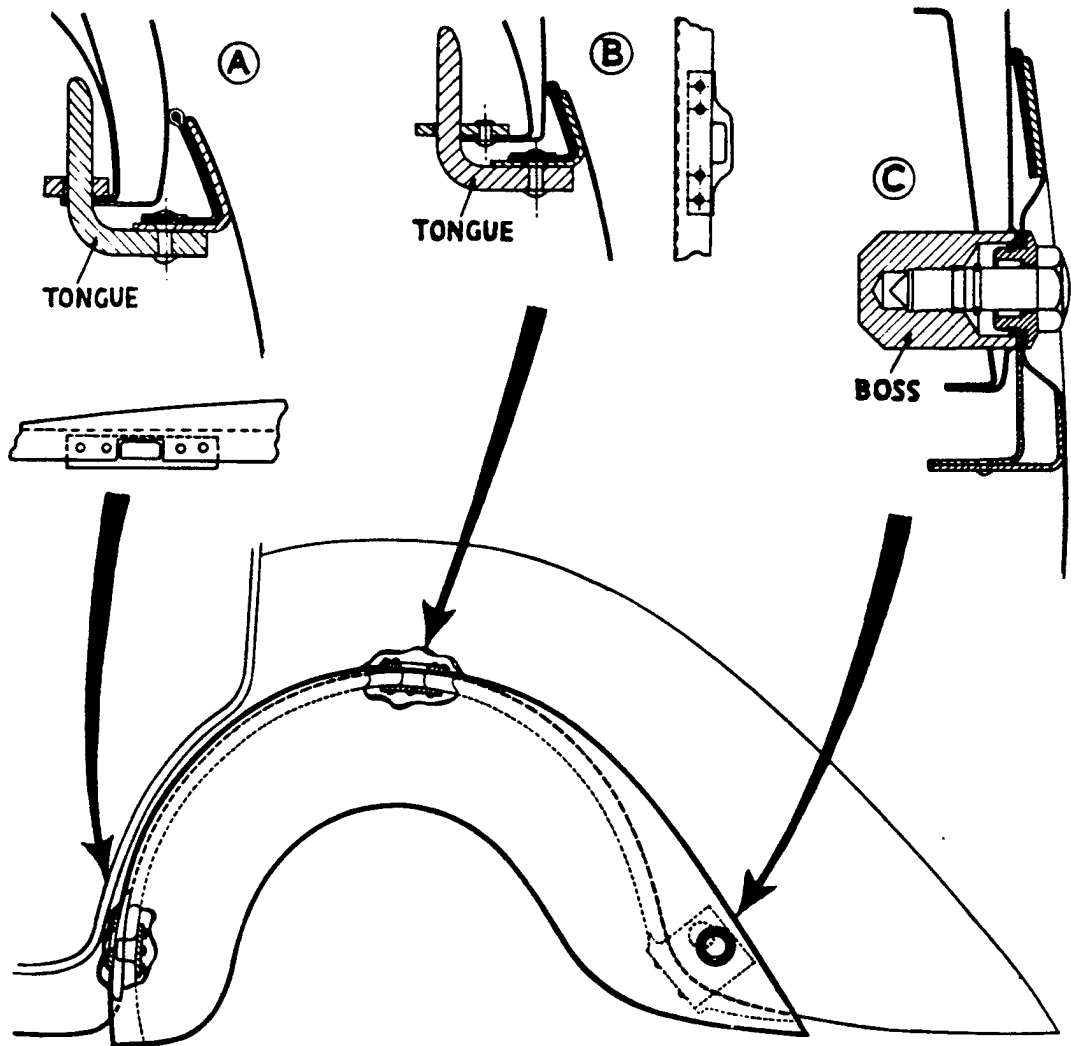
FIG. 2.

When fitted, the wing fairing is secured at three points as shown in Fig. 2. Items 'A' and 'B' are tongue and slot fittings, tongues being fitted

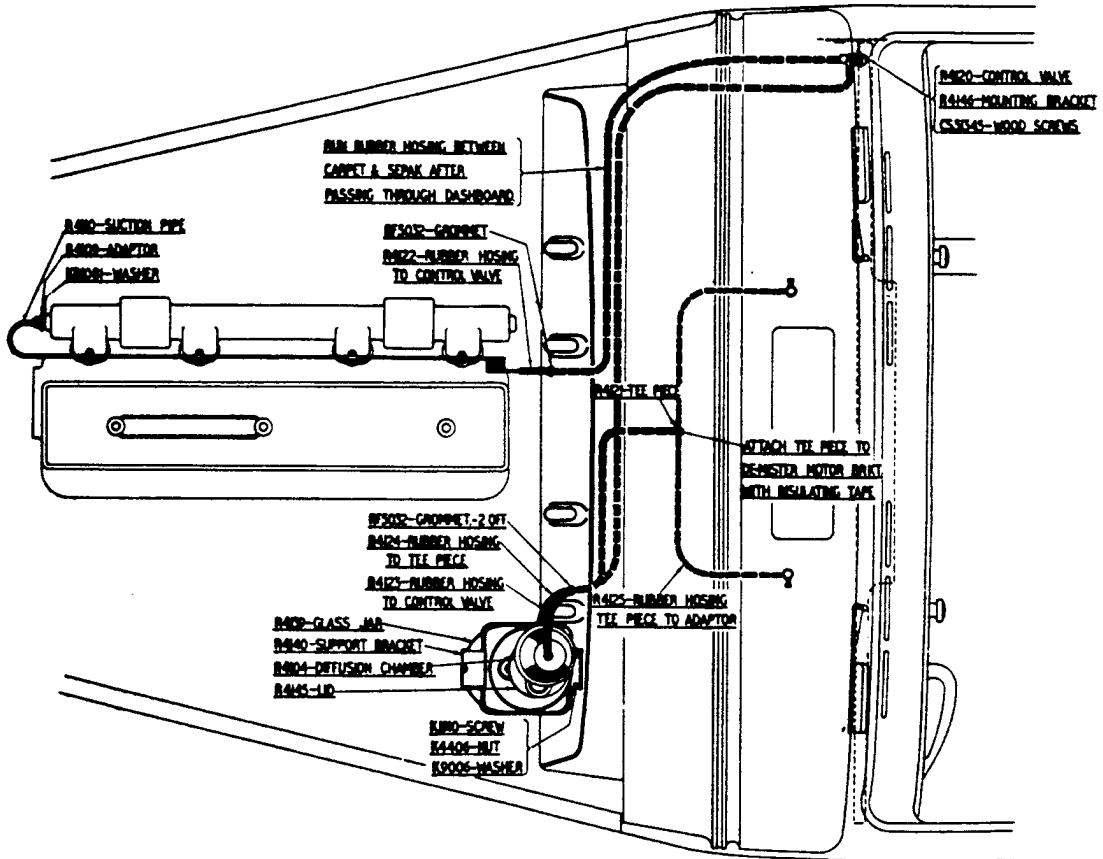
FIG. 7.

With this in mind, it has been decided to clarify the diagrammatic instructions given in Fig. 7, page 4, of the original issue.

7. Install the various lengths of rubber hosing as shown in Fig. 7:-

NOTE:- To avoid kinks, it is recommended that the holes which have been drilled through the sepak are suitably radiused off on the driver's side.

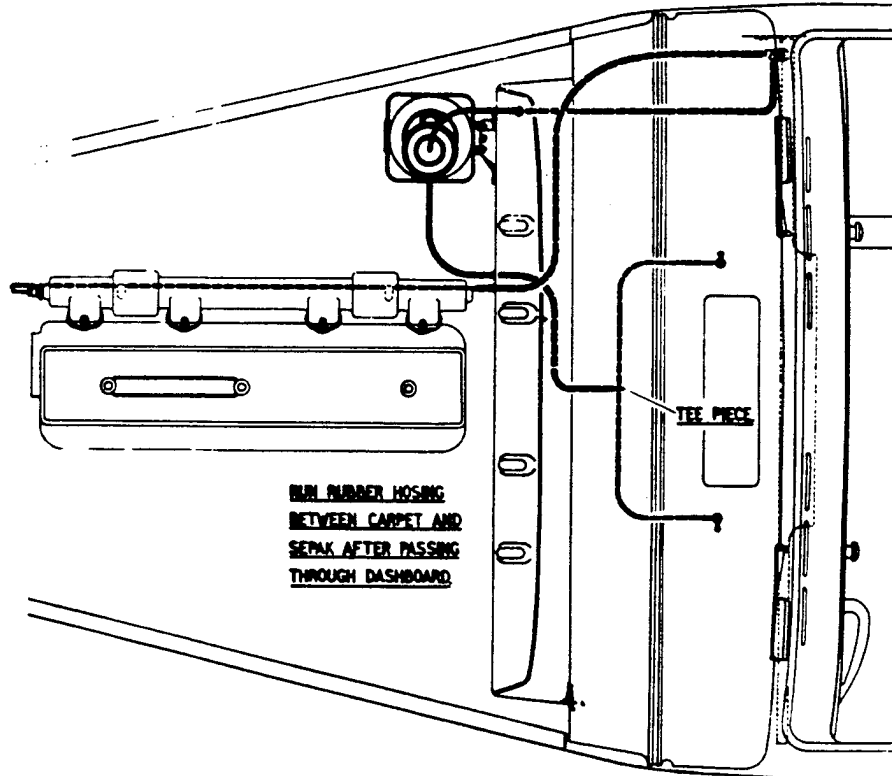
FIG. 10.

**NOTE:** The run of  $3/16$ " I/D tubing from the top adaptor of the pump diaphragm goes to the control button, while that from the lower adaptor is connected to the tee-piece of the spray unit pipe line below the scuttle.

- NOTES:**
- (a) The rubber tubing is supplied in two bulk lengths of 12'0" and 2'0", and will require cutting to suit the individual car.
  - (b) To avoid kinks forming in the tubing after it has passed through the dash and sepak, it is recommended that the holes drilled through the sepak are suitably radiused off on the DRIVER'S side.

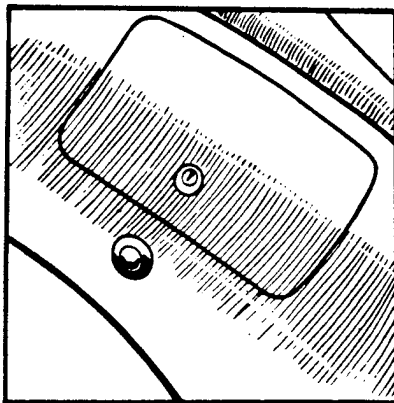
FIG. 1.

Fig. 1 illustrates the finished appearance of a petrol filler door with a lock fitted.

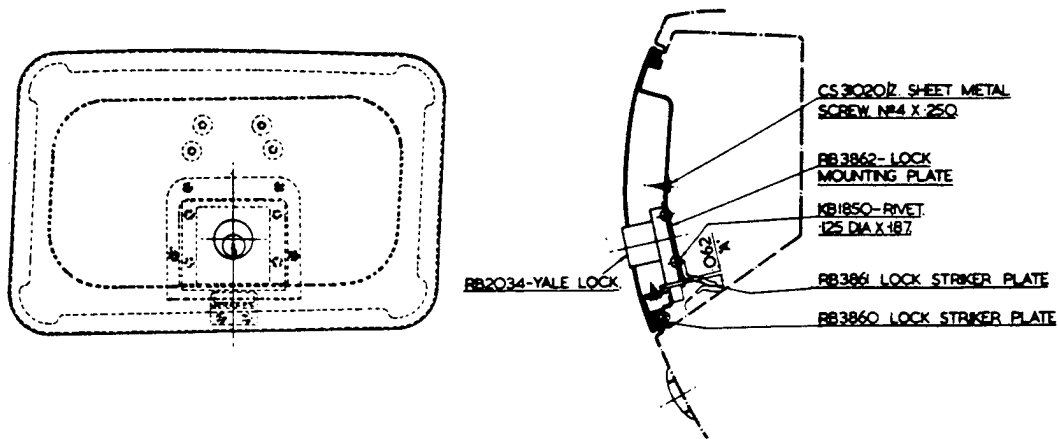
FIG. 3.

6. Weld the rear lock striker plate to the back of the lock mounting plate, ensuring that this is set  $1/16"$  (1.6 mm) inwards from the bottom edge of the mounting plate as shown in dimension "A" Fig. 3.
7. Rivet the lock assembly to the front of the mounting plate, using the four rivets provided.

**NOTE:** Prior to riveting, it is recommended that the slot cut in the mounting plate is checked for clearance in conjunction with the tongue of the lock.

8. Temporarily locate the lock in position in the filler door and mark off the centres for the six retaining screws, using the mounting plate as a template.
9. Remove the lock assembly and drill the inner door panel accordingly. Refit the lock assembly and secure to the door panel by means of the retaining screws as shown in Fig. 3.
10. Drill and secure the front striker plate to the interior flange of the filler compartment as shown in Fig. 3, using two 3-BA countersunk headed screws and nuts. Replace the rubber grommet after tightening the nuts.
11. Refit the filler door to the wing.

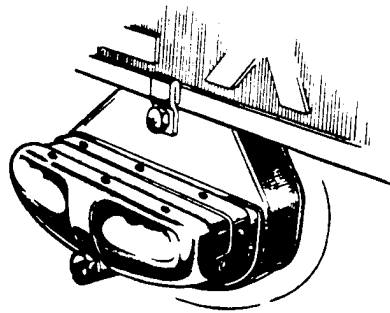
PRE-MODIFIED ASSEMBLY.

In order that all Bentley Mark VI cars now operating in the U.S.A. shall conform with existing lighting regulations, a modified type of rear number plate support bracket has been introduced, which, when used in conjunction with the existing lamp, will provide direct illumination of the rear number plate.

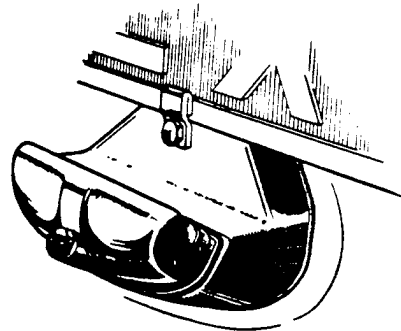
MODIFIED ASSEMBLY.

This modified support bracket differs from the standard fitting by having a built-up boss, the outer face of which is set at an angle of  $28^{\circ}$  relative to the bracket itself. The lamp is fixed to this inclined face, thus ensuring that the number plate is directly lit.

Arrangements have been made for the despatch of sufficient quantities of these modified brackets to cover all known requirements, and Retailers are requested to effect this modification as soon as cars are available. Further supplies of these modified brackets, if necessary may be obtained upon application to the London Service Station, Hythe Road, Willesden, London.N.W.10.

It should be noted that all modified support brackets will require painting at the time of assembly to suit individual requirements.

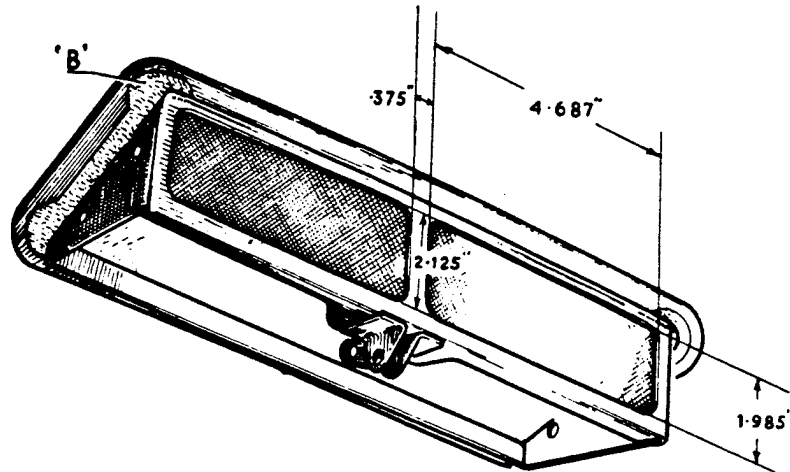
Fig. 2.

Note: If upon examination of the sealing surface of the underside of the lid it is found there is a depression at each of the four corners, ('A' Fig.1), caused by the clinched-over flange, then opportunity should be taken to fill them in as described below, in order to make the surface smooth and flat, thus making a better water seal.

- (a) Thoroughly clean the underside of the lid and fill in the depression at each corner with solder to surface level, ('B', Fig. 2). Also fill in the channel running along the two sides, which lead into each corner. Face off the solder as necessary until it is flush all the way round.
- (b) Mask the wire screen and re-cellulose the lid taking care to match the colour. Do NOT cellulose the wire screen.  
Note: The above method of filling-in, which is preferable to the method described below, should however, only be undertaken where it is possible to match the existing colour, because, owing to the blistering effect of the solder it will be necessary to entirely re-cellulose the lid.
