MODEL BENTLEY MARK VI

MODIFICATIONENGINE OIL FILLER CAP WASHER.

REPLACEMENT OF TAPPETS.

FOR INFORMATION:C & A CYLINDER HEAD GASKETS.

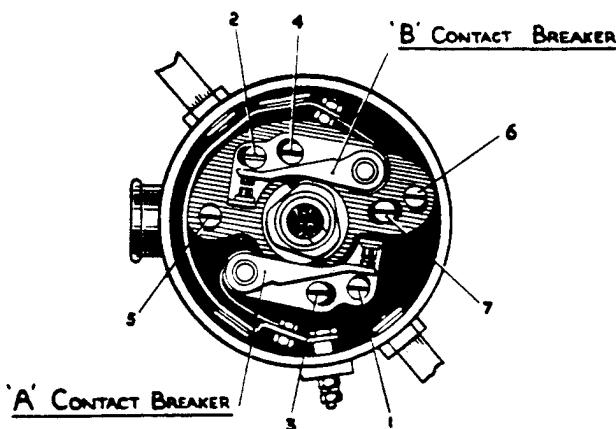
FIG. 1. PLAN VIEW OF DISTRIBUTOR.

- (iii) Trim up the points as necessary with a fine carborundum stone until the faces close flush with each other. All raised portions of the contact surfaces should be removed, but it is not necessary to remove the pit marks. If the points are badly pitted, then they should be renewed.
- (iv) Refit the contact plates, adjusting washers and breaker arms to their original position. Apply a few drops of engine oil to the felt wick at the top of the distributor spindle and one drop of oil to the rocker arm pivot pins. Smear a trace of Mobiloil Grease No. 2 on the cam surface and refit the rotor.

- (i) Remove the rotor arm from the top of the spindle.
- (ii) Loosen the small bolt attaching the spring of 'A' Contact breaker, Fig.1, to its anchorage and remove the breaker arm complete with its fibre adjusting washer/s. Remove the locking screw 1, (Fig.1) and remove the contact plate. It is essential that each contact breaker arm, their respective fibre adjusting washer/s and contact plate should be kept together and refitted to the same side of the distributor from which they were removed. Carry out the same procedure for 'B' contact breaker - removing the locking screw 2.

- (v) Turn the engine until the fibre heel of 'A' contact breaker arm is on a lobe of the cam to give maximum opening, loosen the contact plate locking screw, 1, and turn the adjusting screw 3, to obtain the correct gap between the points i.e. .020" (0.508 m/m), and then retighten the locking screw (1). Check that the setting of the gap has not been disturbed by the tightening of the locking screw. Carry out the same procedure for 'B' contact breaker arm by loosening the locking screw 2, and turning the adjusting screw 4.

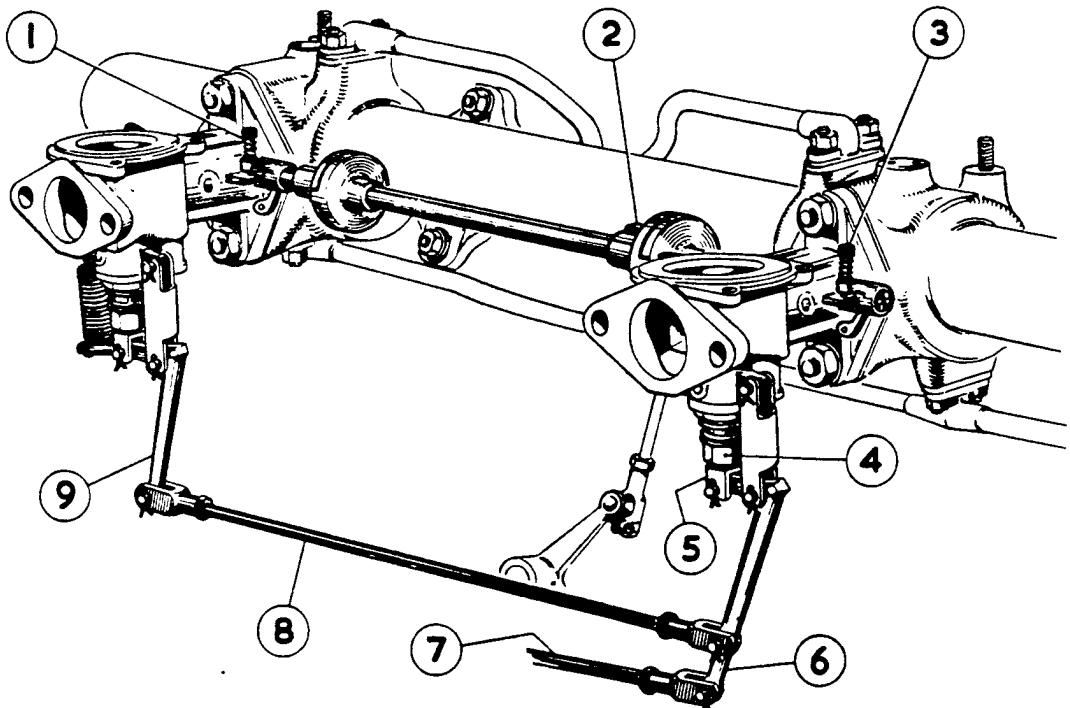
FIG. 2. VIEW OF CARBURETTOR CONTROLS (CARBURETTORS PARTLY DISMANTLED FOR CLARITY).

If after carrying out the above mentioned operations, and upon running the engine until it attains its normal running temperature, it is found that the slow running is uneven, it will be necessary to adjust the carburettors as described below:-

If the mixture is weak, the exhaust note will be irregular and splashy, whereas, if the mixture is too rich, the exhaust note will have a constant rhythmical uneven beat, known as "hunting".

The jet adjusting nut is actually a "stop" against which the jet head (5) should bear. Screwing up the nut weakens the mixture and unscrewing it strengthens the mixture.

- (vi.) With the hand throttle lever on the steering wheel placed at the bottom of its range, adjust, if found necessary, the throttle stop adjusting screw (3) of the front carburettor until the correct idling speed has been obtained.

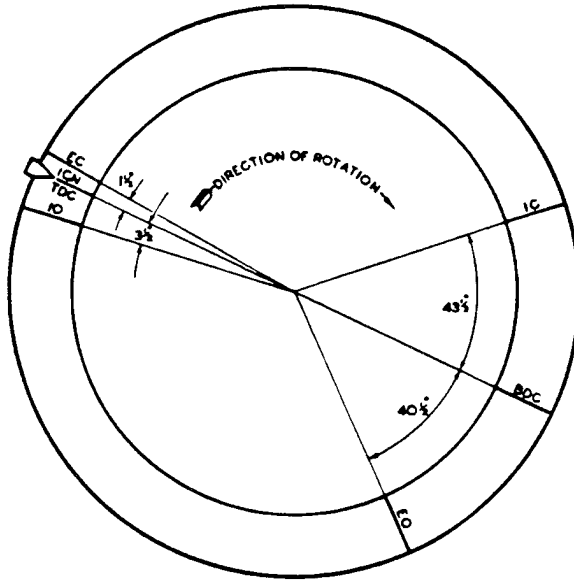
FIG. 1 OLD TIMING MARKINGS ON FLYWHEEL, LEFT-HAND DRIVE CARS.

Early type flywheels are marked as shown in Fig. 1 and 2. Later type flywheels and replacement flywheels, will be marked as shown in Fig. 3. It will be noted that the T.D.C. mark only is shown with additional markings at five degree intervals from 5° to 20° on either side of the T.D.C. mark designated EARLY and LATE.

Basically, owing to the possibility of camshafts and flywheels having been replaced in service, valve timing should be carried out in accordance with the camshaft fitted and not necessarily in accordance with the markings on the flywheel fitted.

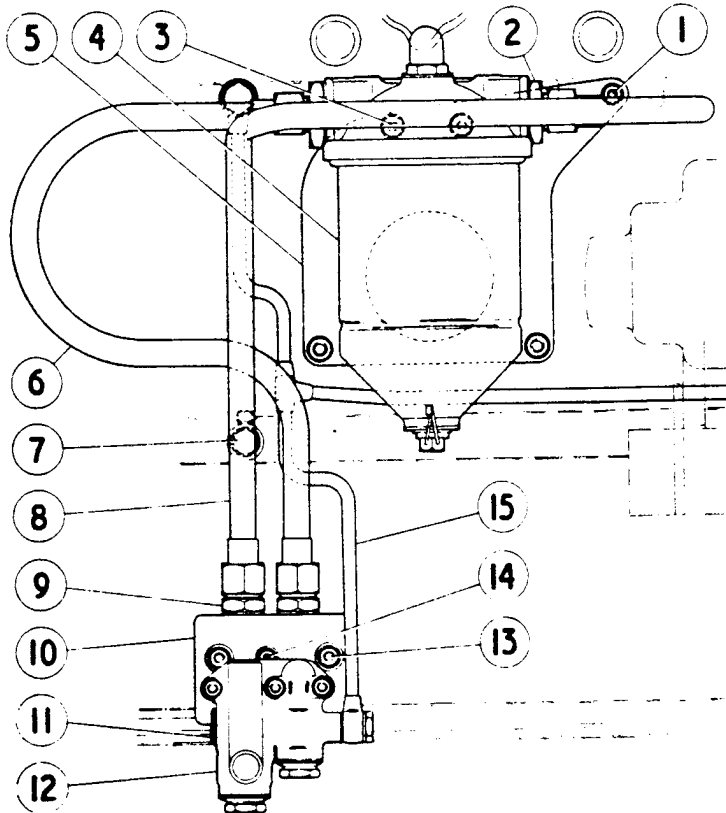
FIG. 9. FRONT ELEVATION - FULL FLOW OIL FILTER.

Concerning Scheme 'B' of Service Bulletin No. BB-143 (Section E), it has been brought to our notice that in one or two instances the external inlet and outlet oil feed pipes, (6 & 8 Fig. 9 of Bulletin No. BB-143) to and from the Full Flow Filter have been reversed when fitting to the transfer block (10). This arrangement causes the filter element to collapse and block the oil flow.

It will be observed upon reference to Fig. 9, that the lower end of the inlet oil pipe (6) is connected to the right-hand side of the transfer block and the outlet oil pipe (8) to the left-hand side.

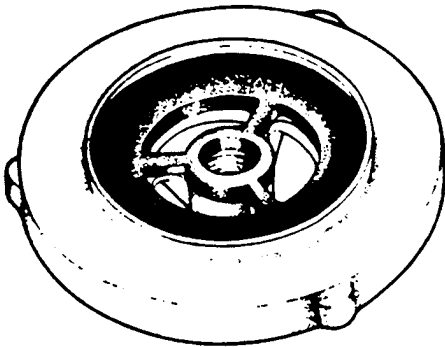
Fig.3. Modified 'Top Cap'

If the outer lip is found to stand proud of the inner sealing face (see Fig.1), a modified 'Top Cap' (see Fig.3) should be fitted and the original discarded.

The filter head should be painted with a green spot to serve as a means of identification after the above instructions have been carried out.

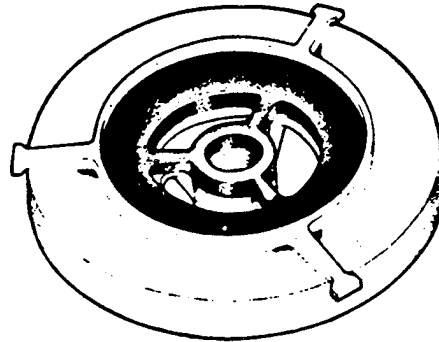
Fig.4. Original 'Top Cap'

If the inner sealing face stands proud of the outer lip (see Fig.2) the original 'Top Cap' (as shown in Fig.4) can be retained. For future replacements only the modified 'Top Cap' will be supplied.
