Bulletin

MODEL BENTLEY MARK VI

MODIFICATION.**REAR BRAKE EQUALISER.**

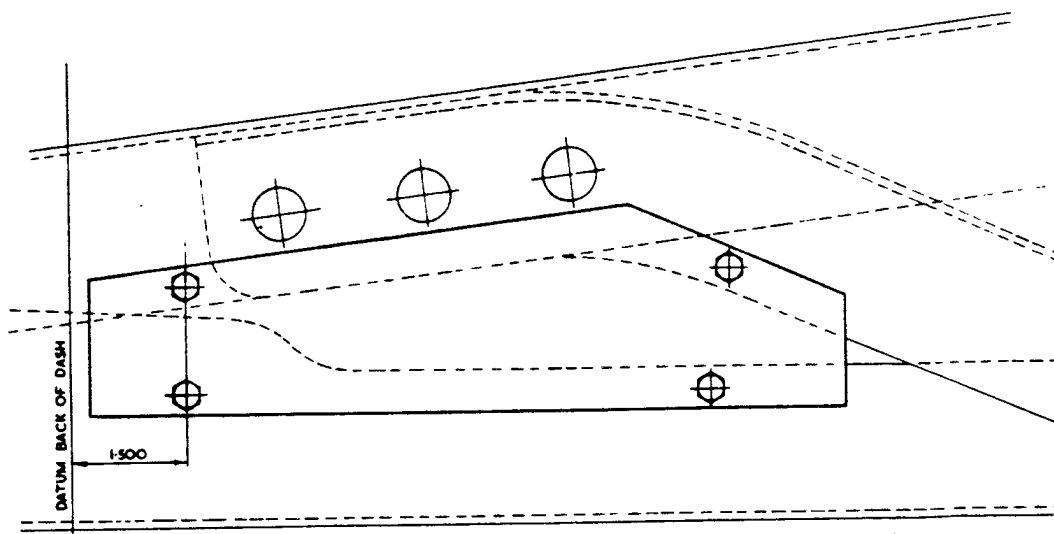
FIG. 1 FITTING OF UNDER-FRAME COVER PLATE.

Further to the above, it is recommended that additional protection plates for the throttle control countershaft on the right-hand side frame member are also fitted whenever this modification is incorporated on early type chassis.

1. Fit the under-frame cover plate (RF-6209) as shown in Fig. 1.
 - a) Offer up the plate, and mark off the relative positions for the four retaining setscrews.
 - b) Drill the four holes 0.1562" dia., and then tap 2 BA (31 T.P.I. R/H).
 - c) Fit the cover plate.

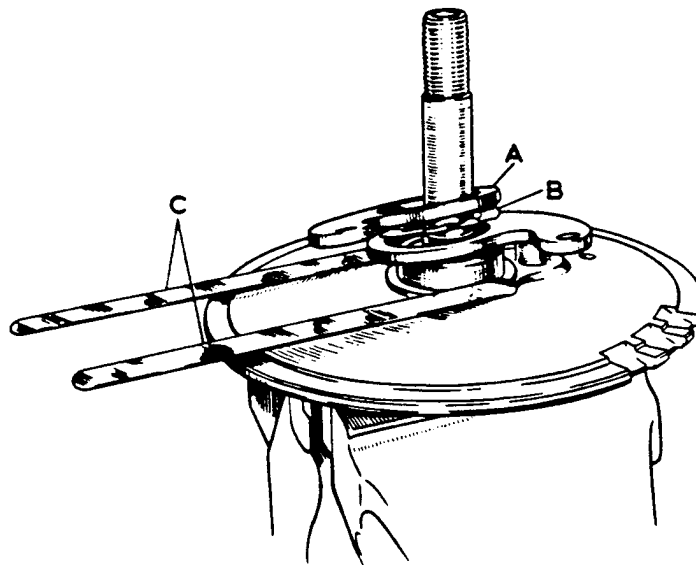
FIG.2.
A. Brake Actuating Lever. B. Servo Washer (R.5037).
C. Feeler Gauges.

1. From approximately B-311-YA and onwards a spring clip was fitted to the upper brake actuating lever to eliminate servo "clonks", this will have to be removed if it fouls the corrugated washer when compressed.
2. Under certain circumstances it has been found that owing to servo manufacturing limits, difficulties have arisen in fitting the corrugated washer, and in order to overcome this, and to ensure a long service life, the following method of fitting is to be employed.

The complete servo motor is to be removed, dismantled, and a packing washer approximately .0625" thick placed between the pressure plate

and the flange on the servo shaft. The servo is then placed in a vice as shown (Fig.2), the corrugated washer fitted into position, and the servo assembled. The adjusting nut is tightened fully home, thus compressing the corrugated washer.

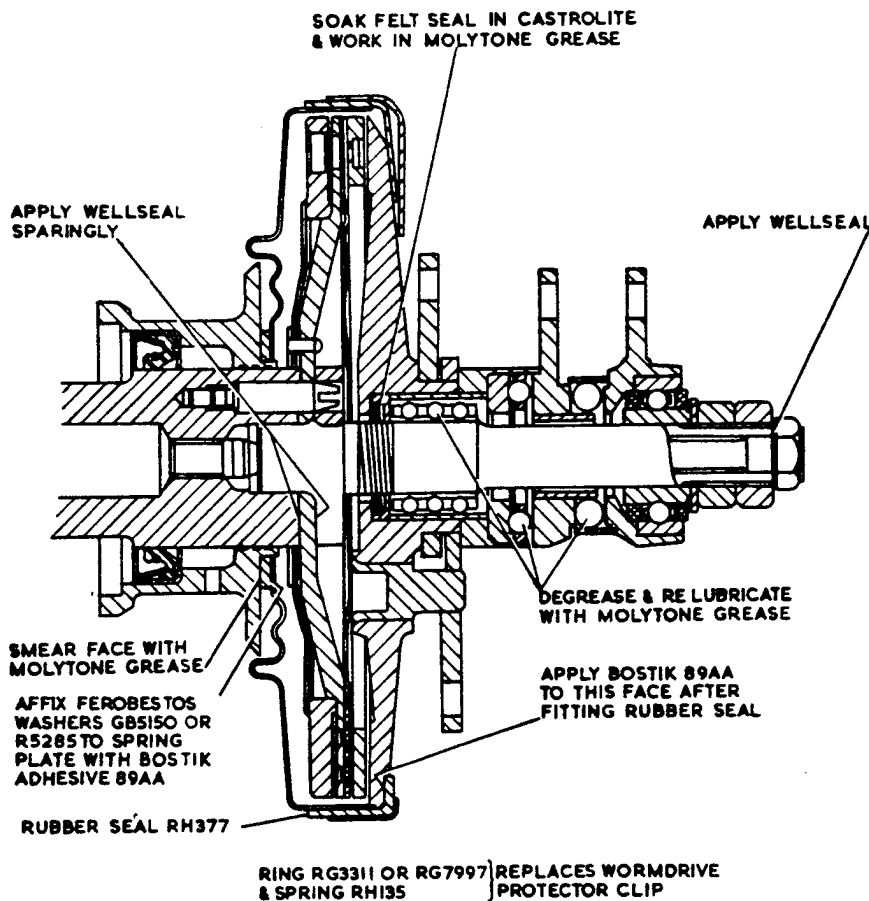
FIG. 1.

Where inspection of the liner shows the presence of oil, the source of oil leakage must first be ascertained and rectified.

Before re-assembling, the following modifications are required, if not already incorporated.
