# TEE-ONE TOPICS

Number 35 May, 2004

## THE DESIGN HISTORY OF A V8 ENGINE

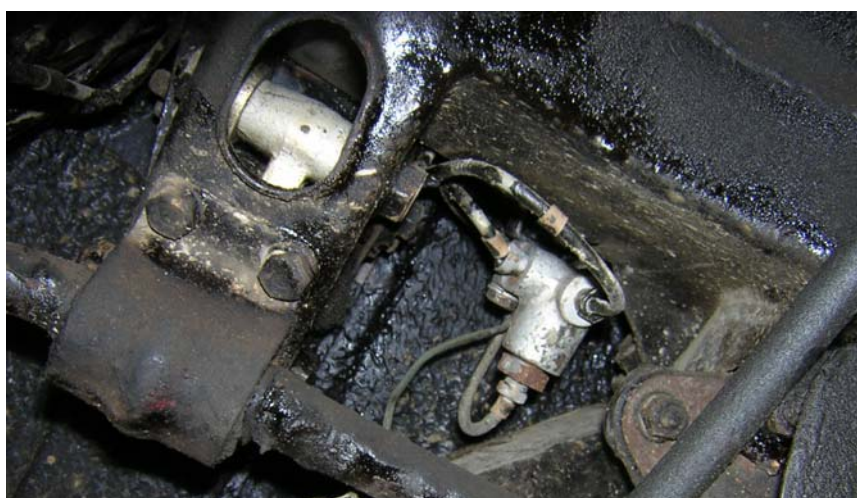
This strange little object with the pipes protruding from it can be seen if you care to lie under your Shadow at the rear, is a hydraulic restrictor. It is one of two and among other functions
